U.S. Department of Housing and Urban Development  
Office of Policy Development and Research

# ***Assessing Housing Durability: A Pilot Study***

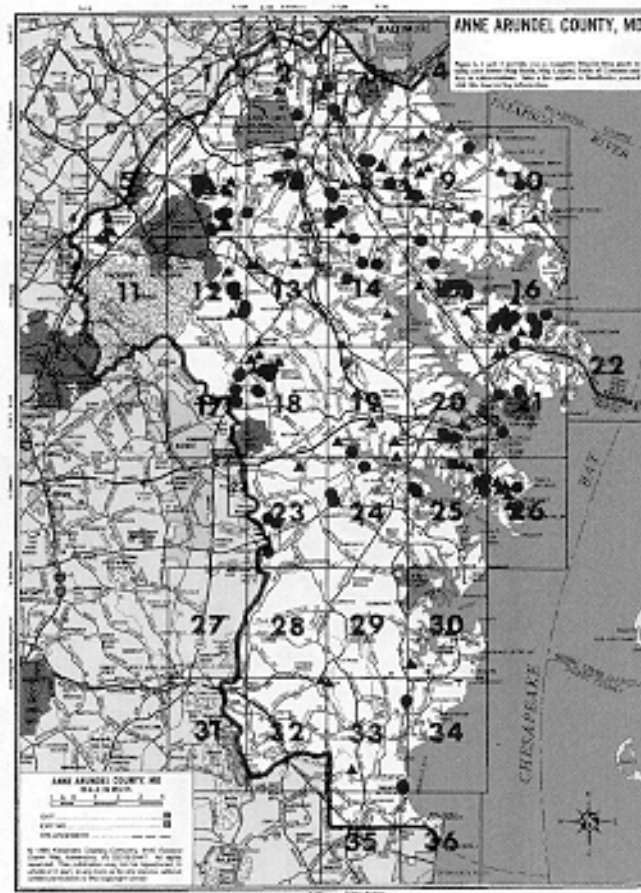
**Figure 1**  
**Study sample region.**  
(Anne Arundel County, MD)

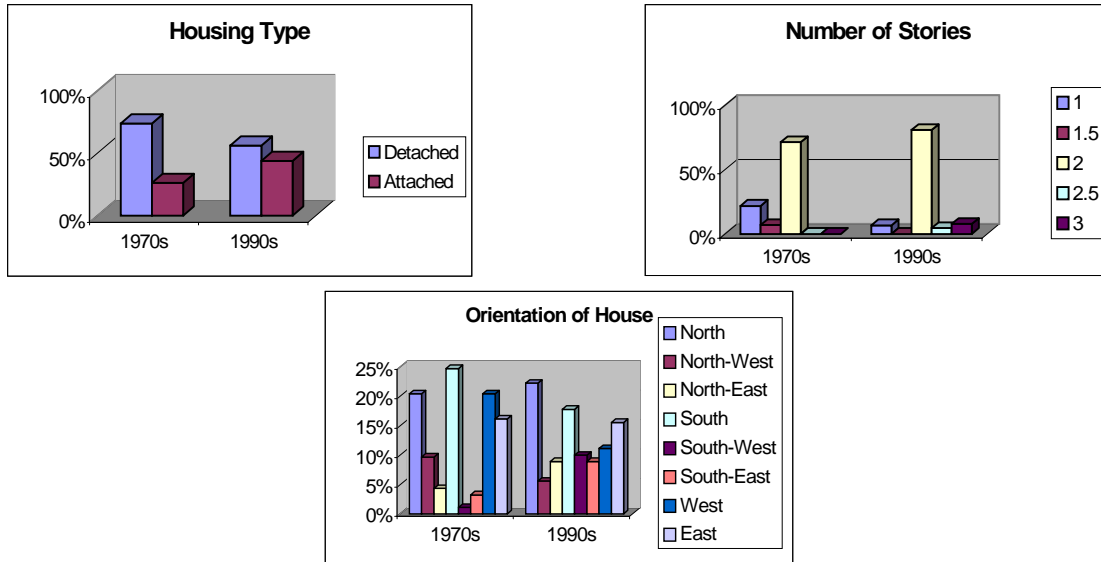
**Figure 2**  
General sample housing characteristics.

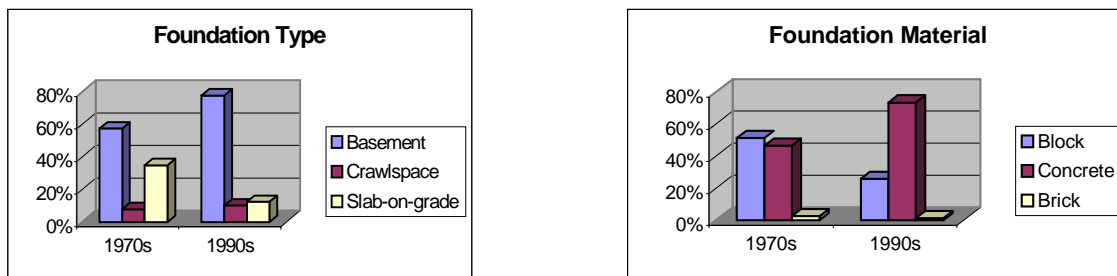
**Figure 3**  
Foundation characteristics of sampled homes.

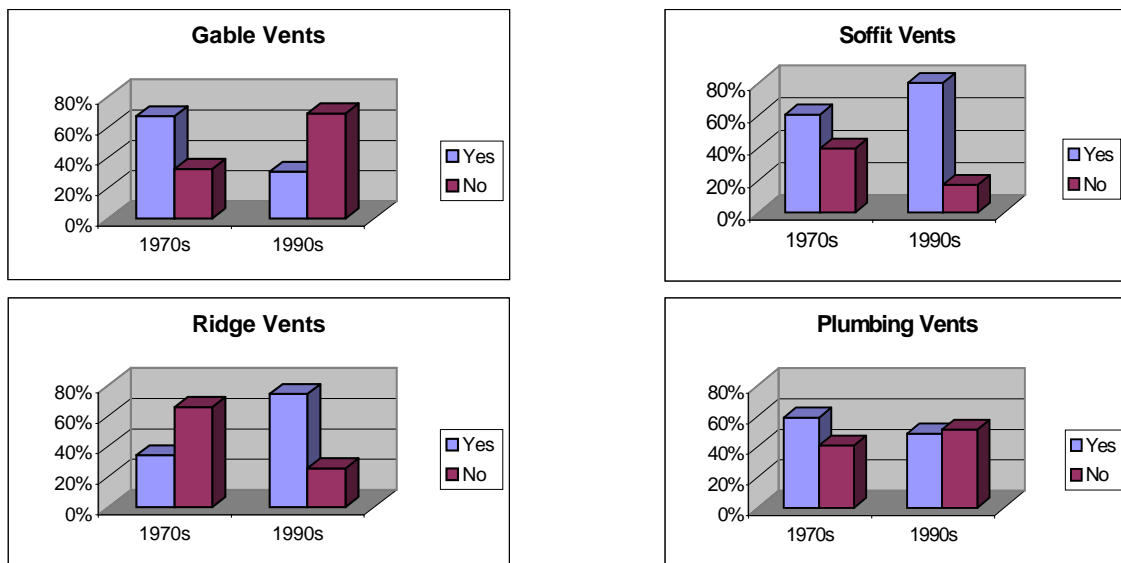
**Figure 8**  
Roof venting and penetrations.

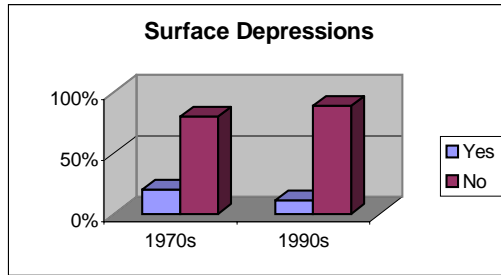
**Figure 12**  
**Frequency of surface depressions observed on sampled sites.**

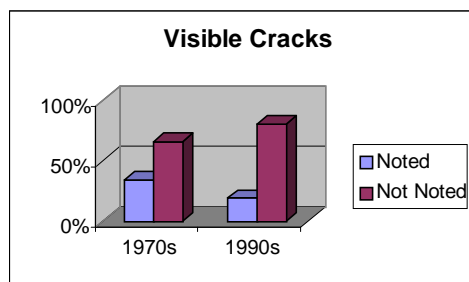
**Figure 13**  
**Frequency of observed foundation cracks on sampled homes.**

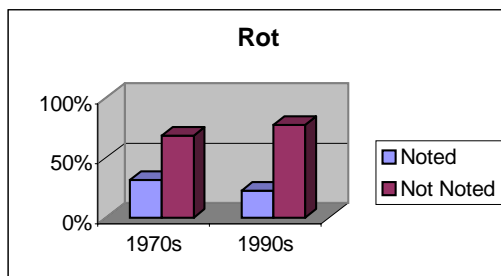
**Figure 14**  
**Frequency of observed rot in sampled homes.**

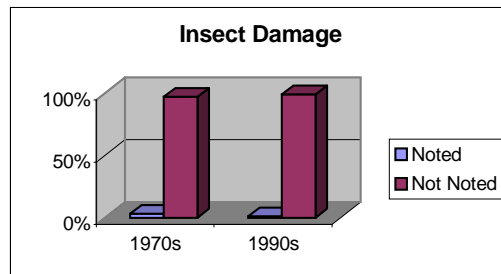
**Figure 15**  
Frequency of observed termite damage.

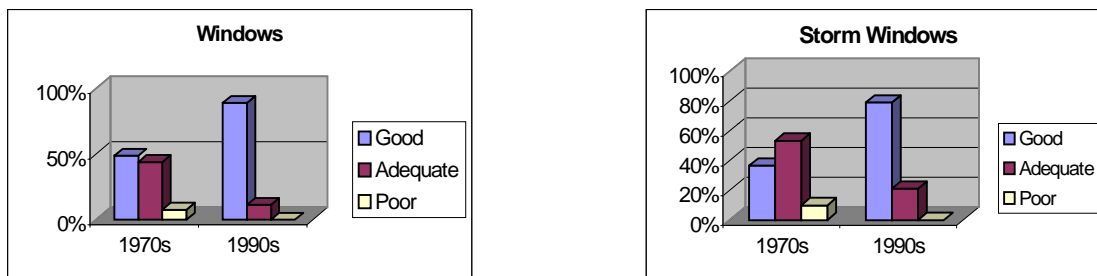
**Figure 16**  
Window condition ratings of sampled homes.

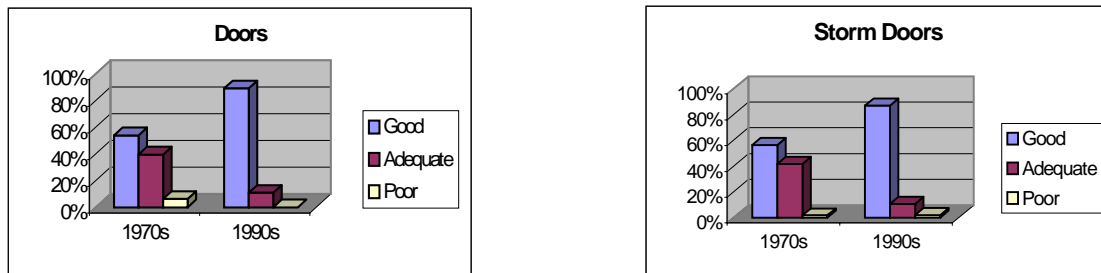
**Figure 17**  
Door condition ratings of sampled homes.

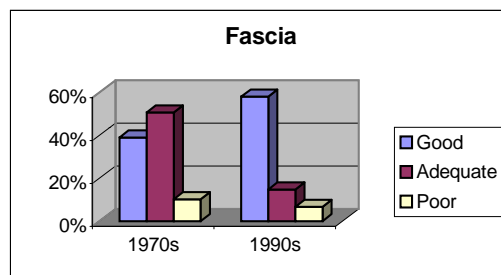
**Figure 18**  
Fascia condition ratings.

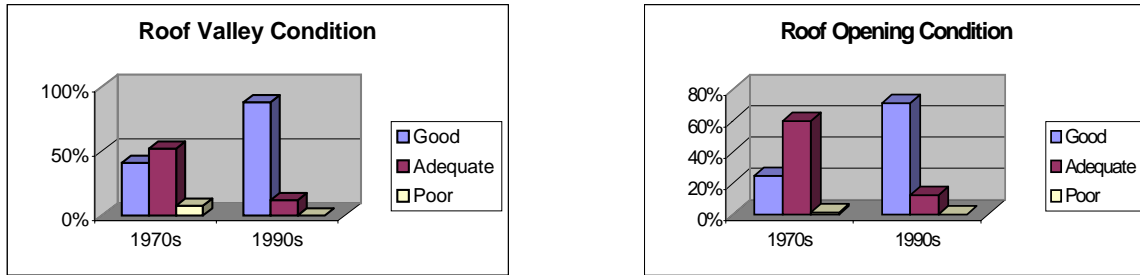
**Figure 19**  
Condition ratings of roof features.

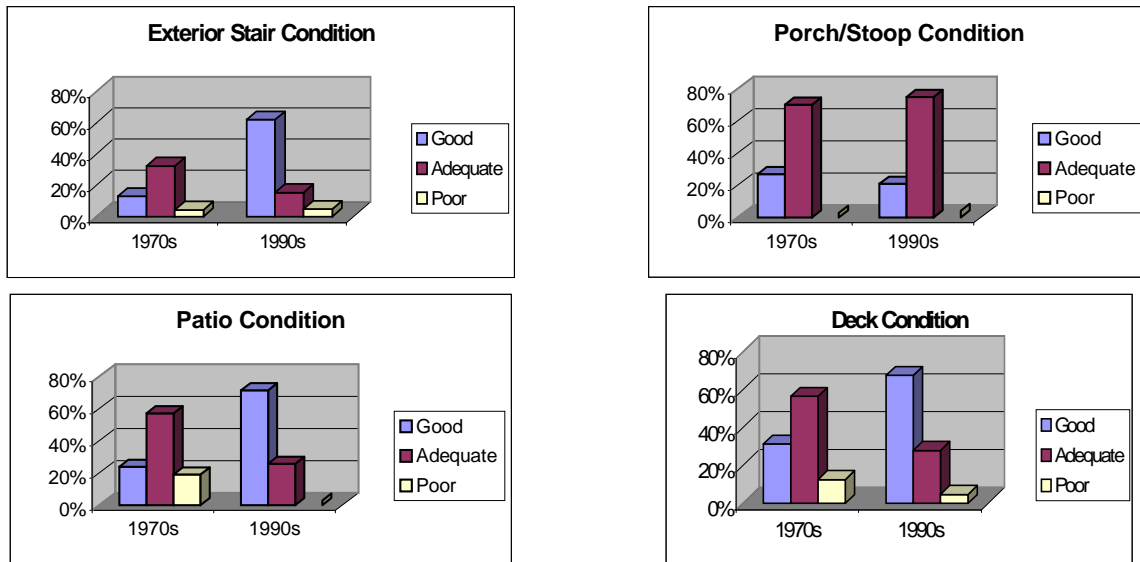
**Figure 20**  
Ratings of exterior stair, porch, patio, and deck condition.

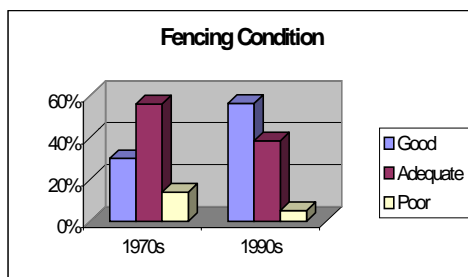
**Figure 21**  
Rating of fencing condition.

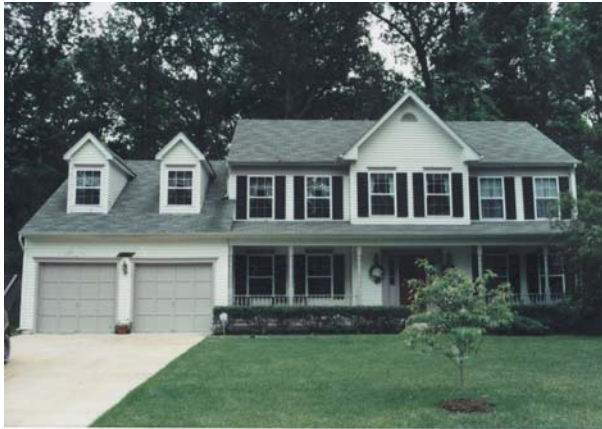
**Figure 22**  
Example of good rating for site grade and drainage.

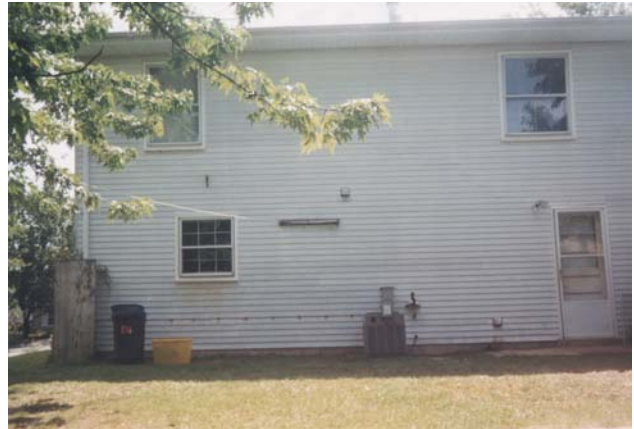
**Figure 23**  
Example of poor rating for site grade and drainage.

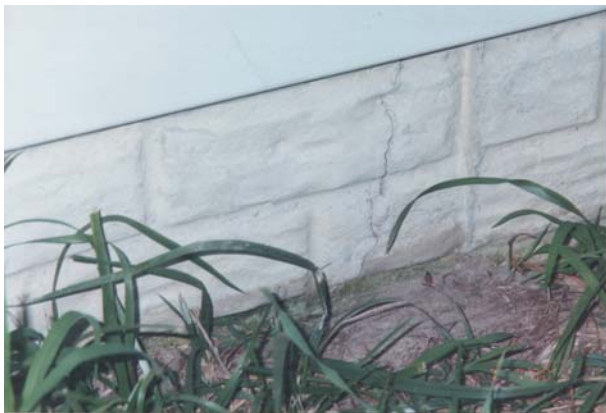
**Figure 24**  
A typical small crack found in a concrete foundation wall.

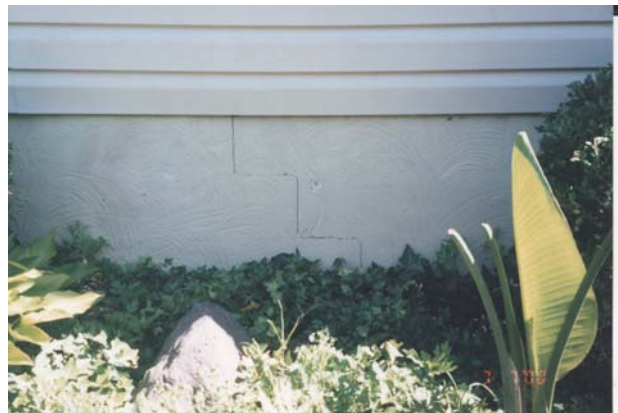
**Figure 25**  
A typical small crack found in a masonry foundation wall.

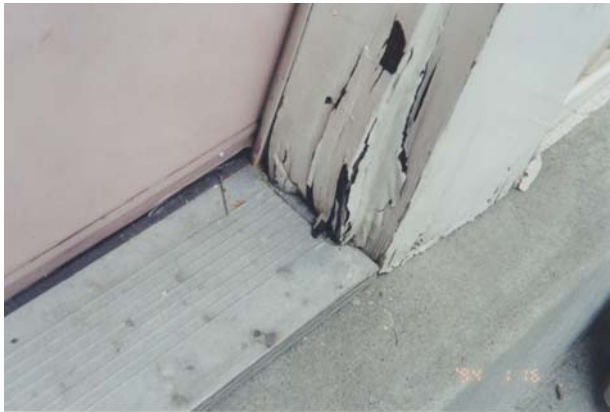
**Figure 26**  
Rot at the bottom of a door frame in a 1990s sample house.

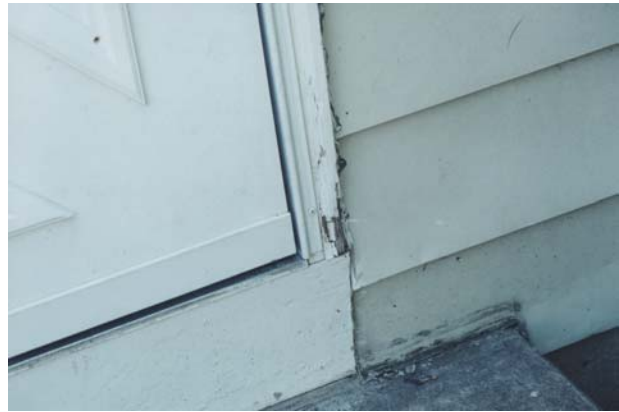
**Figure 27**  
Rot at the bottom of a door frame and trim in a 1970s sample house.

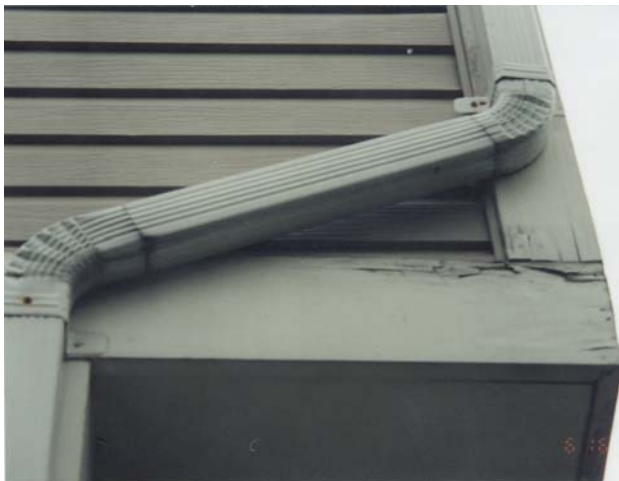
**Figure 28**  
Rot in exterior wood trim of a 1990s sample house.

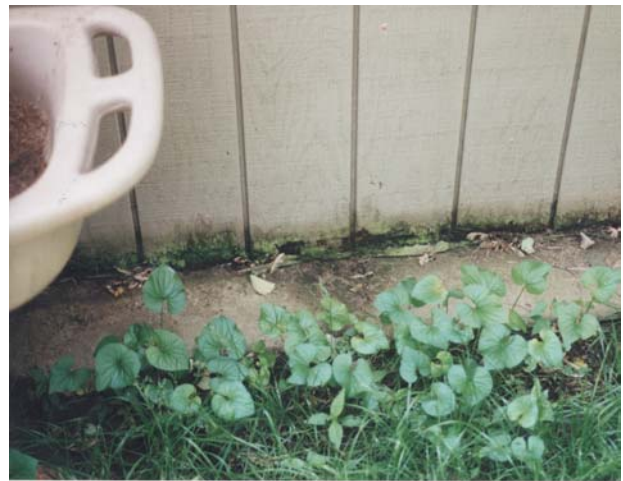
**Figure 29**  
Rot at the bottom of wood panel siding (insufficient ground clearance) in a 1970s sample home.

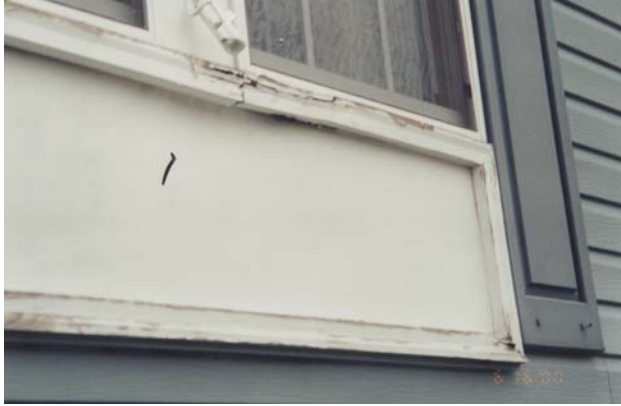
**Figure 30**  
**Rot in wood trim associated with poor detailing (i.e., lack of cap flashing) and maintenance in a 1990s sample home.**

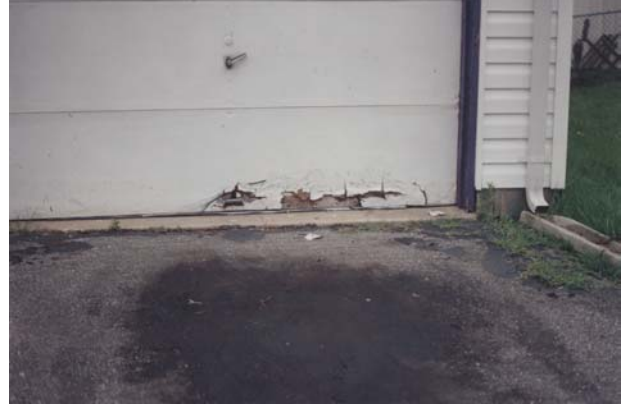
**Figure 31**  
**Rot of wood composite panel on a garage door (1970s house sample).**

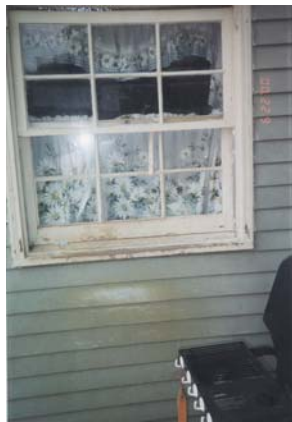
**Figure 32**  
**Abnormal wear and tear on a wood window as an apparent result of pet scratching.**

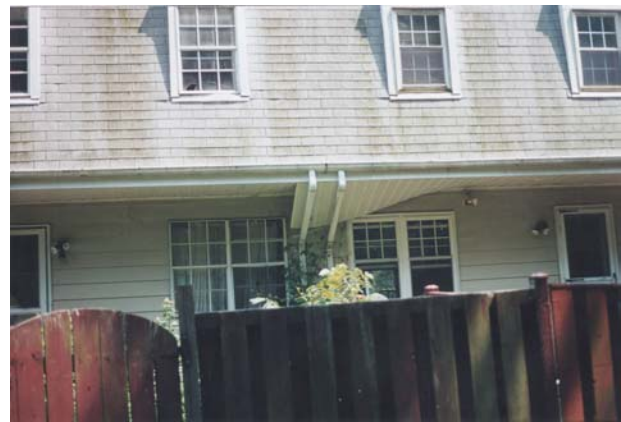
**Figure 33**  
**Broken window pane on second-story window.**

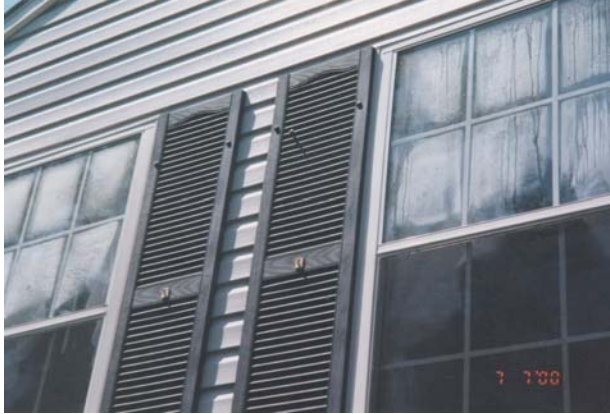
**Figure 34**  
Condensation inside double-pane windows.

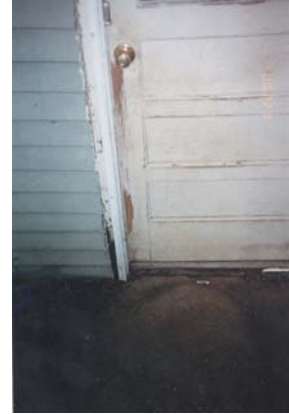
**Figure 35**  
Abnormal wear and tear on a wood door as an apparent result of pet scratching.

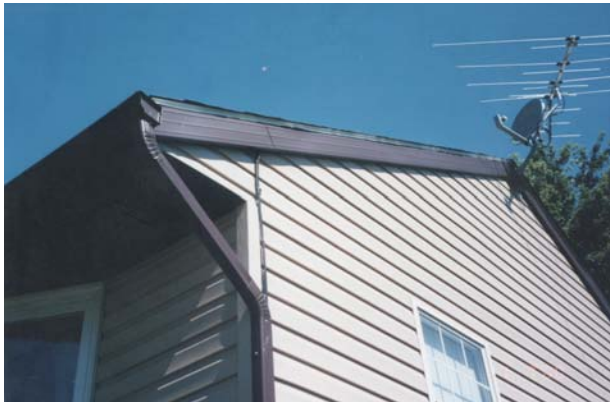
**Figure 36**  
Example of aluminum fascia covering older fascia material on a 1970s sample house (rated good by inspector).

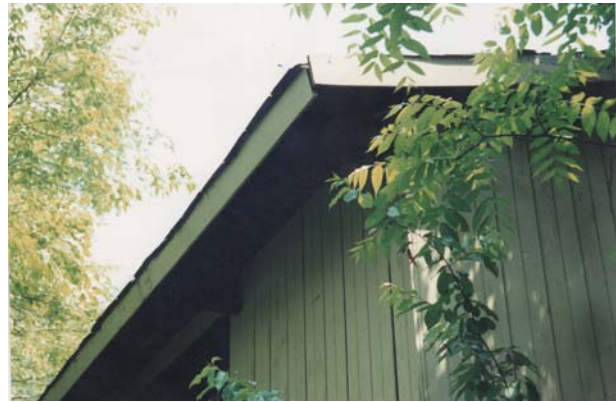
**Figure 37**  
1970s sample house with wood fascia needing minor repair (rated adequate by inspector).

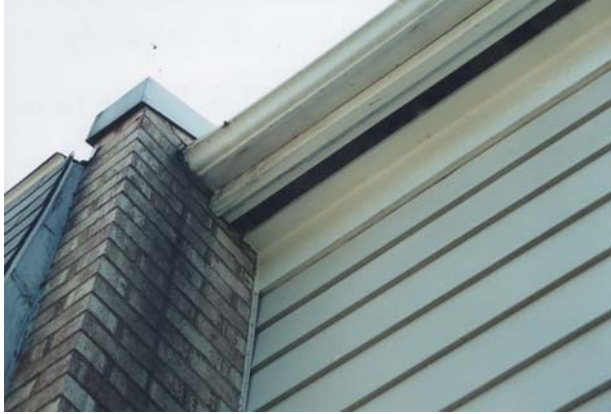
Figure 38 shows that the wood fascia of a 1970s townhouse was also subject to rot at end joints at the brick party wall. Figures 39 and 40 illustrate a failed gutter and damaged soffit for two 1970s sample homes. Other problems with gutters are shown in Figures 41 through 45.

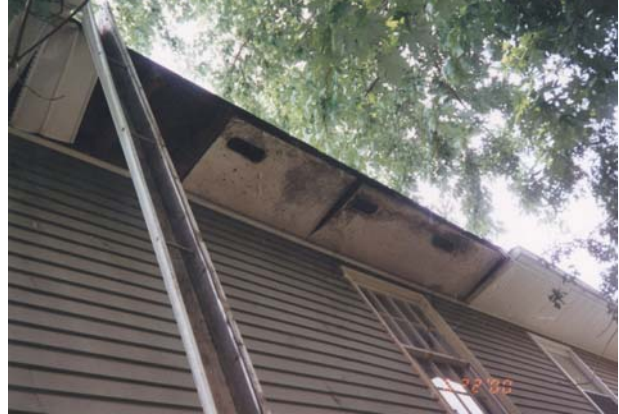
Fascia with a poor rating due to signs of rot and paint failure at butt joint to a party wall on a 1970s townhouse sample.

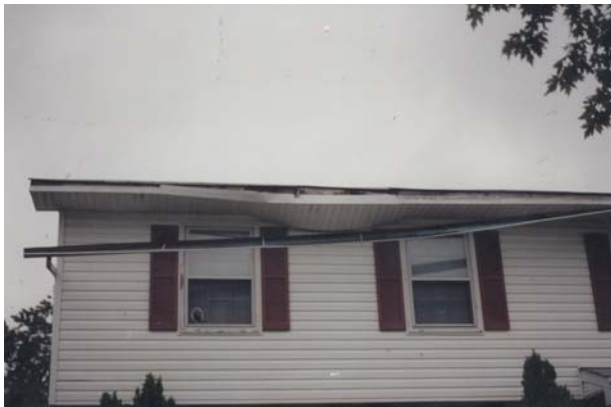
Failed gutter and signs of water damage to soffit on a 1970s duplex house sample.

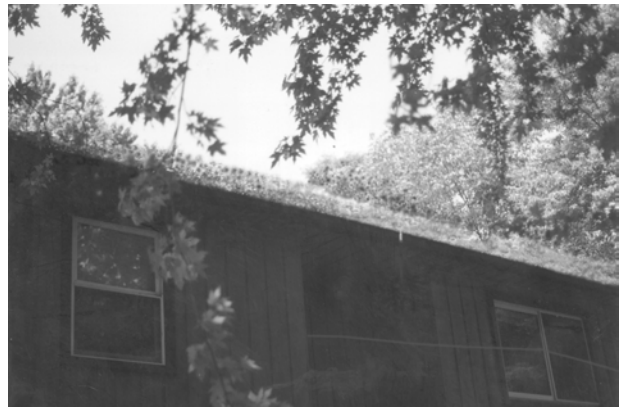
Failed guttering and signs of water damage on wood fascia underneath aluminum fascia cover (1970s house sample). Note paint failure on window frames.

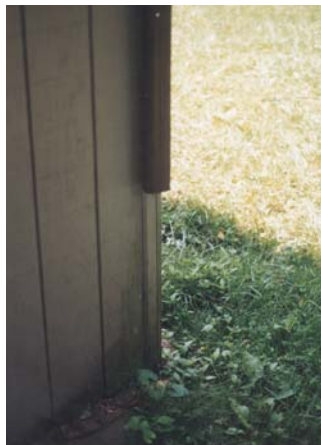
Vegetation growing in poorly maintained gutter.

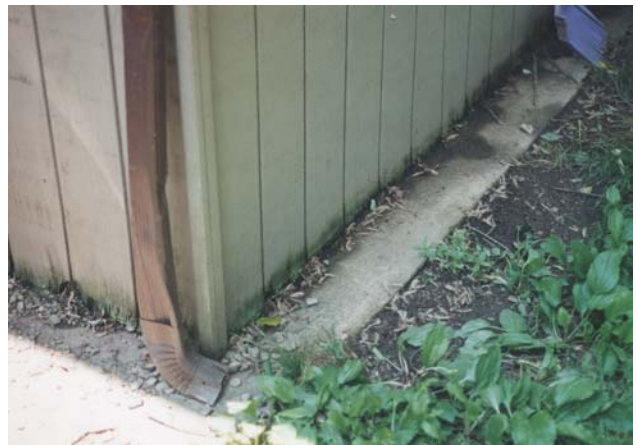
Failure to maintain outfall of gutter downspout. Note that wood panel siding does not have sufficient ground clearance.

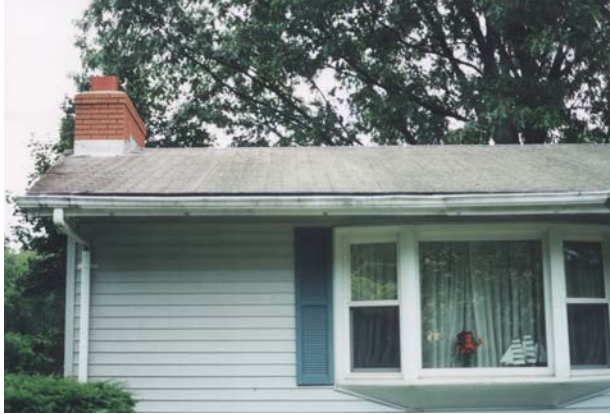
**Figure 44**  
**Sagging gutter.**

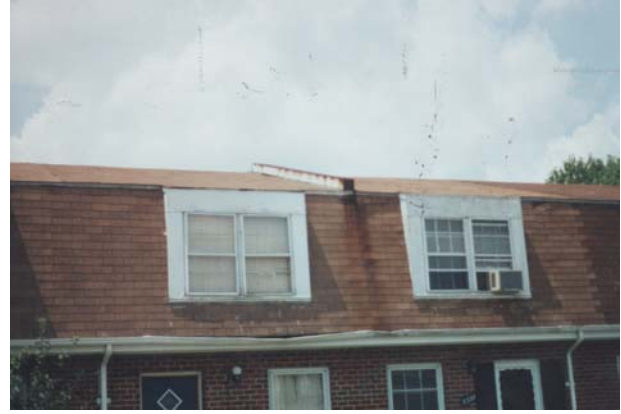
**Figure 45**  
**Rusting party wall cap flashing and damaged gutters.**

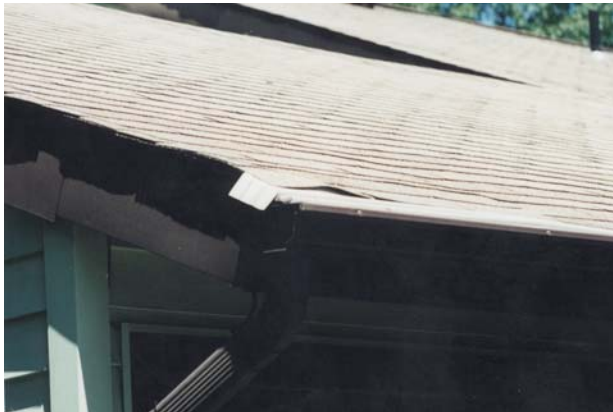
**Figure 46**  
**Example of a 1970s house sample with roofing rated as adequate.**

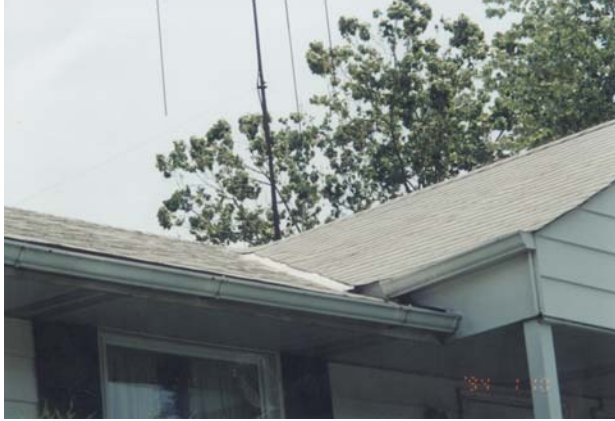
**Figure 47**  
**Example of a 1990s house sample with roofing rated as adequate.**

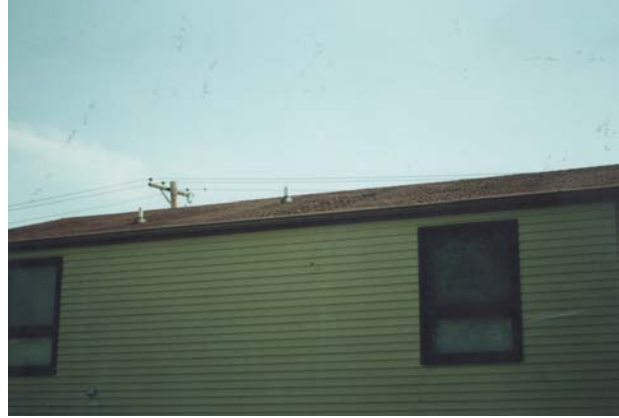
**A 1970s house with a poor roof based on improper valley flashing and curled shingle tabs on the left roof surface.**

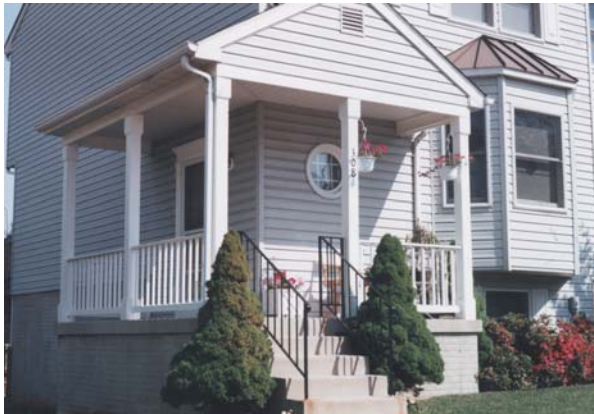
This section addresses porches, decks, and sidewalks. Figures 50 and 51 show the porches of two 1990s and 1970s sampled homes that were rated as good. In each case, the porch floor was concrete and wood, where used, was adequately protected from weather and moisture. However, wood deterioration was evident on the porches of the 1970s and 1990s house samples as shown in Figures 52 and 53, respectively.

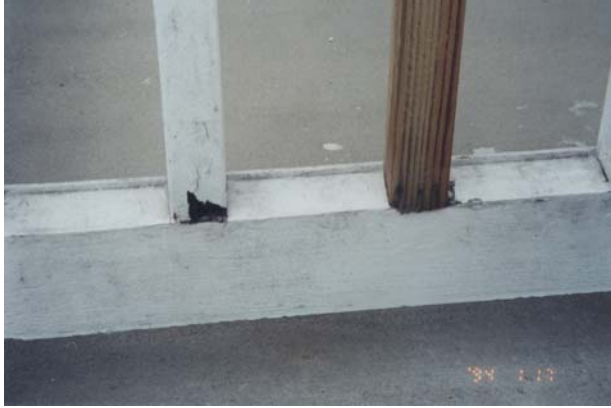
**Figure 52**  
**Rot in a wood picket on the porch of a 1970s sample home (one picket has been replaced with treated wood).**

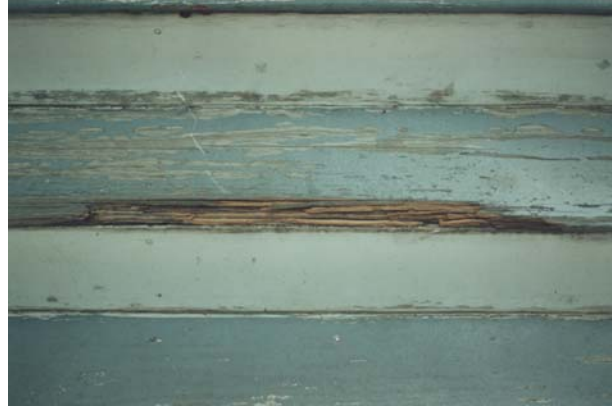
**Figure 53**  
**Wood floor boards under the porch roof of a 1990s house sample show signs of deterioration.**

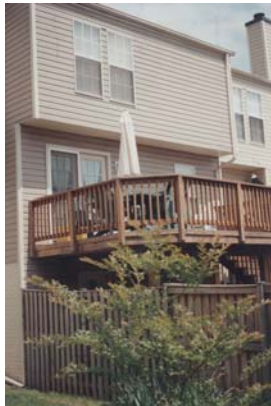
**Figure 54**  
**Example of a wood deck in good condition (1990s house sample).**

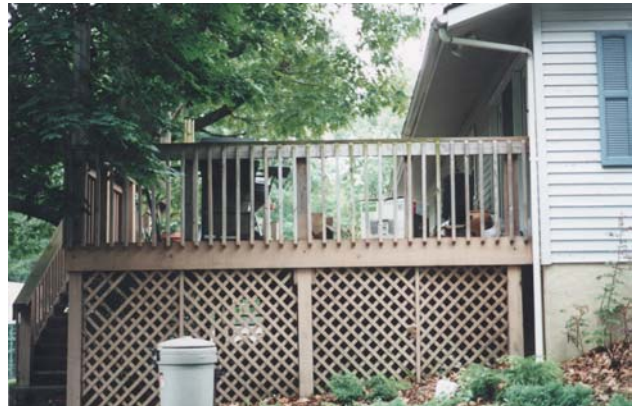
**Figure 55**  
**Example of a wood deck in good condition (1970s house sample; age of deck unknown).**

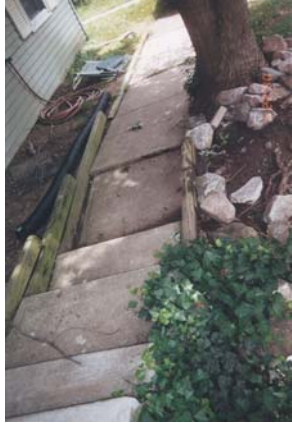
Figure 56 shows an example of a sidewalk in poor condition for a 1970s sample home. Uplift of the sidewalk was caused by growth of a tree planted too close to the sidewalk. In Figure 57, ponding of water on a sidewalk adjacent to a 1990s house sample is apparent immediately following rain. The downspout and splash block discharge to the sidewalk surface.

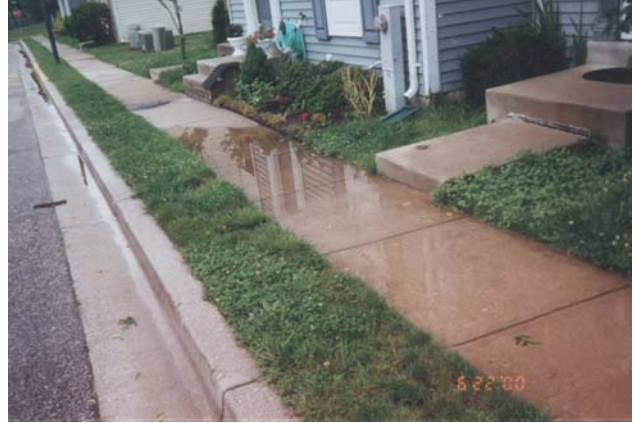
**Sidewalk of a 1970s sample house in poor condition due to root movement and growth of a closely located tree.**
