Assessment of Damage to Single-Family Homes Caused by Hurricanes Andrew and Iniki

This report, *Assessment of Damage to Single-Family Homes Caused by Hurricanes Andrew and Iniki*, evaluates the performance of houses damaged by these hurricanes. Extensive data collection, statistical analysis, and observations provide a realistic perspective on the damages that can guide decisions related to housing in hurricane-prone areas. While comprehensive in detail, this report also identifies the major problems in home construction that can lead to productive improvements in hurricane resistant housing.

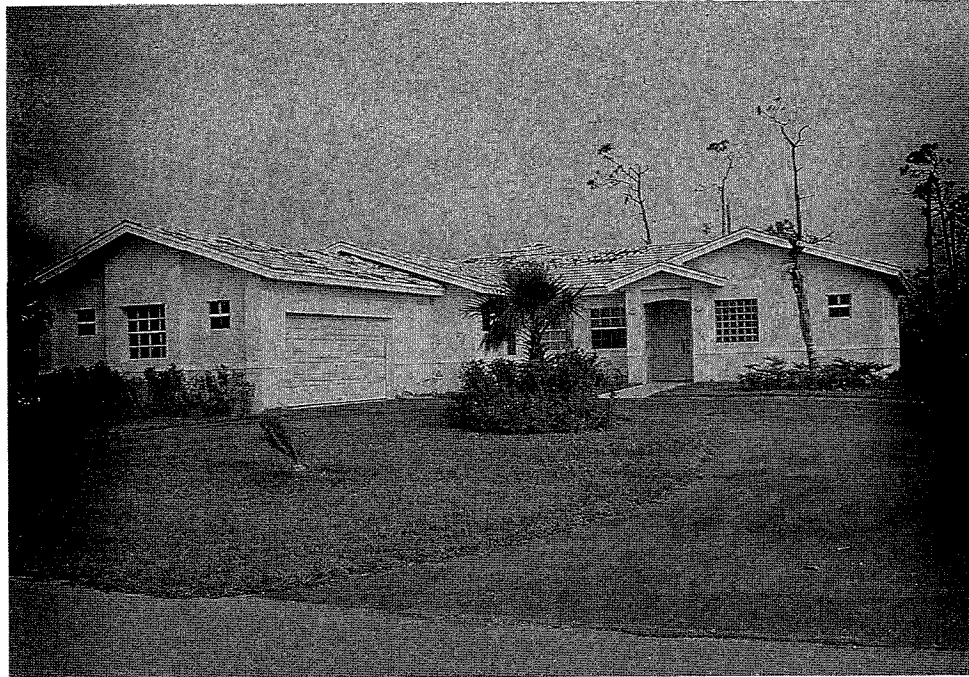
DAMAGE RATING SUMMARY	
OVERALL	1
ROOF	1
WALLS	1
INTERIOR	X
FOUND.	1
GRID	B

Figure 10. Wind-damaged home with a none to one-third (Level 1) damage rating for the overall building condition. This house had an open inland exposure to the wind. Only one window was broken and the garage door was dented. ("X" means not specified or not accessible to the grader.)

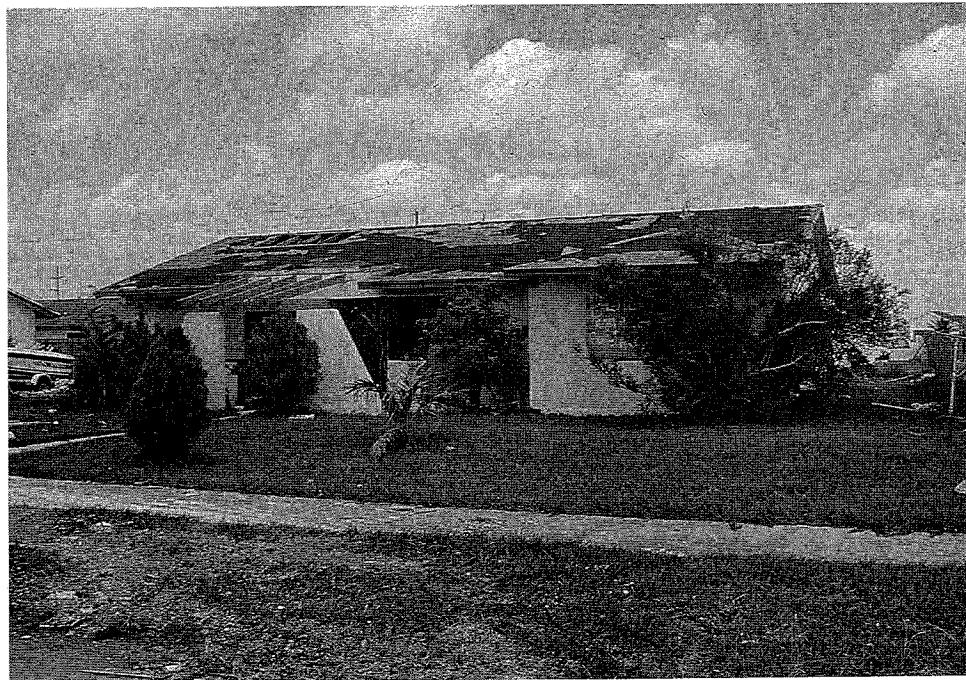
DAMAGE RATING SUMMARY	
OVERALL	2
ROOF	2
WALLS	1
INTERIOR	3
FOUND.	1
GRID	H

Figure 11. Wind-damaged home with a one-third to two-thirds (Level 2) damage rating for the overall building condition. This level of damage is considered representative of the overall damage to the housing stock in the survey.

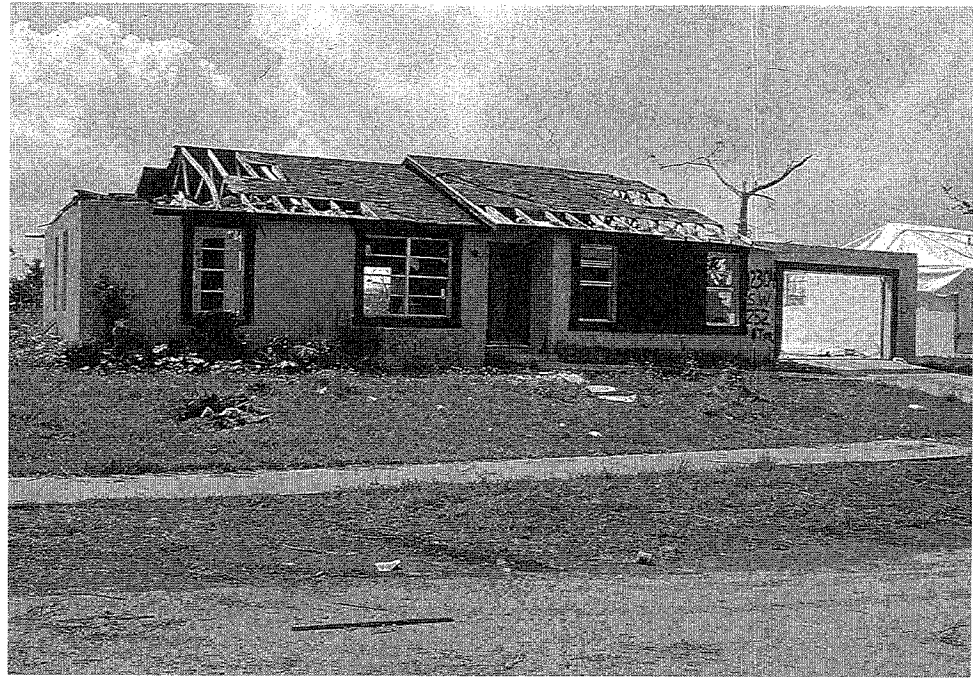
DAMAGE RATING SUMMARY	
OVERALL	3
ROOF	3
WALLS	1
INTERIOR	3
FOUND.	1
GRID	E

Figure 12. Wind-damaged home with over two-thirds (Level 3) rating for the overall building condition. Both gable ends are destroyed, the roof over the garage is gone, many pieces of sheathing are missing, and all doors and windows were severely damaged.

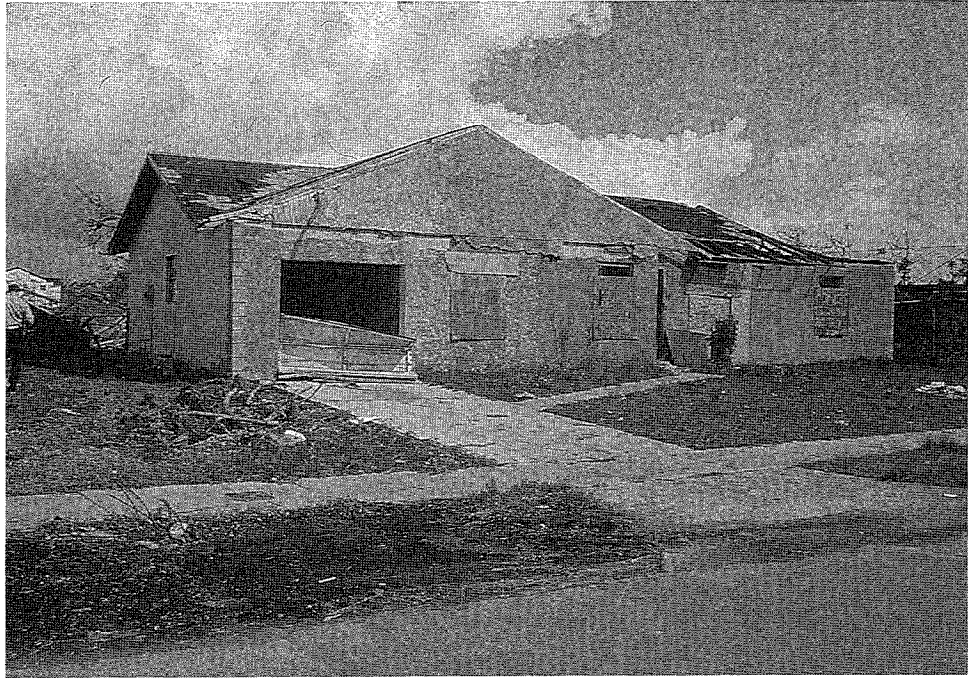
DAMAGE RATING SUMMARY	
OVERALL	3
ROOF	3
WALLS	1
INTERIOR	3
FOUND.	1
GRID	E

Figure 14. Example of a one-story, wind-damaged house. This home had three gable-end walls of which two failed.

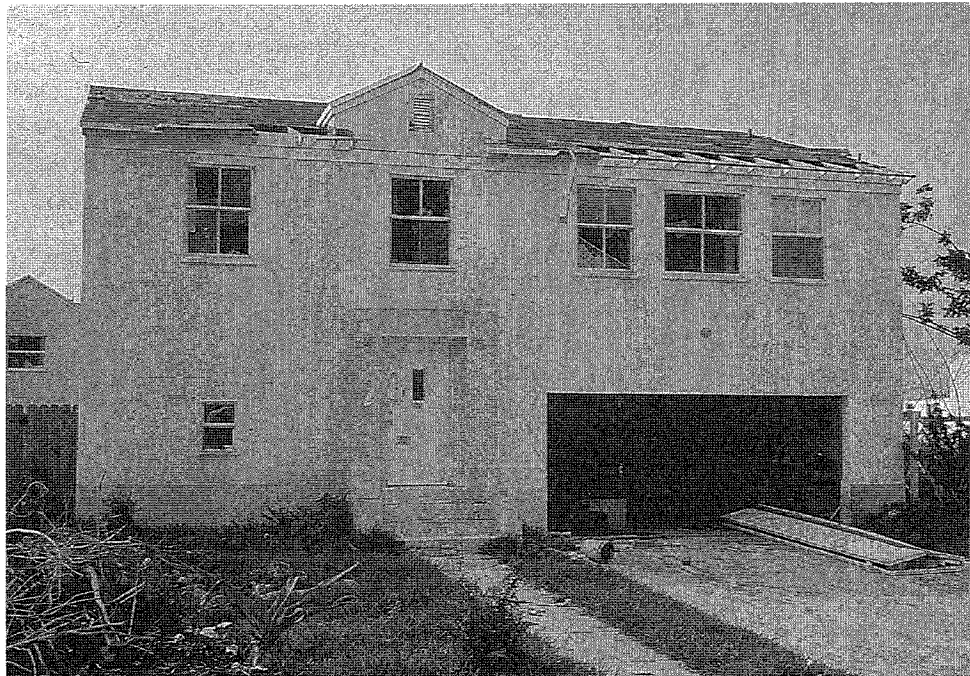
DAMAGE RATING SUMMARY	
OVERALL	3
ROOF	3
WALLS	1
INTERIOR	3
FOUND.	1
GRID	F

Figure 15. Example of a two-story, wind-damaged house (concrete block). It was noted that all windows were broken and that sheathing was lost from the roof perimeter. The gable ends did not collapse, but the water damage was substantial due to stripped shingles, broken windows, and lost sheathing.

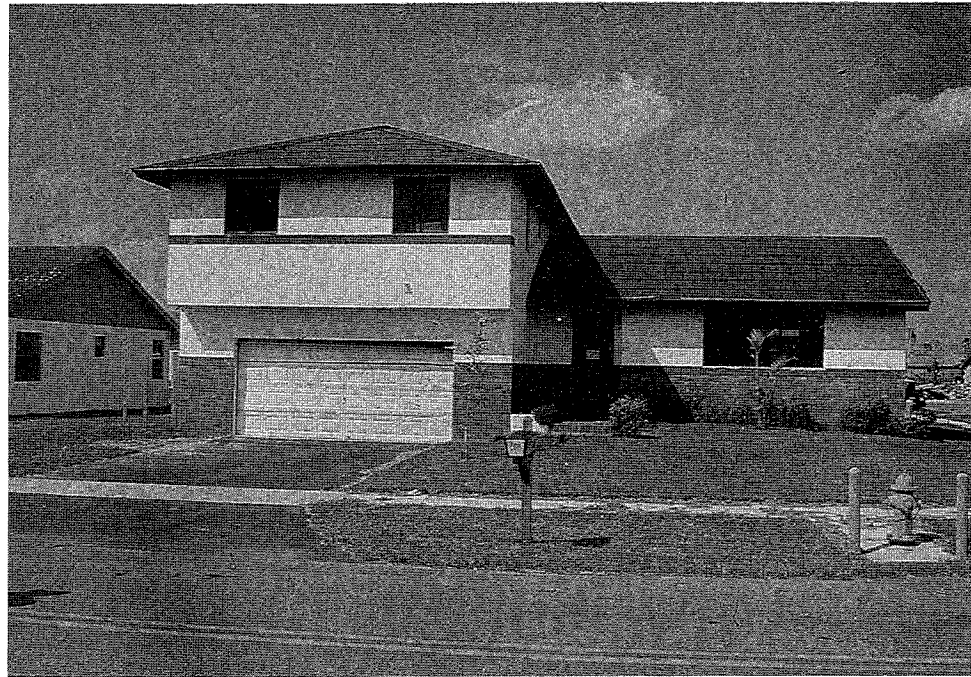
DAMAGE RATING SUMMARY	
OVERALL	2
ROOF	2
WALLS	1
INTERIOR	3
FOUND.	1
GRID	G

Figure 16. Example of a two-story, wind-damaged house. The wood-frame second story of this house was stressed, but it survived. The crucial damage was from water entering through broken windows, damaged roof coverings and some lost sheathing panels.

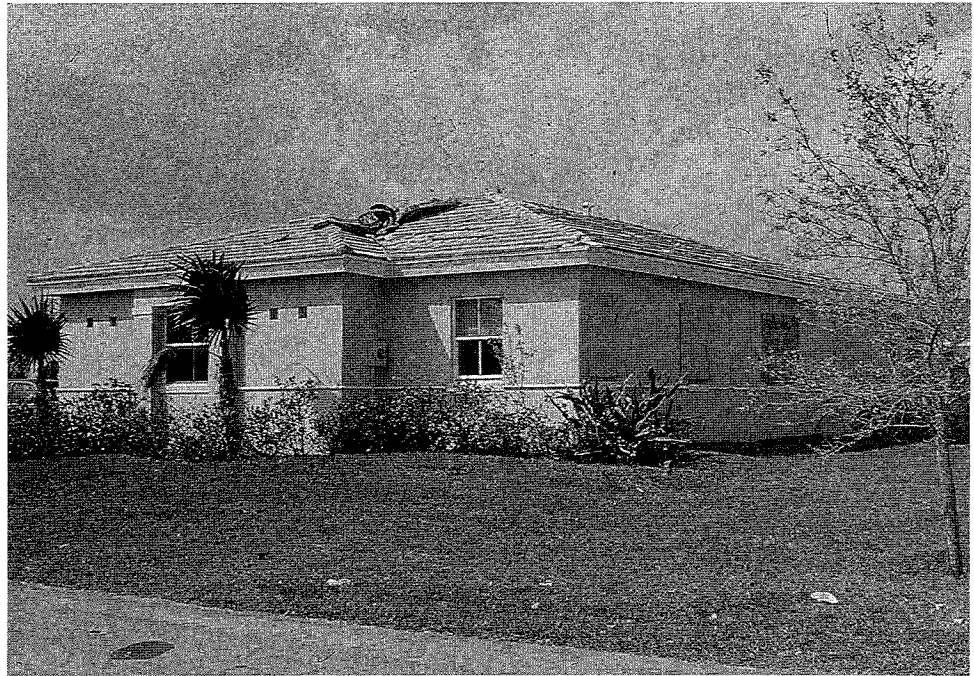
DAMAGE RATING SUMMARY	
OVERALL	1
ROOF	1
WALLS	1
INTERIOR	1
FOUND.	1
GRID	A

Figure 20. A low-profile hip roof with minimal wind damage. Loss of unprotected windows was the primary reason for the limited water damages noted on the survey sheet.

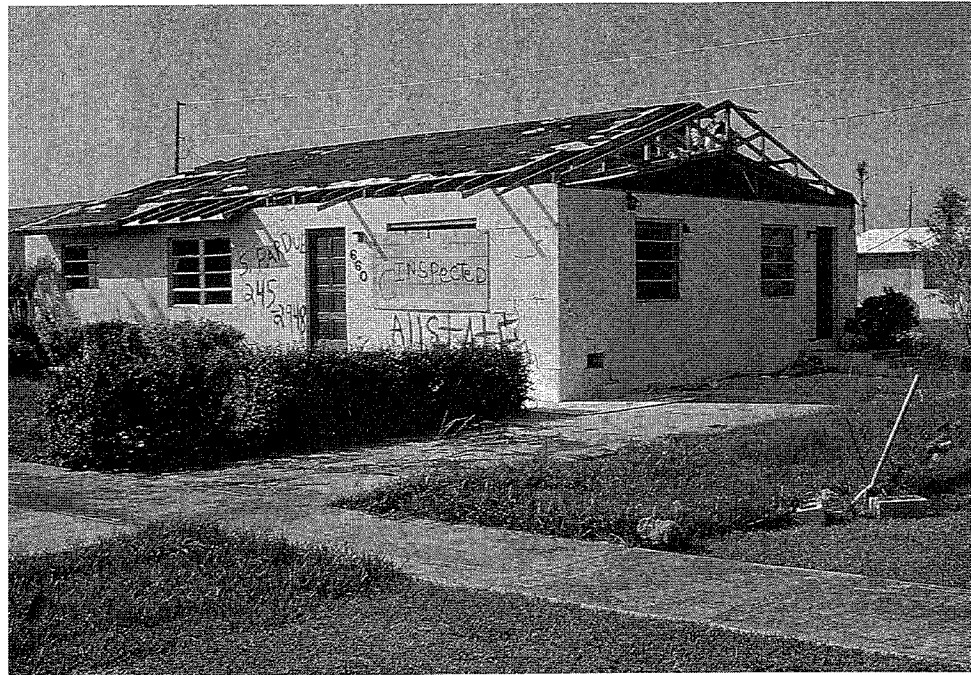
DAMAGE RATING SUMMARY	
OVERALL	3
ROOF	3
WALLS	3
INTERIOR	3
FOUND.	1
GRID	1

Figure 26. Loss of roof sheathing in high-pressure areas of the roof, especially at gable ends where rake overhangs were commonly framed for appearance and not for strength. Note also the fracturing of the block wall.

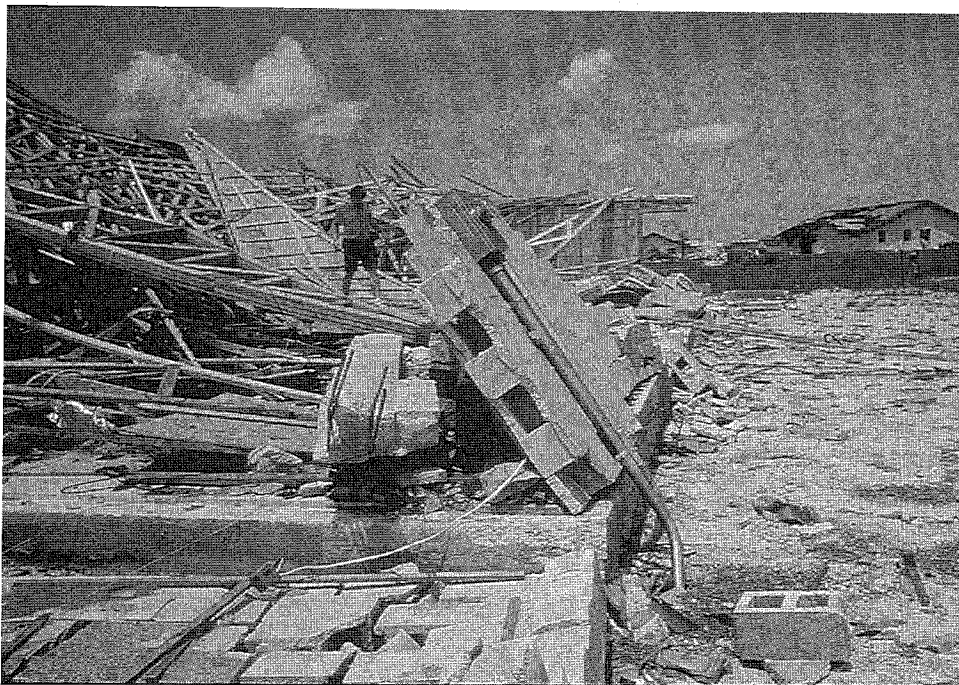
Figure 27. Wind damage to a CBS wall under construction. Note the rebar withdrawal at the corner of the concrete tie beam and the absence of rebar for the wall in the foreground.

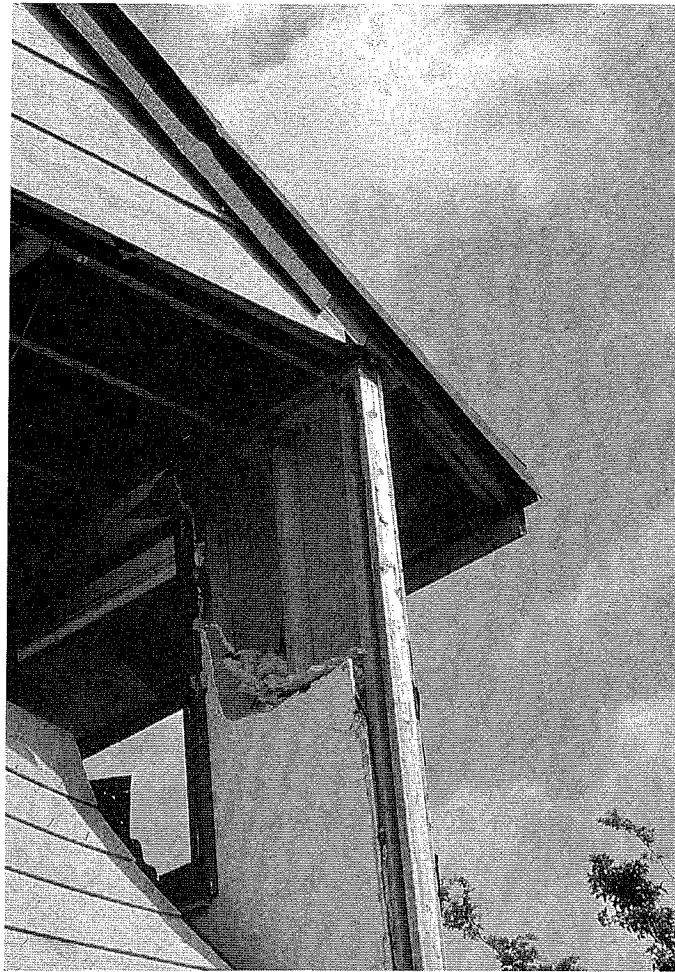
Figure 28. Wind damage to a wood-frame wall (two-story) showing improperly connected corner.

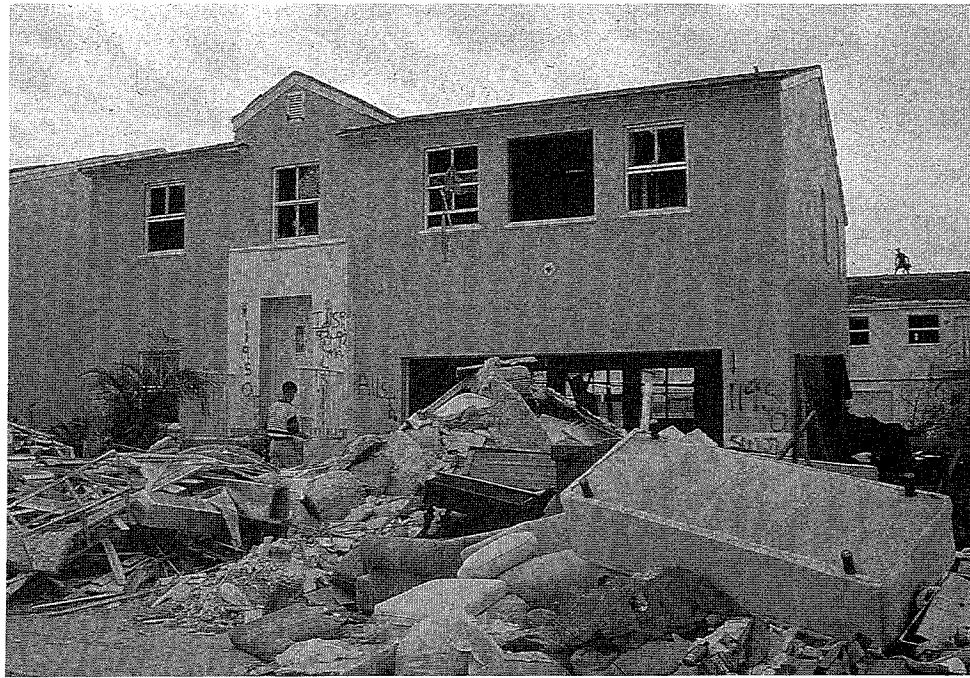
DAMAGE RATING SUMMARY	
OVERALL	3
ROOF	3
WALLS	1
INTERIOR	3
FOUND.	1
GRID	F

Figure 30. Items commonly damaged by water are piled in front of this home, which lost all of its windows, the garage door, much of the roof covering, and some roof sheathing. This severely damaged home is essentially intact structurally.

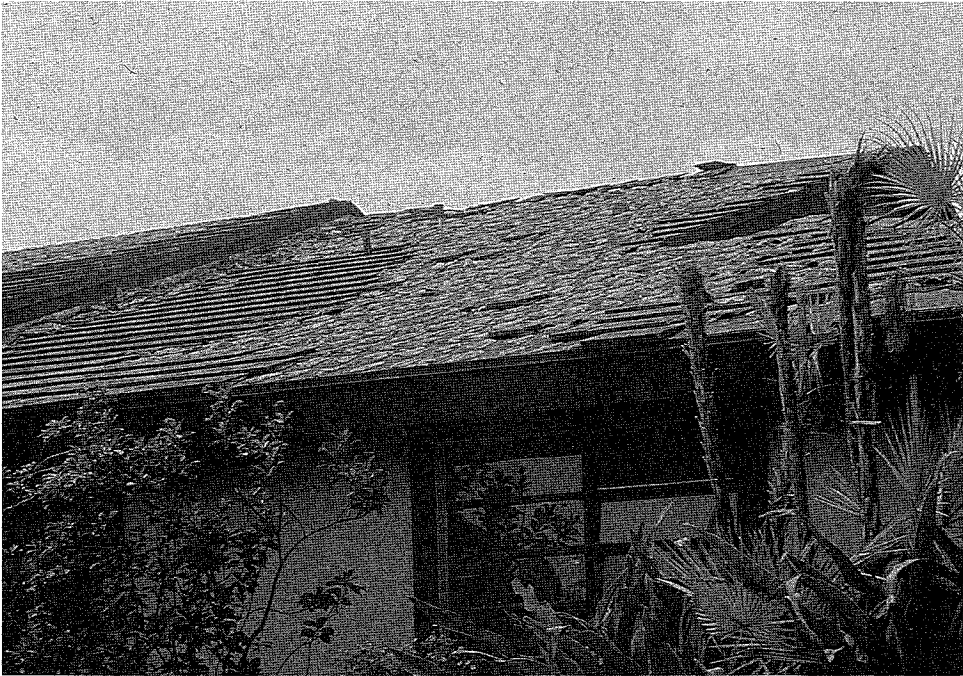
DAMAGE RATING SUMMARY	
OVERALL	1
ROOF	1
WALLS	1
INTERIOR	1
FOUND.	1
GRID	B

Figure 33. Wind damage to a flat tile roof. In part, the use of insufficient beds of cement mortar contributed to this unusual level of damage for flat tile roofing. Roofing underlayment prevented serious water damage. The "Roof" damage rating includes all elements of structural integrity along with water resistance.

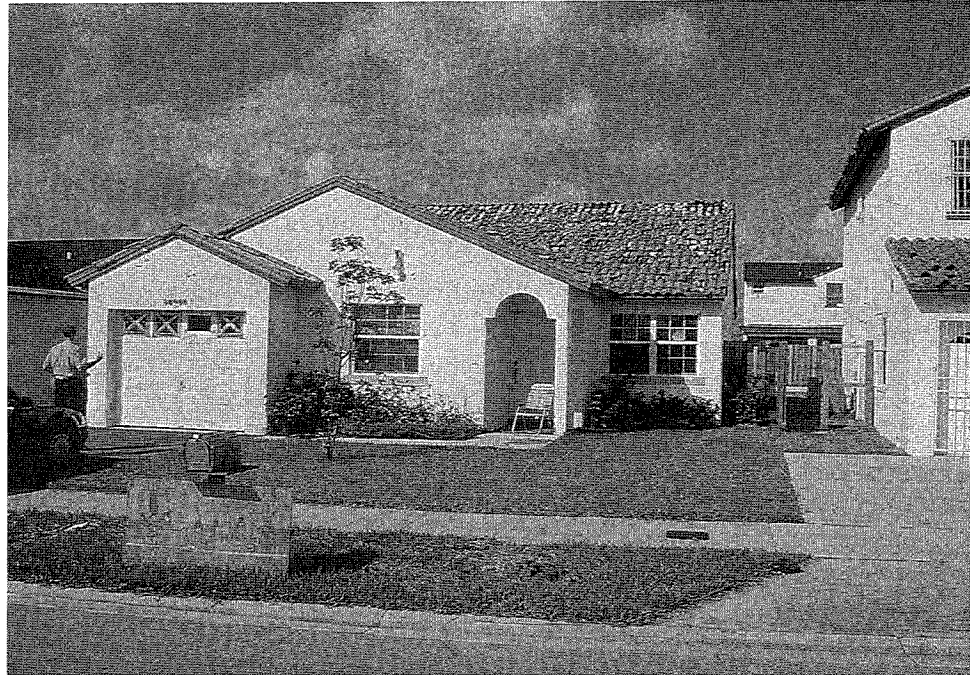
DAMAGE RATING SUMMARY	
OVERALL	1
ROOF	2
WALLS	1
INTERIOR	1
FOUND.	1
GRID	E

Figure 34. Wind damage to a barrel clay tile roof. In part, the use of insufficient beds of cement mortar contributed to this level of damage for some barrel-clay tile roofing. Roofing underlayment normally prevented serious water damage.

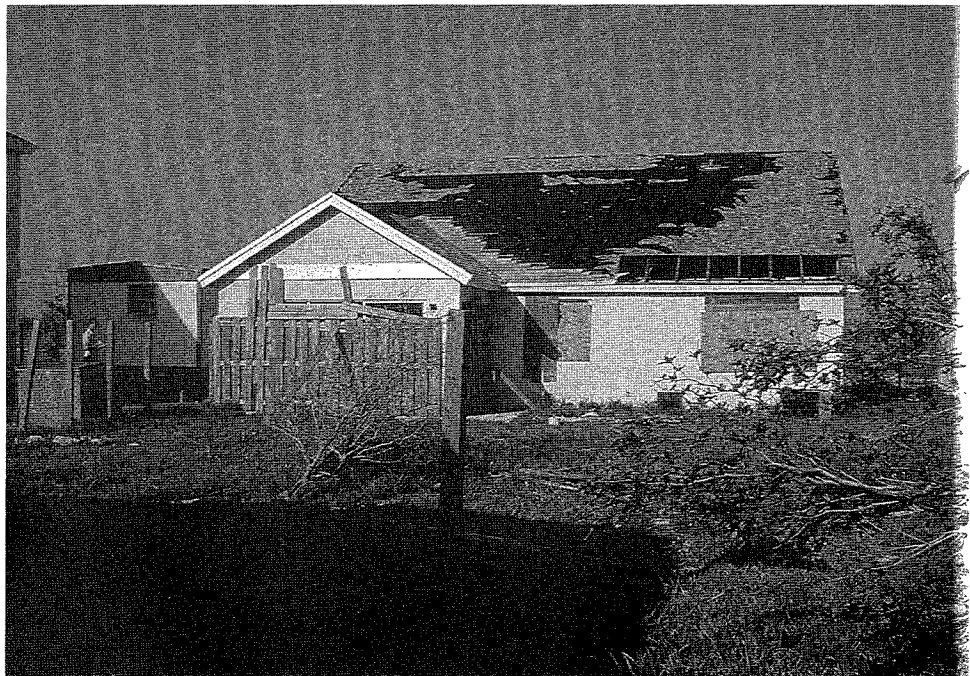
DAMAGE RATING SUMMARY	
OVERALL	3
ROOF	2
WALLS	1
INTERIOR	3
FOUND.	1
GRID	C

Figure 35. Wind damage to a composition shingle roof. Composition shingles were almost completely removed on many homes by Andrew's winds. The extensive water damage overrides the relatively sound structural condition of this house.

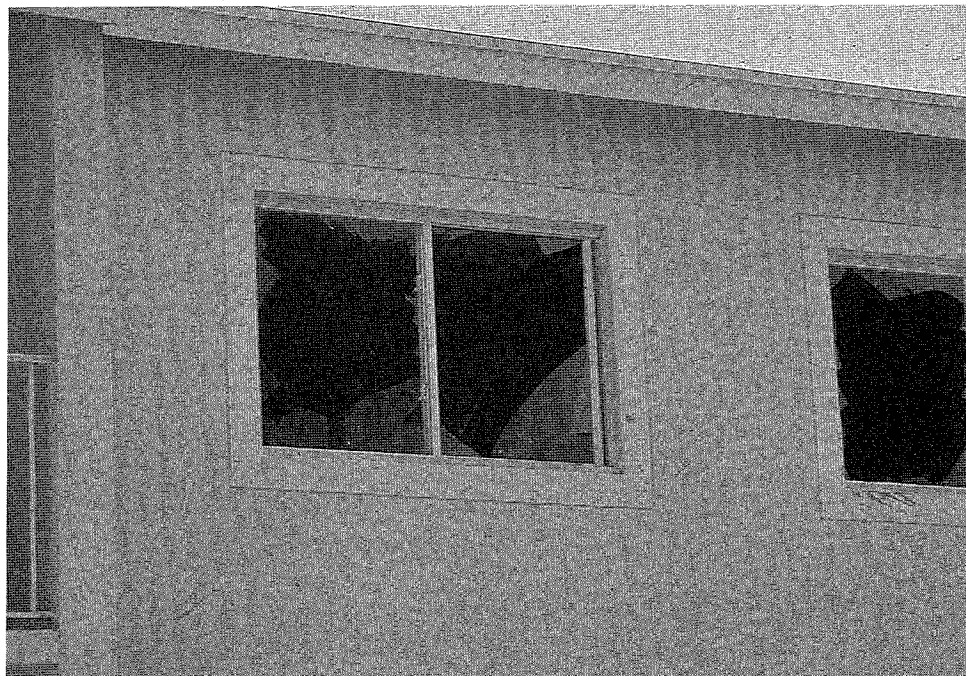
Figure 38. Illustration of damage to unprotected windows.

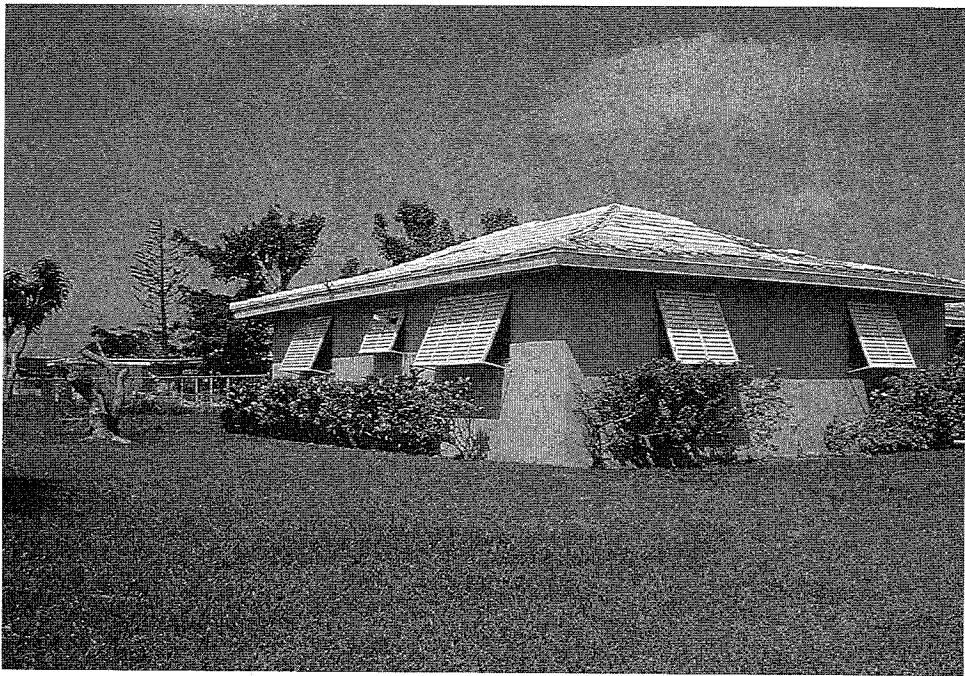
DAMAGE RATING SUMMARY	
OVERALL	1
ROOF	2
WALLS	1
INTERIOR	1
FOUND.	1
GRID	B

Figure 39. Simple hurricane shutters provided adequate window protection for this home. Water damage was minimal.

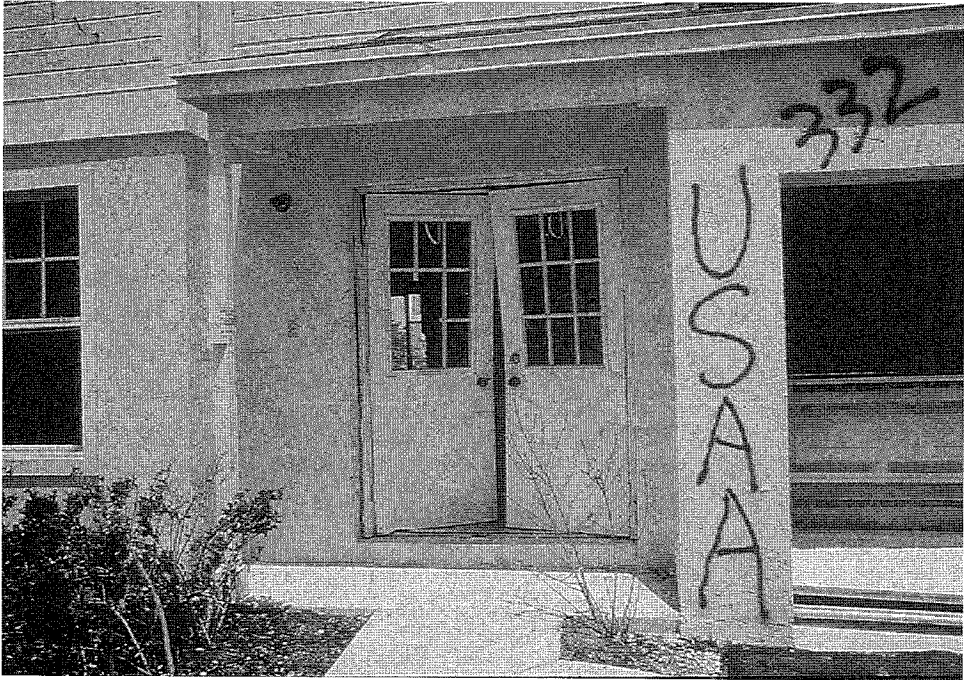
The survey team also noted many cases of entrance door failures. Most designs put the entire wind load on the hinges and the latch. Doors that are fitted with strong floor and jamb deadbolts, or open outward so that the jamb stops give support against inward wind forces, limit the potential for door failure. Damage to a pair of double doors is shown in Figure 40.

Figure 40. Illustration of damage to double entrance doors.

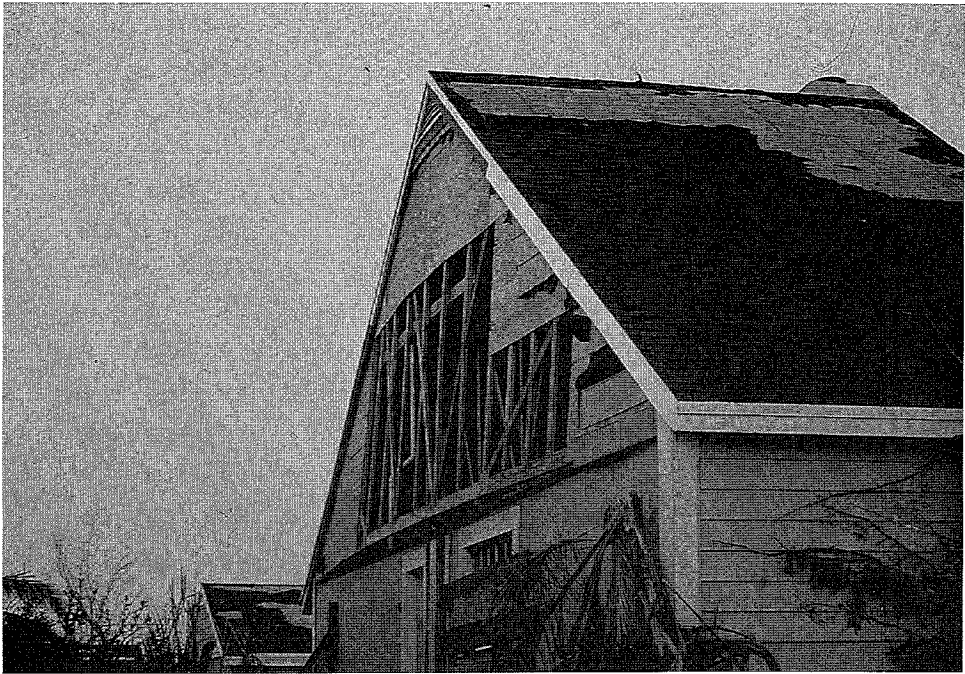
Figure 45. Sheathing blown-out at a gable end wall with a steep pitched roof.

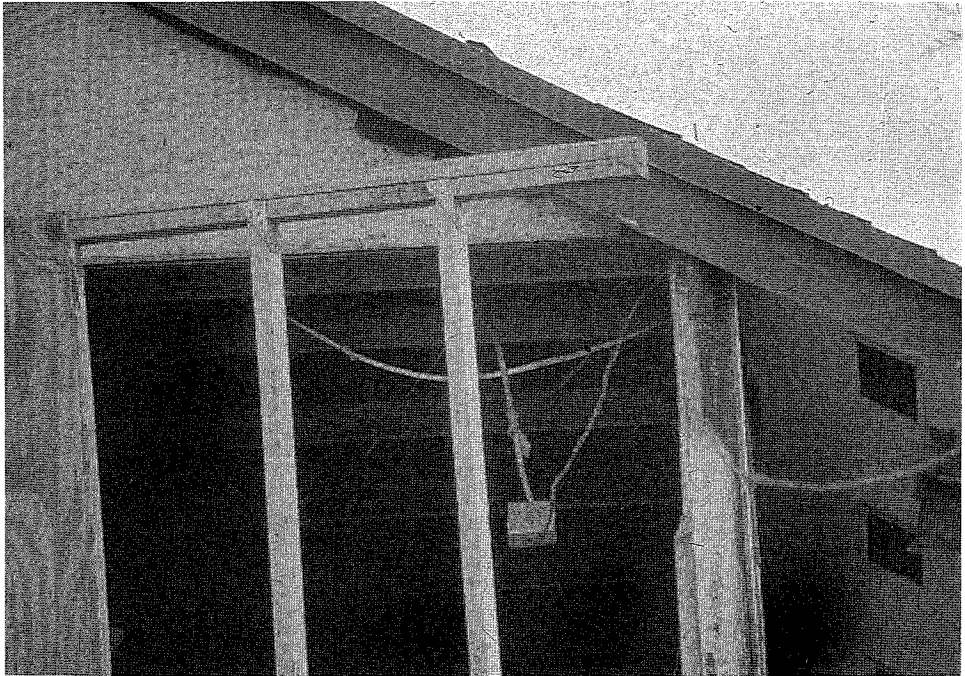
Figure 46. Improper connection of a corner in a blown-out wall section.

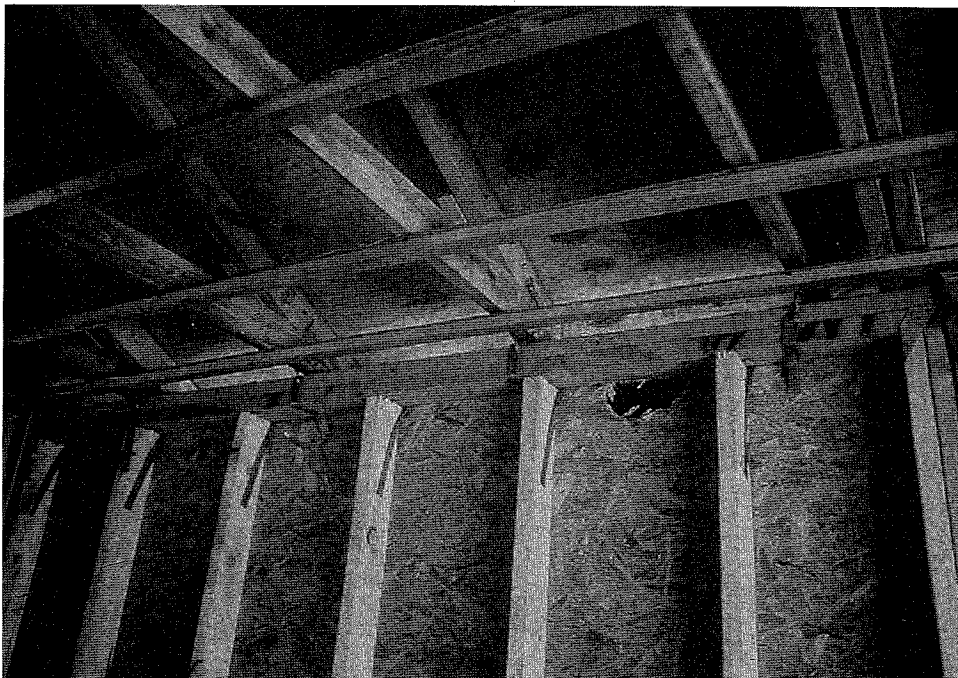
Figure 48. Resilient steel channels used behind drywall render the ceiling diaphragm less effective by detaching the drywall from the roof trusses.

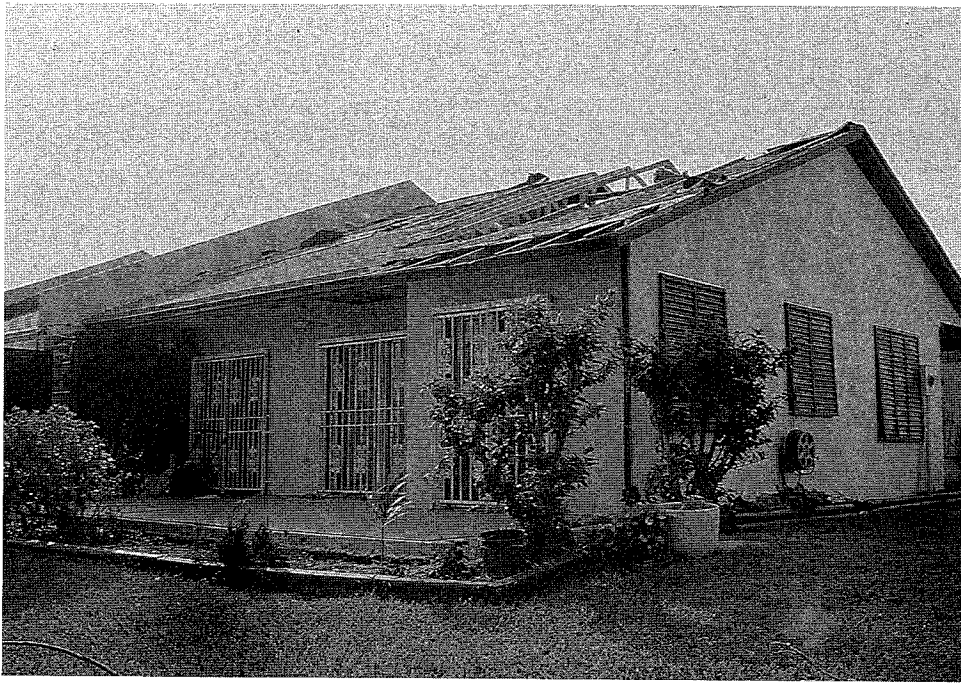
Figure 50. Damage to the end unit of a group of one-story town houses.

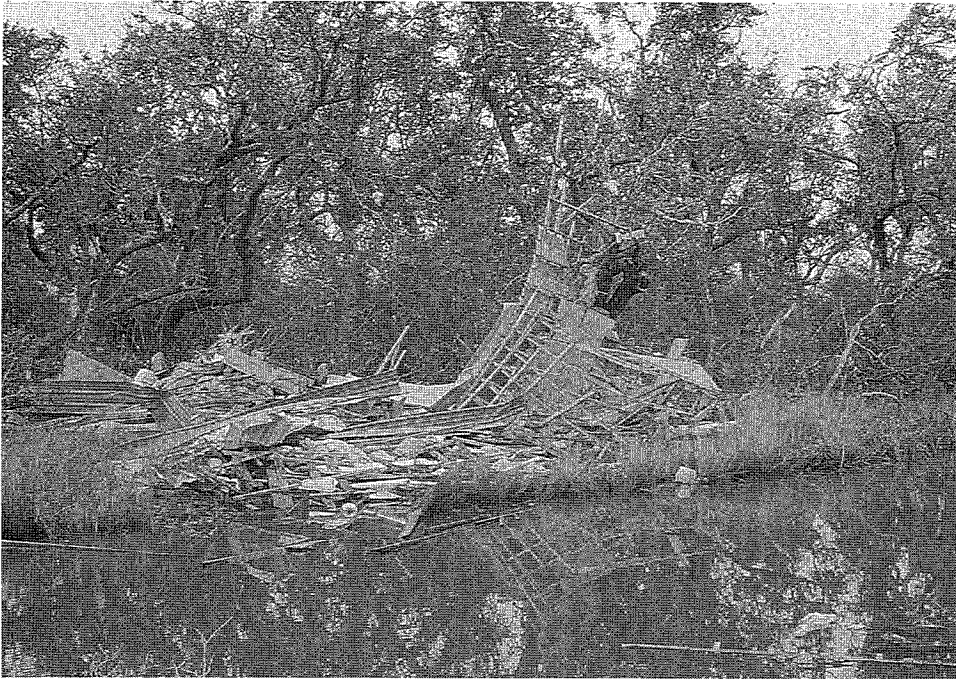
Figure 53. Upper story and roof of the home shown in Figure 52 (50+ yards downwind).

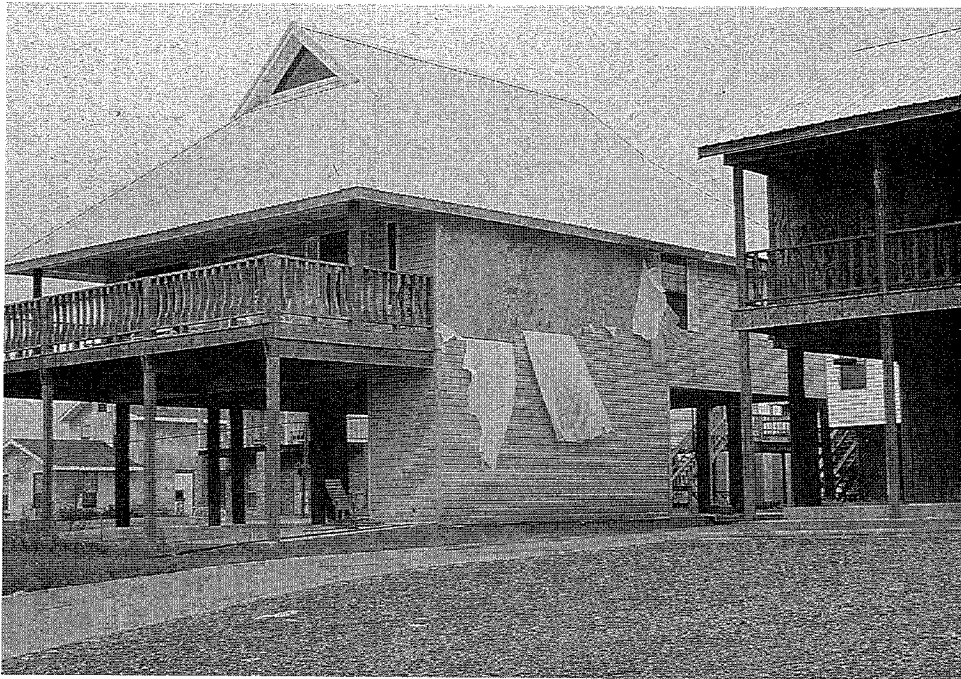
Figure 57. Vinyl siding and trim was cited as a special problem by one builder.

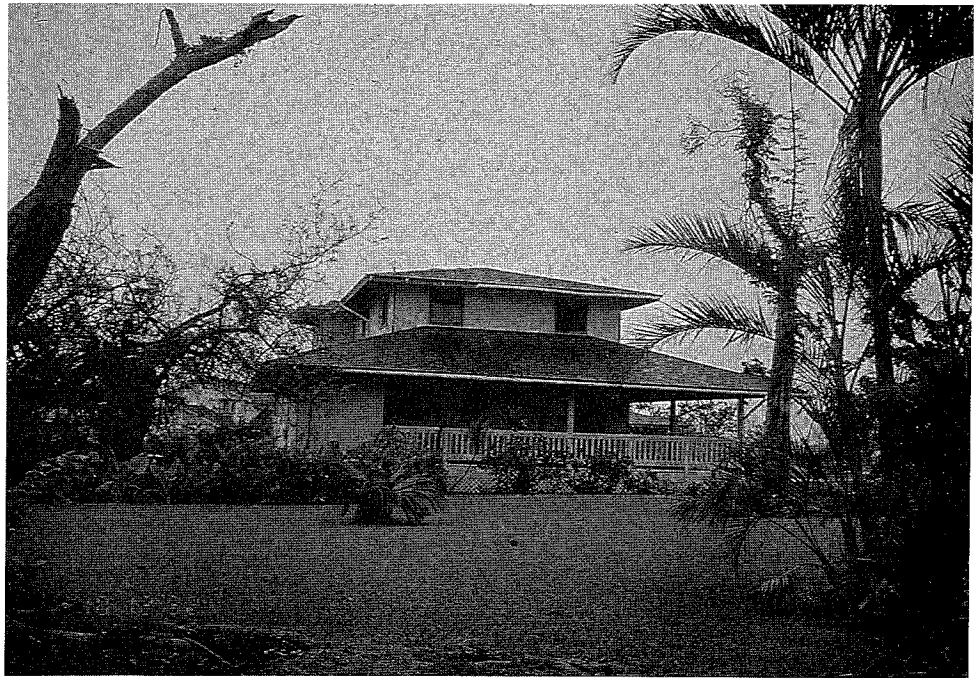
Figure 62. Wind-damaged home with a Level 1 damage rating for overall building condition. This two-story home was built using conventional wood framing with T1-11 siding. The roof is hip shaped with large overhangs and porches. The survival of this home was noted as "excellent," but minor water damage and damaged rain gutters were recorded on the survey form.

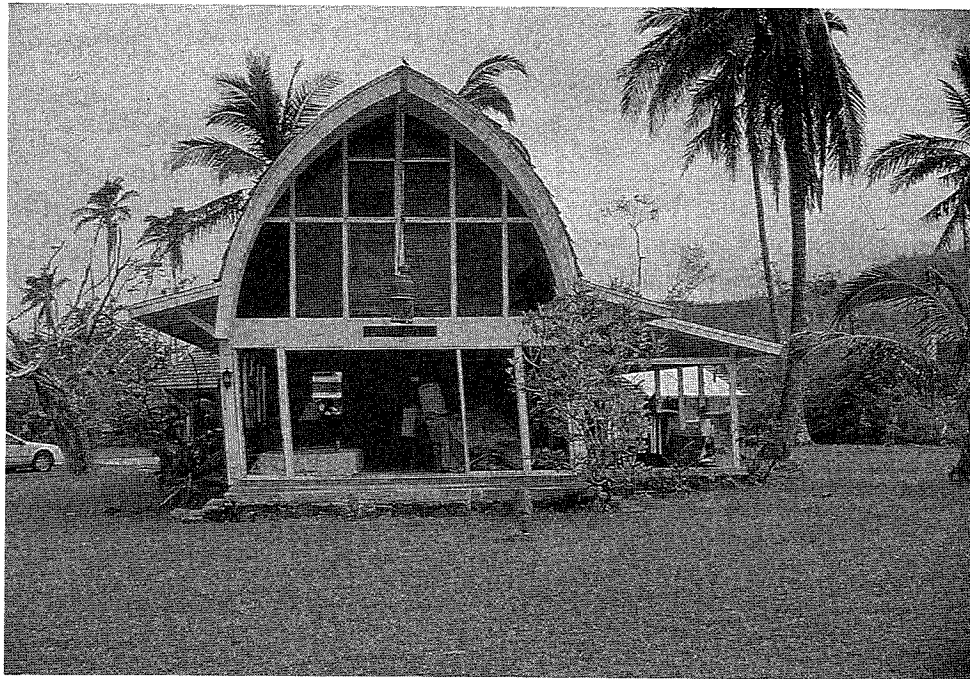
Figure 63. Wind-damaged home with a Level 2 damage rating for overall building condition. This custom home was built in 1965 using site-built, nail-laminated arches (not be confused with modern glue-laminated arches). The roof (and wall) was made of wood decking fastened to the arches and wood shingle roofing. As shown, this home suffered severe racking as a result of delamination of the arches and insufficient lateral bracing. The racking appears to have broken some of the glazing. The slab-on-grade foundation was unharmed. ("X "means the wall rating was combined with roof for this home.)

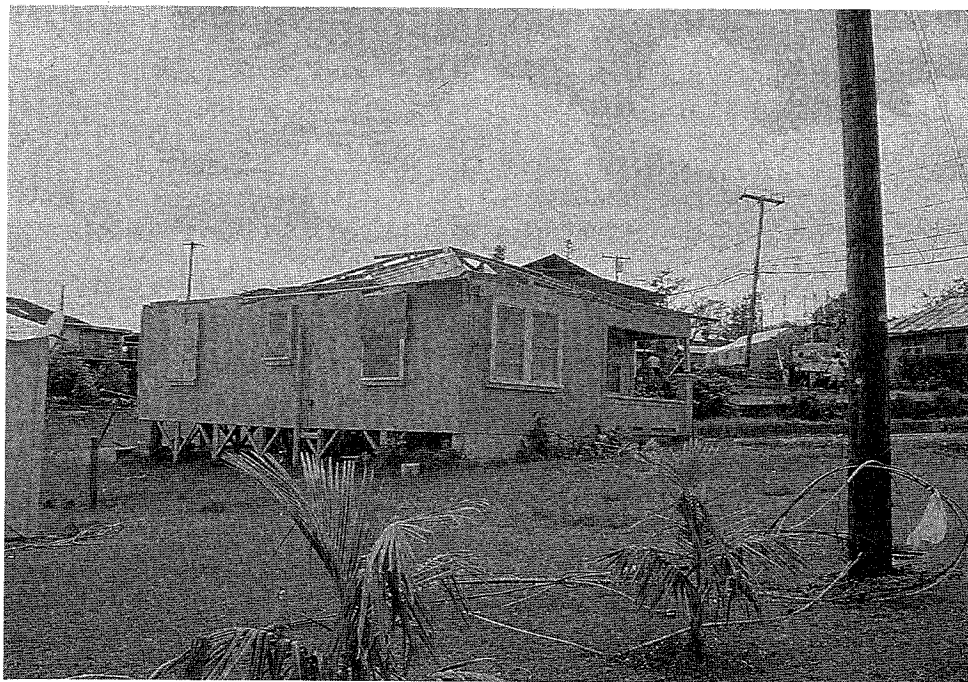
Figure 64. Wind-damaged home with a Level 3 damage rating for overall building condition. This single-wall home suffered severe damage to the roof—both structurally (roof framing) and in envelope soundness (loss of metal sheathing/roofing). Though interior water damage was severe, the exterior walls and foundation remained intact.

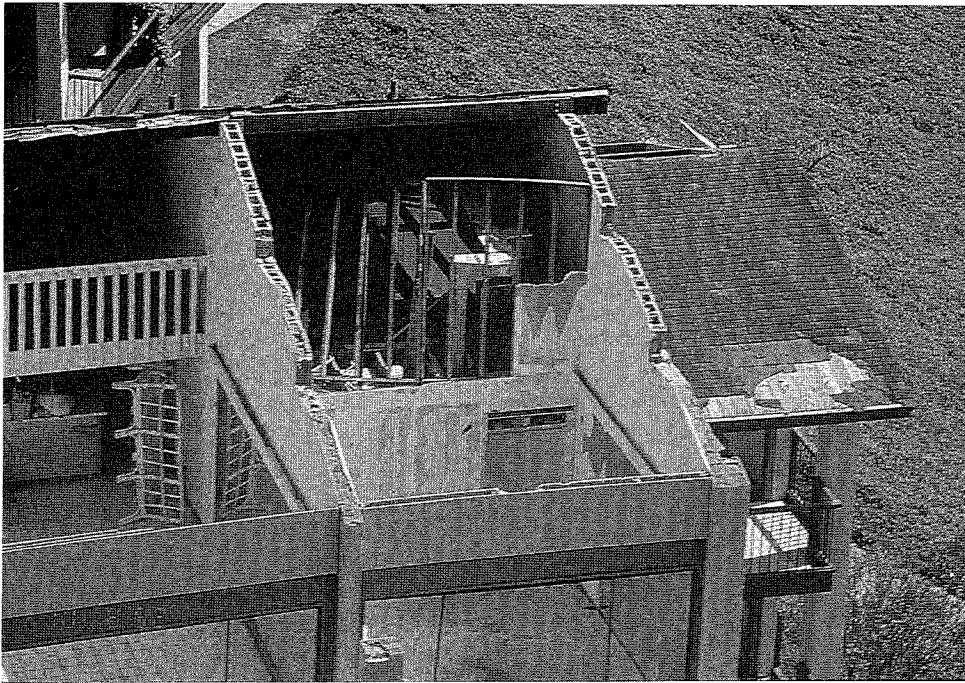
Figure 70. Heavy timber and plank roof blown away due to inadequate tie downs.

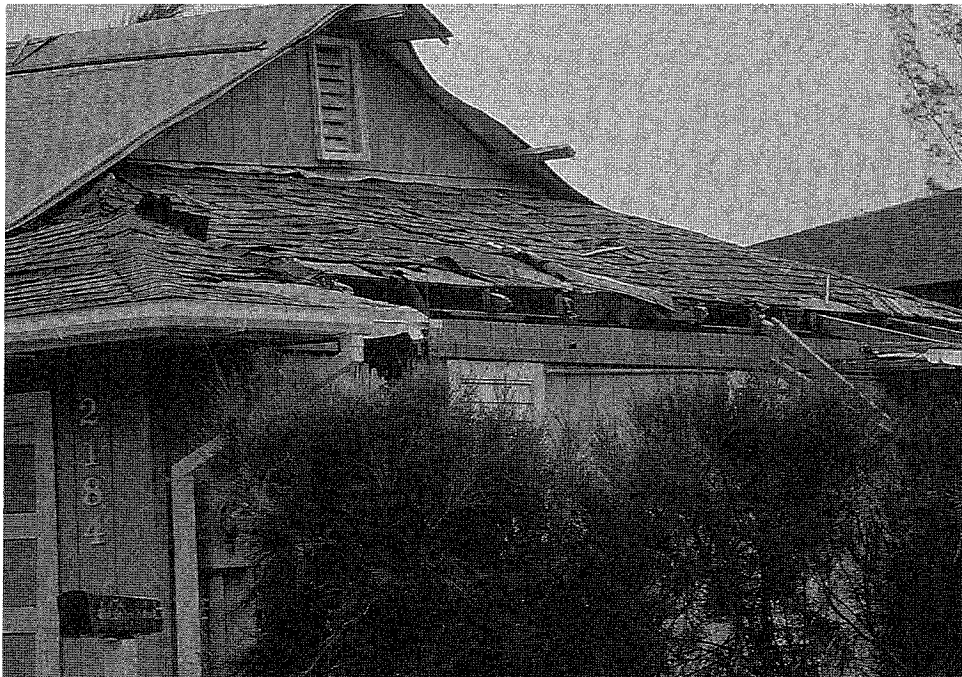
Figure 71. Roof framing at overhangs was particularly vulnerable.

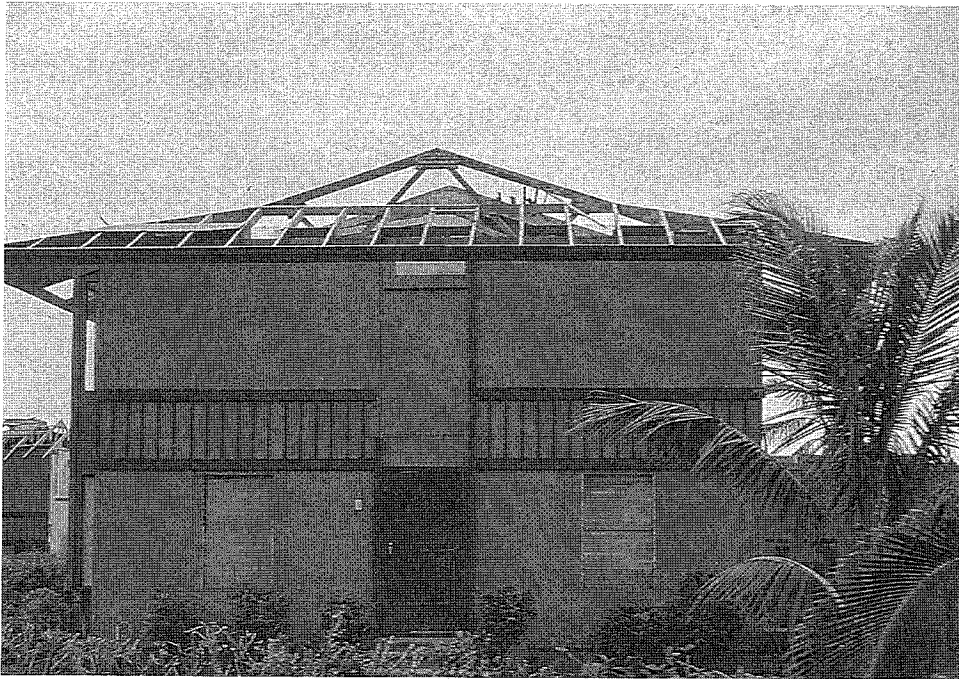
Figure 77. Severe loss of plywood roof sheathing indicating inadequate connections.

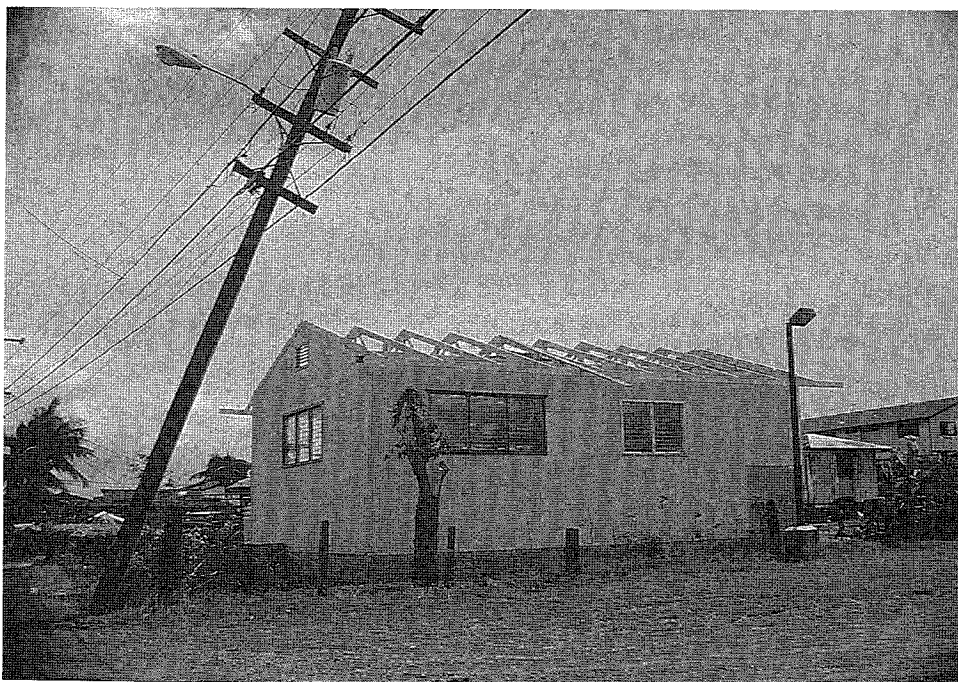
Figure 78. Roof purlins stripped from roof along with metal roofing. Purlins were commonly fastened to trusses with only one nail at each intersection.

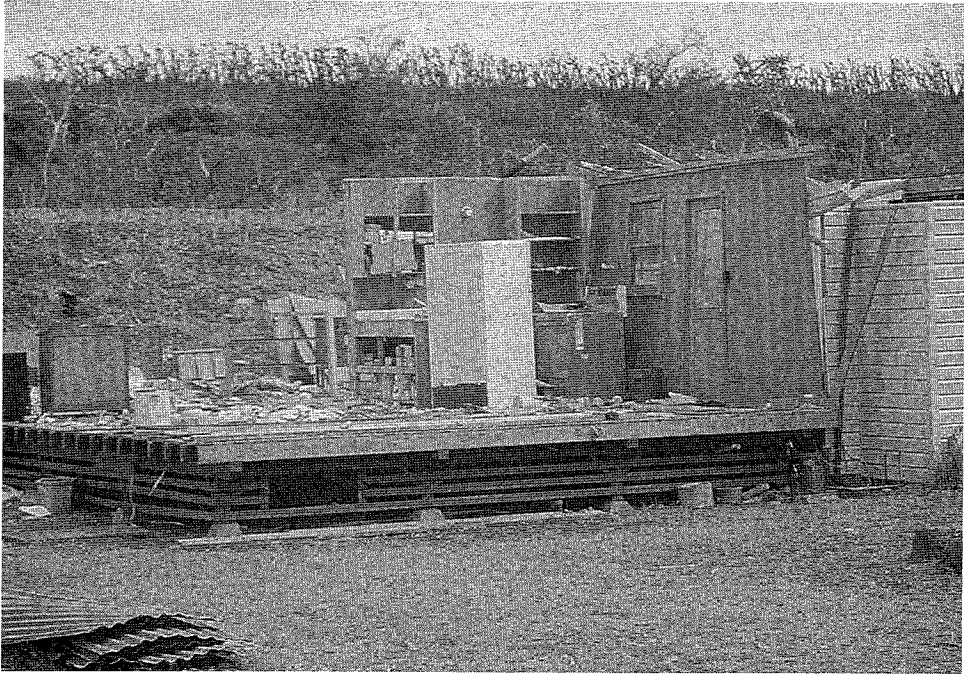
Figure 81. Damaged house showing the vulnerability of single-wall construction.

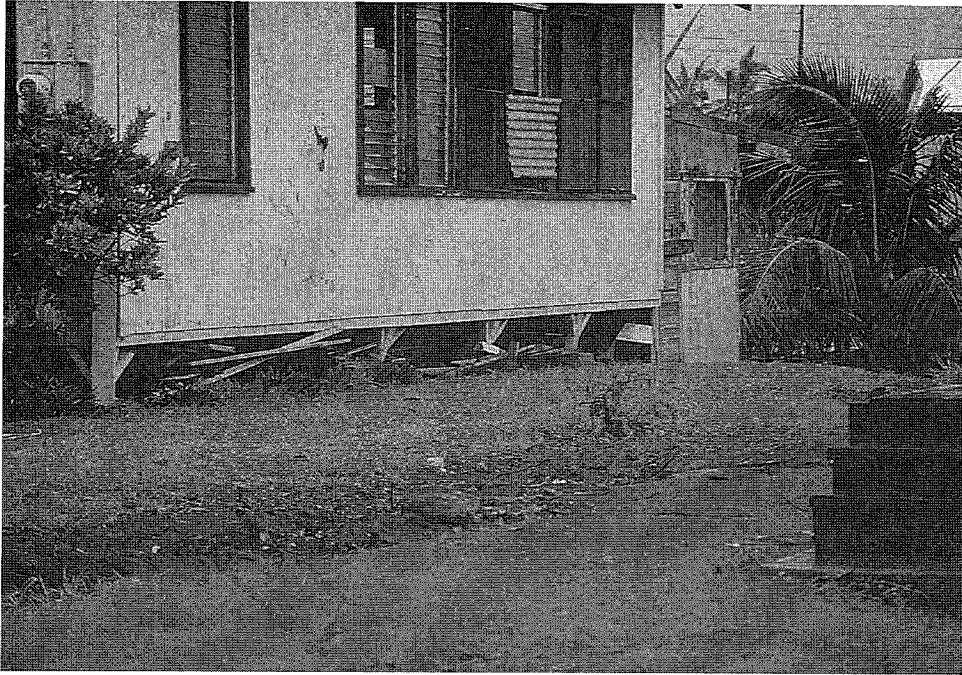
Figure 91. Wood pier foundation shifts under the shear forces created by the wind.
