Assessment of Damage to Single-Family Homes Caused by Hurricanes Andrew and Iniki

This report, *Assessment of Damage to Single-Family Homes Caused by Hurricanes Andrew and Iniki*, evaluates the performance of houses damaged by these hurricanes. Extensive data collection, statistical analysis, and observations provide a realistic perspective on the damages that can guide decisions related to housing in hurricane-prone areas. While comprehensive in detail, this report also identifies the major problems in home construction that can lead to productive improvements in hurricane resistant housing.

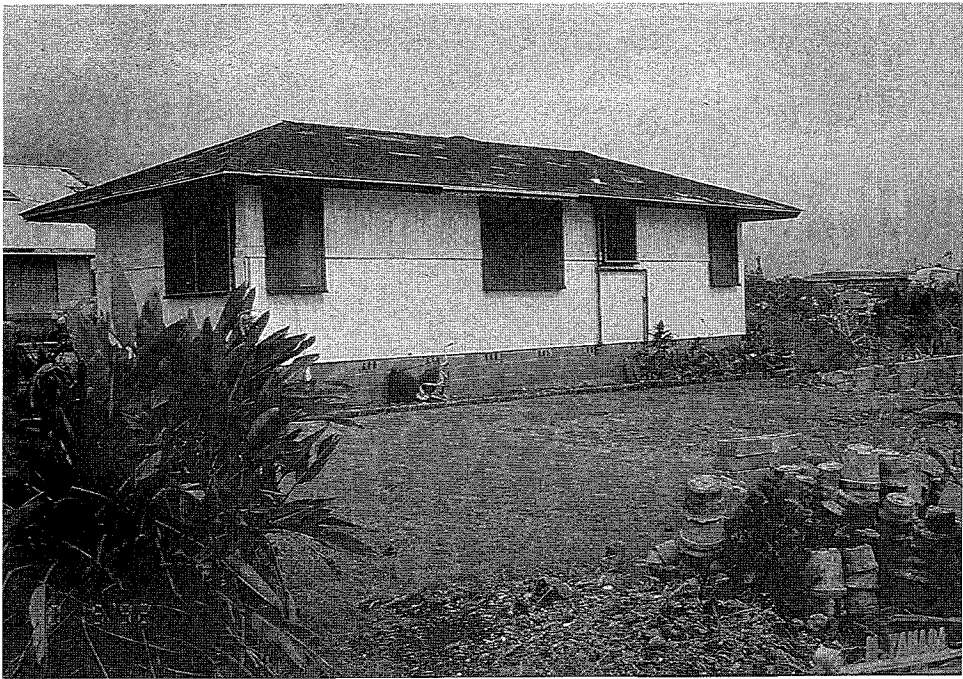
Figure 99. Typical damage to composition roof shingles.

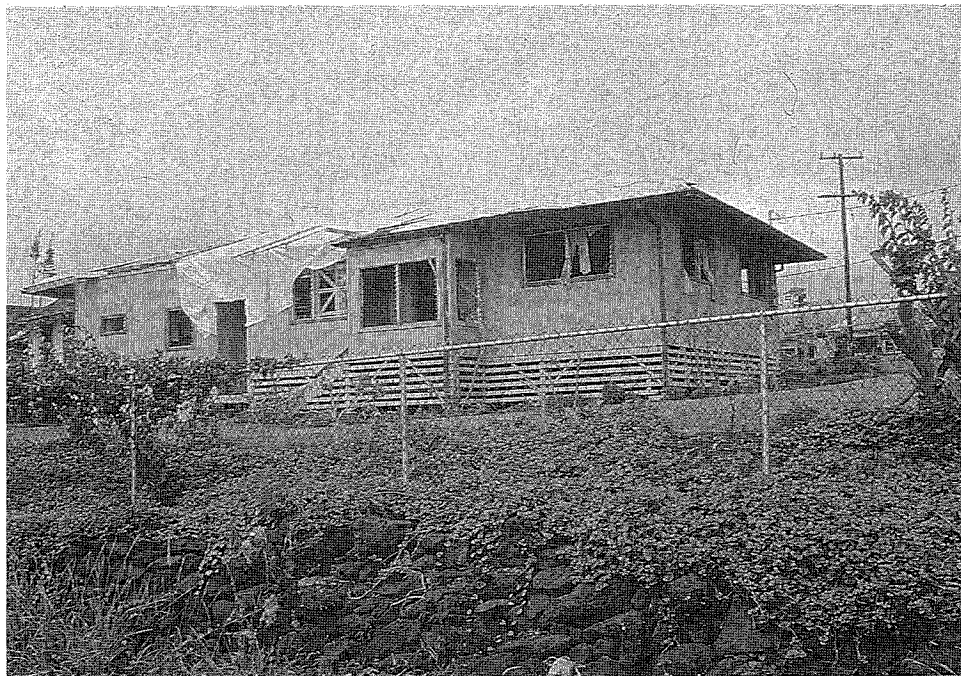
Figure 103. Shattered windows from gravel originating from a neighboring tar and gravel roof.

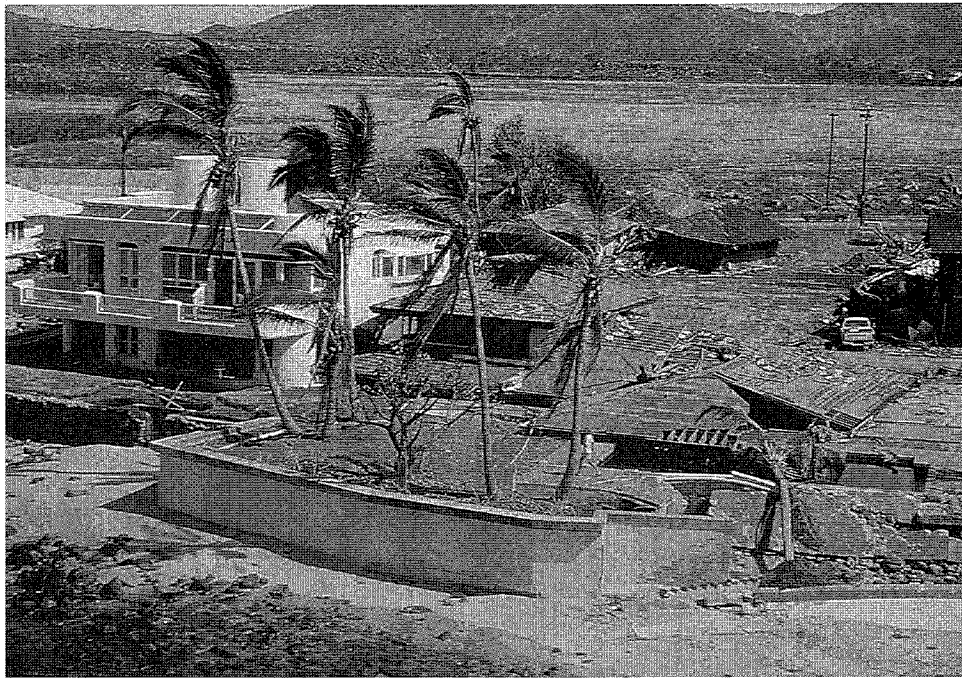
Figure 109. Storm surge damage to adjacent unelevated homes. The home on the left allowed the storm surge to pass through the lower level, which reduced the surge pressure on the structure.
