THE NEW YORK CITY 510 DEMONSTRATION:
THE NEIGHBORHOOD CO-OP EXPERIMENT

Contract 202-0008
Task Order No. 2

Resident and Building Report

February 1981

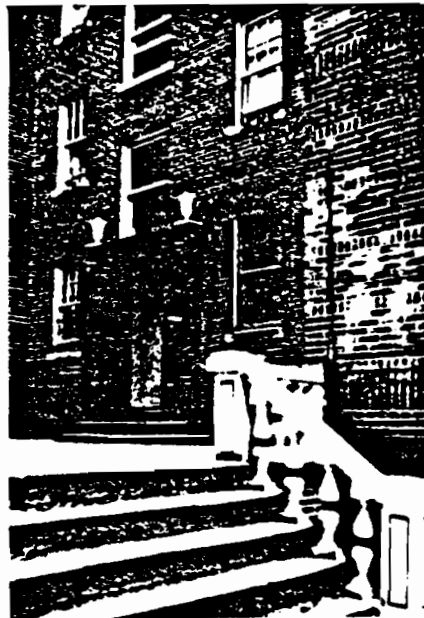
The building appears basically sound, with some signs of settlement and neglect. The courtyard stairs are cracked and uneven, and there is some indication of heaving in the courtyard surface. The fountain is not functioning. The brick wall requires some pointing and limited replacement, and there is evidence of several sill failures. Substantial floor deflection was observed in several areas of the interior, but HPD accepts the builder's contention that no structural work will be needed

(left) Concrete
courtyard stair
leading to one of
two residential
entries .

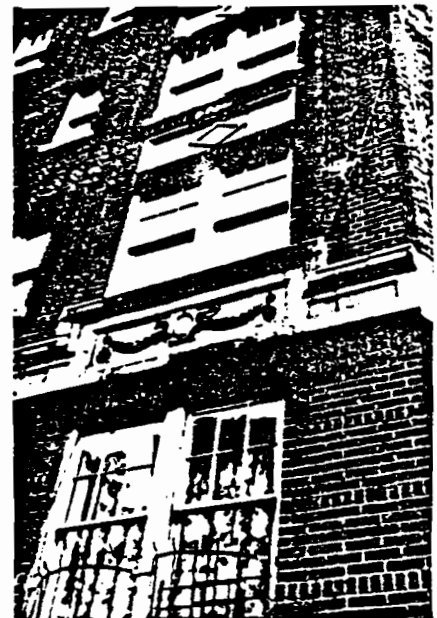
(right) Example of
concrete ornamenta-
tion and wrought
iron window
railings .

The iron window railings are frequently missing and those that remain have been damaged and twisted, perhaps beyond saving. The fire escapes, however, are quite serviceable, and need only scraping and painting.

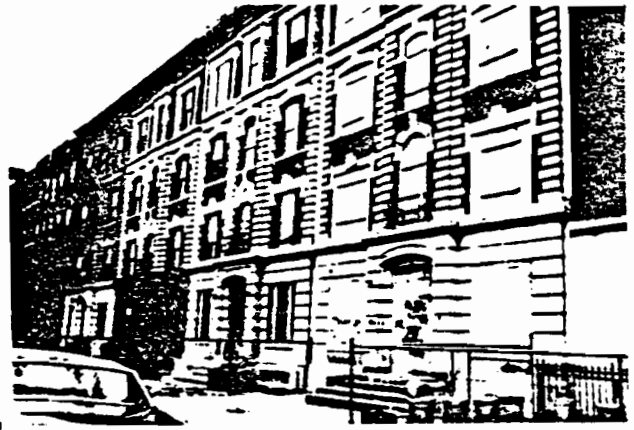
376 St. Johns Place, showing the building is sealed with concrete block and wood. Evidence of fire damage is visible above the 2nd story on the left.

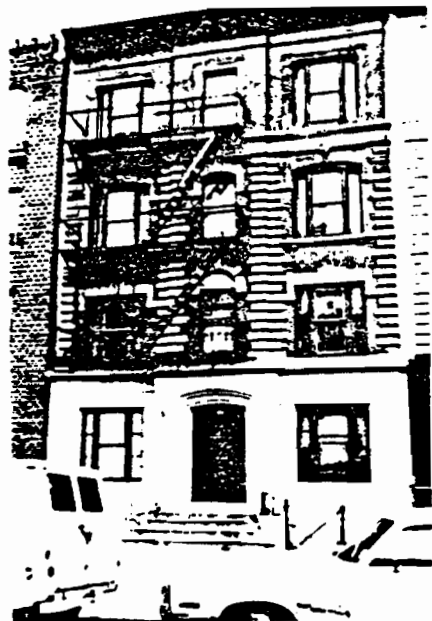
388 St. Johns Place, showing the original wood windows and iron rail at ground level.

The original wood windows, which form bays along the front of the building, are in fairly good condition. They have wide double-hung center panels, and fixed, narrow side panels. The fire escape attached to the front face of the building is rusted but sound. The stone sills show signs of deterioration in several instances and the stone stoop has cracked and separated. Although needing paint, the pressed metal cornice under the eaves seems to be in good condition.

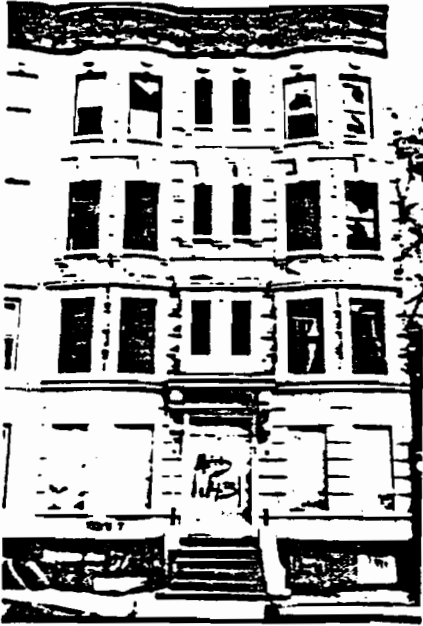
Windows are showing signs of deterioration, with paint peeling and flaking, revealing the beginnings of rot. The building has broken windows on the first and fourth floors.

431 Sterling Place, showing the stone facing along the first story, window ornamentation and brick binding at the upper floors. Note the open, shattered windows exposing the interior to weather.

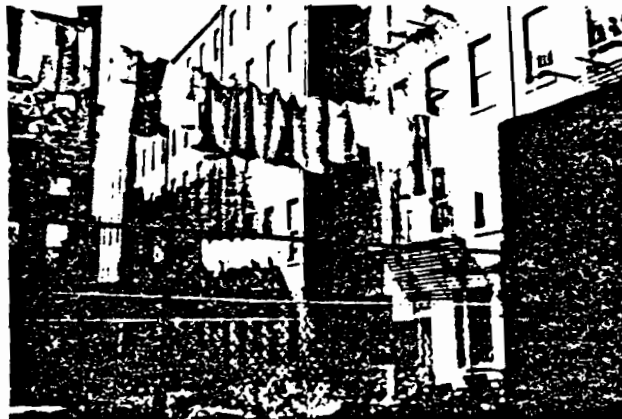
View from rear courtyard, showing
stucco coat along entire rear
facade.

The masonry exterior is in sound condition and requires limited repointing. The original windows were severely damaged and at the time of inspection were being replaced with new aluminum windows by the City's Weatherization fund. The structures have a flat built-up roof that appears to be sound. The entire facade of the 10th Avenue buildings will be refurbished with a grant from the State of New York.
