APPENDICES

INDIVIDUAL PLANT REPORTS

Duct leakage measurements for all plant reports are expressed as the number of cubic feet per minute of air leaking from the ducts (either total leakage or leakage to the outside) when they are pressurized to 25 pascals, divided by the overall square footage of the home, given as a percentage.

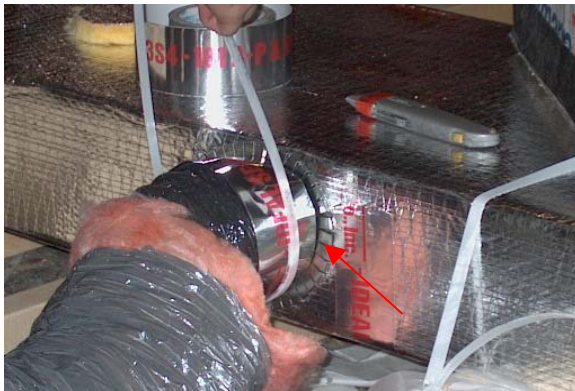
It is difficult to create a durable seal using tape or mastic alone.

Applying tape as a temporary seal then covering the seam and tape with mastic will result in a superior and durable seal.

- 1. Seal side mounted collars.** Fiberboard systems rely on tabs folded into the duct for mechanical fastening. These are less rigid than screw-type fastenings and increase the difficulty of sealing. Tapes designed for metal to fiberboard attachment may be used for sealing these collars; and some manufacturers have had good success with this method. The other method (practiced at this plant) is to apply enough tape to secure the collar at the top and bottom, and to apply a liberal layer of mastic completely covering the tape.

The tape will support the duct during construction in the plant and the mastic will eventually cure to form a strong, durable seal. However, curing of the mastic could take several days depending on temperature and humidity conditions.

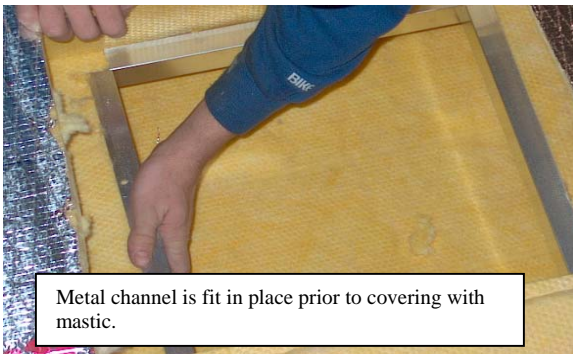
3. **Use care and attention to detail in crossover branch connections.** This is a critical area for leak prevention. Apply a good quantity of mastic between the mating surfaces of each trunk. Accurately cut the holes and use the metallic channel material shown to serve as a mechanical attachment. This material should be sealed with mastic along all exposed edges. Strap the two trunks securely to prevent any movement of the duct until the applied mastic has had sufficient time to cure. Installers should be made aware that the mating surfaces are relatively fragile and may open if any pressure is applied to either trunk prior to curing.

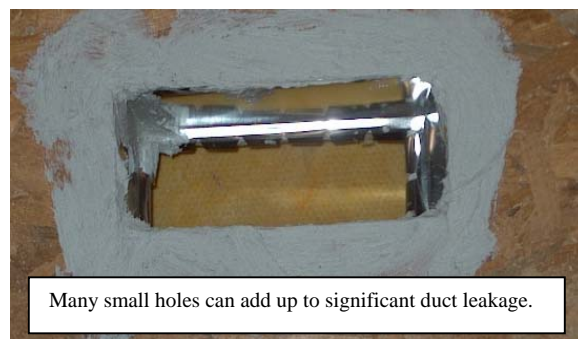
Perimeter supplies need to be sealed to the floor to prevent leakage into the belly.

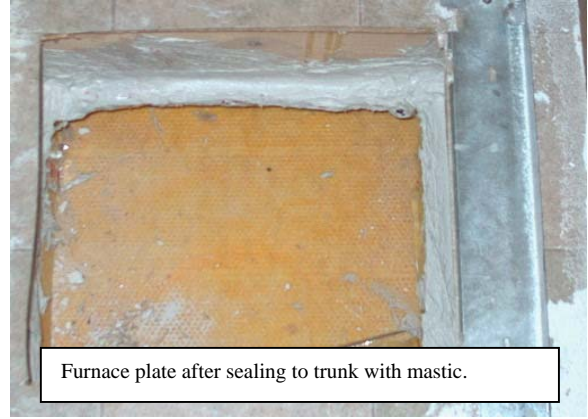
Furnace plate after sealing to trunk with mastic.

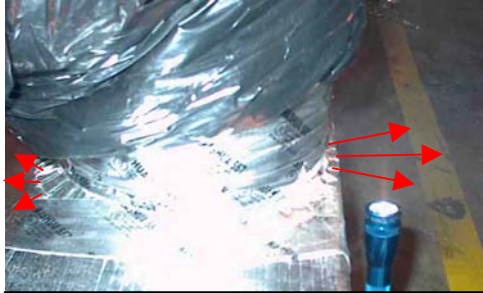
Smoke is seen leaking under the collar flange.

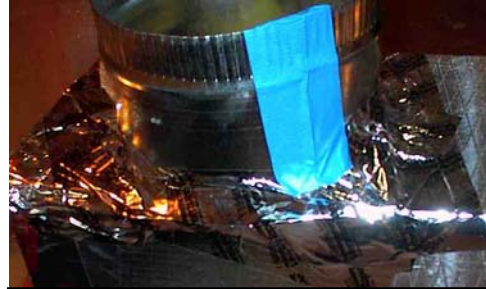
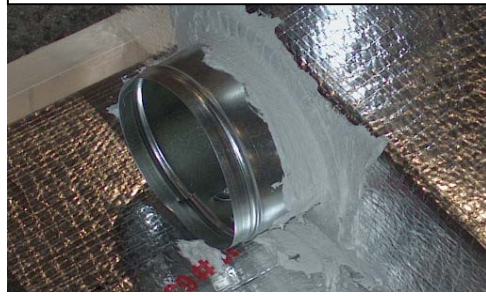
Round collars completely sealed with tape (above) or mastic (below) show no leakage.

1. **Seal start collars to trunk.** Start collars are known to leak, especially when freehand cut “round” holes are used. Use mastic or 100% tape coverage to seal start collars to the fiberboard.
2. **Seal flex duct to metal collars and boots with tape.** Straps alone will not seal flex duct to metal. Use appropriate tape to make this seal. Use tape and straps in conjunction with the multiple crossover connections.

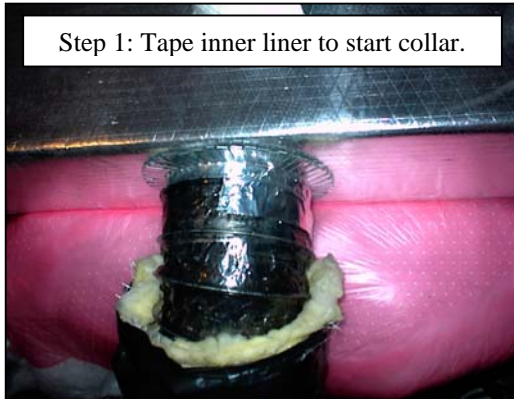
Step 1: Tape inner liner to start collar.

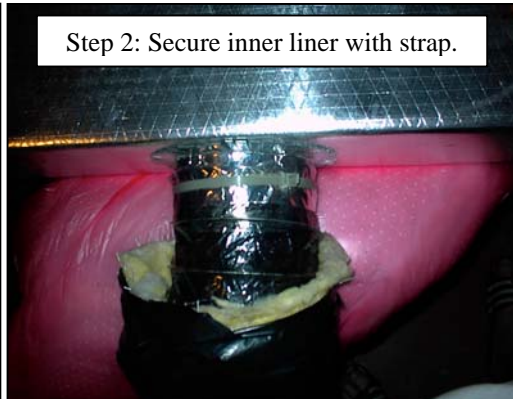
Step 2: Secure inner liner with strap.

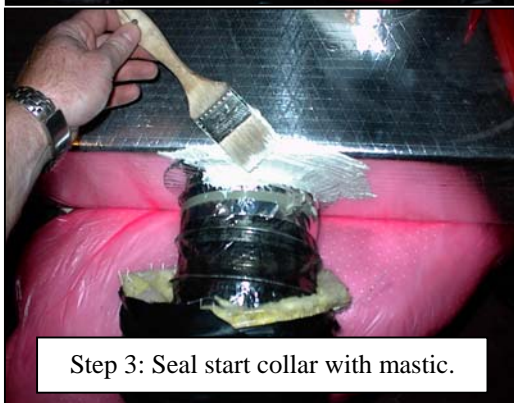
Step 3: Seal start collar with mastic.

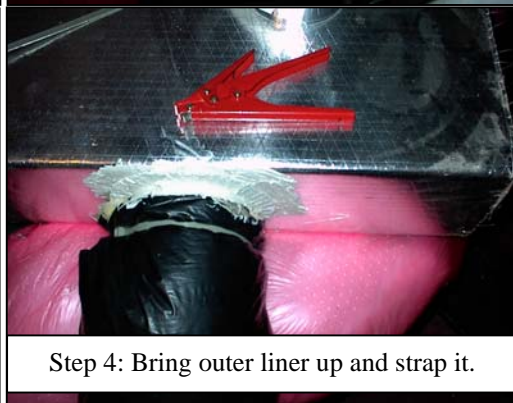
Step 4: Bring outer liner up and strap it.

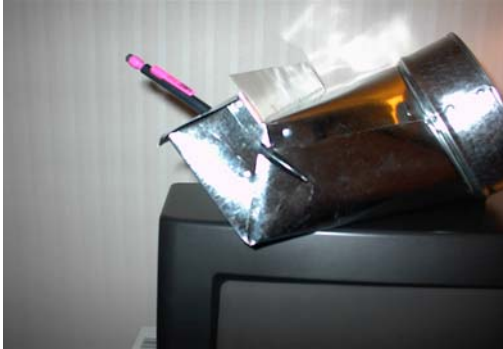
3. **Seal boots with mastic.** Supply boots have gaps that will leak conditioned air into the floor system, which in turn can leak to the outside. Because there are six or more in each section, this can add up to significant leakage. Cover all the seams completely with tape or brushed-on mastic.

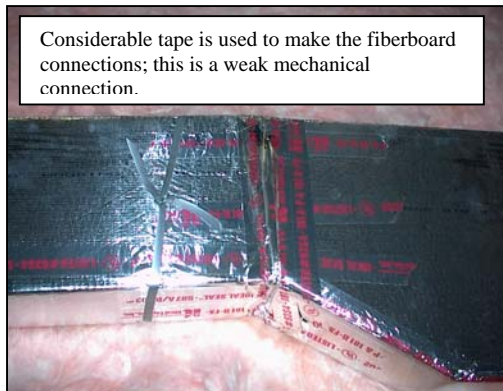
4. **Use a squeegee tool on taped joints in fiberboard ducts.** Moderate stress is applied to the trunk when it is moved from the overhead station where it is assembled to the floor below. Be sure taped seams are properly squeegeed to ensure maximum adhesion strength. Take care not to break any seams when moving and installing this duct into the floor.

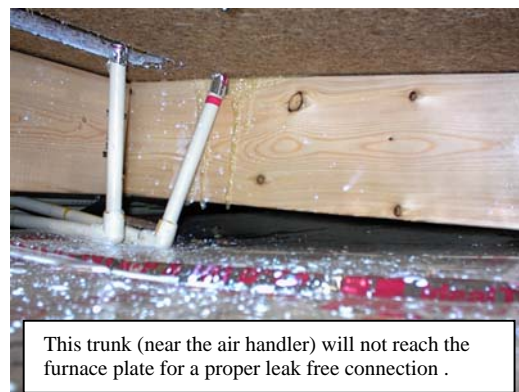
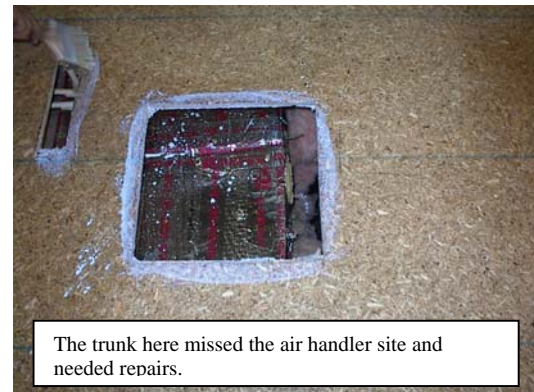
5. **Positioning of the trunk is important for a proper seal with the air handler.** The furnace plate connection is the most important connection to seal. In several homes the trunk was not secured snugly to the floor joists resulting in a gap between the trunk opening and the furnace plate. Also, trunks were found that were not aligned exactly under the air handler. These are difficult repairs to make leak free. To minimize these incidents, develop an engineered plan for these situations rather than having the production staff make one up on the fly.

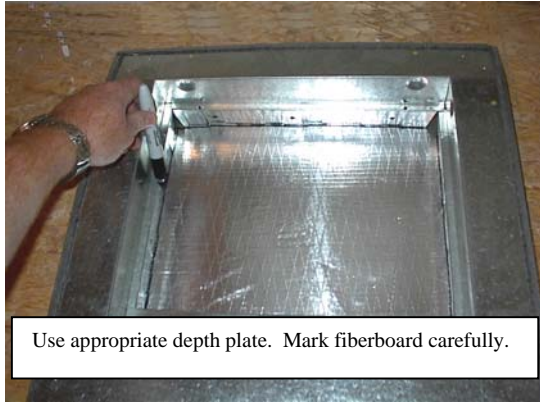
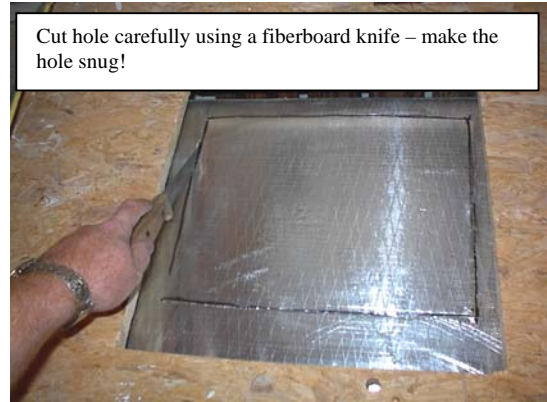
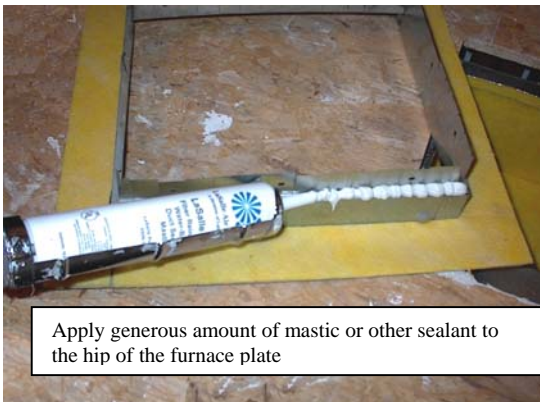
6. **Properly fasten and seal the air handler plate to the duct board.** This requires carefully marking the duct board using the furnace plate as a guide and carefully cutting the hole into the trunk. The manufacturer recommends using a duct board knife to make this cut. This hole should not be oversized; there is only 1/4 of lip available for sealing to the duct board. Tape will not seal the plate to duct board. Use mastic as shown.

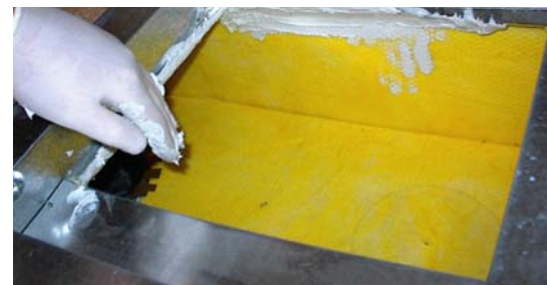
Additional mastic can be used to fill any remaining gaps in this connection. Mastic should not be used as a substitute for a poorly made cut. Mastic will not provide structural support – only air sealing. Mastic should be allowed to fully cure before use.

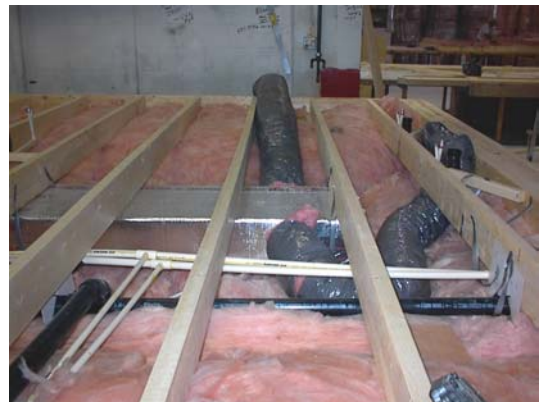
7. **For improved airflow, minimize excess length and curves in the flexible duct sections.**

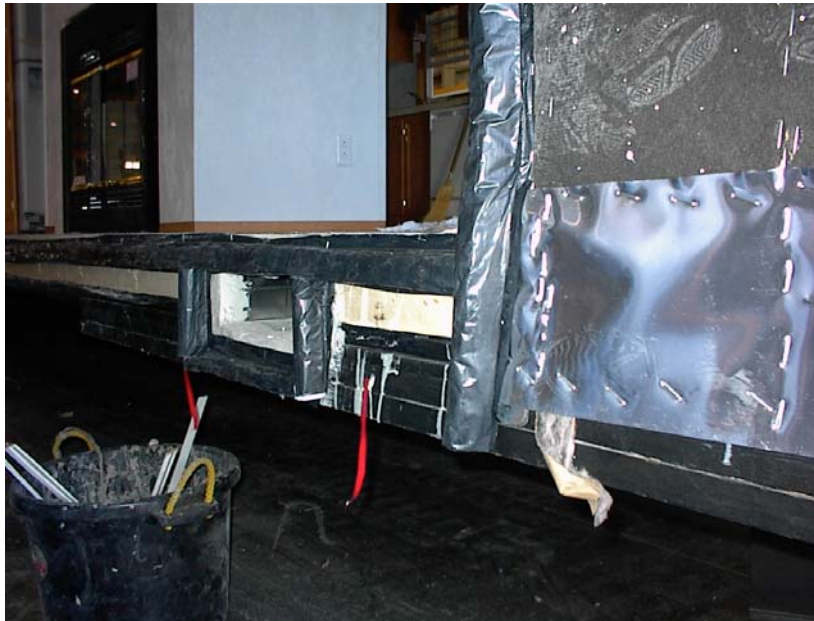
Below is an interior view of the marriage wall which shows the plant-installed marriage line gasket and the through-the-rim crossover duct.

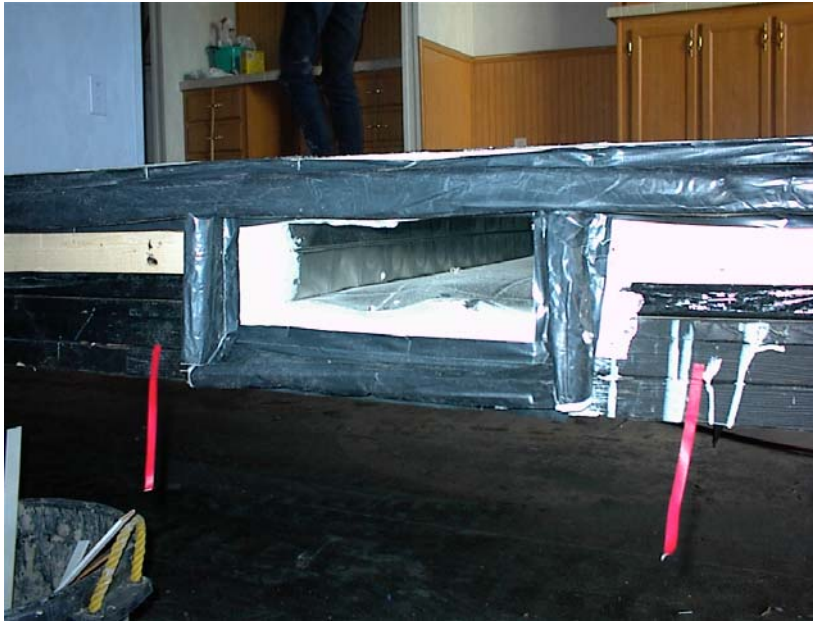
Close up of crossover configuration. Note the use of mastic to air seal the trunk prior to the application of the gasket.

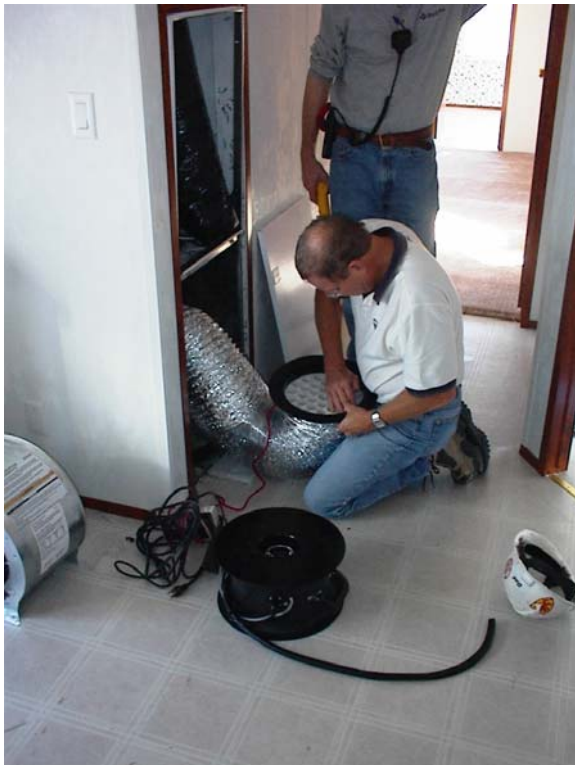
DAPIA installing calibrated duct fan at the preferred location to measure duct leakage. Removing the blower and measuring close to the ducts minimizes measurement errors.

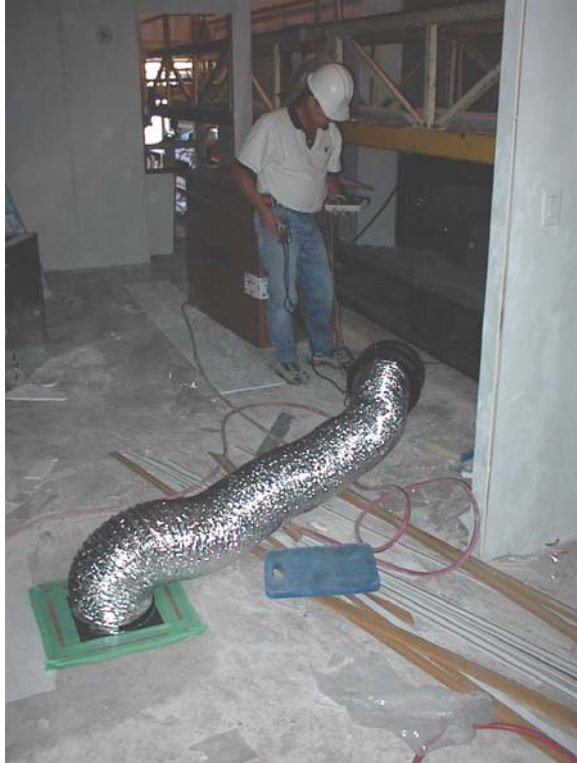
DAPIA installing calibrated fan at a supply to measure duct leakage in a floor section that is without a furnace. Although this is a less preferred location to access the ducts, with the small leakage levels experienced, any error is negligible.

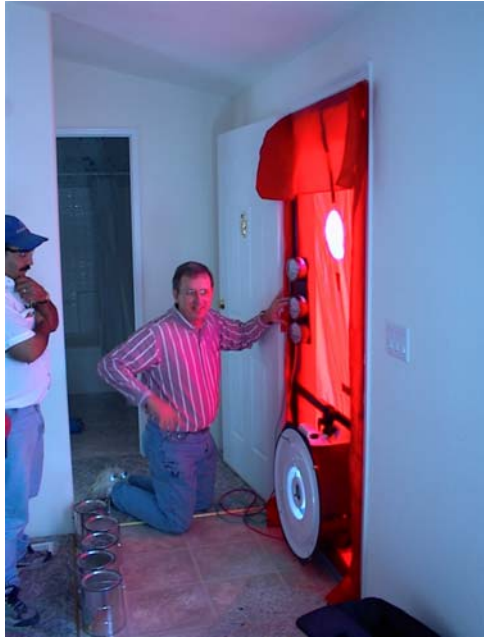
Blower door testing being conducted in a single section home outside the plant.

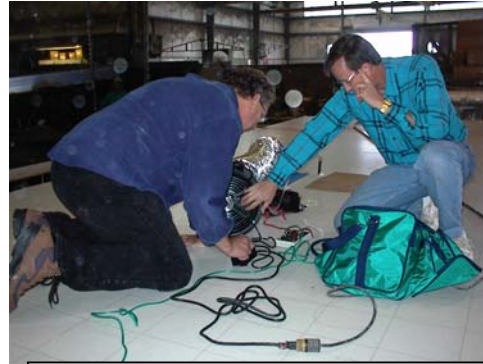
Duct tightness testing in the plant. This home section has no air handler unit so testing equipment is connected to a supply opening.

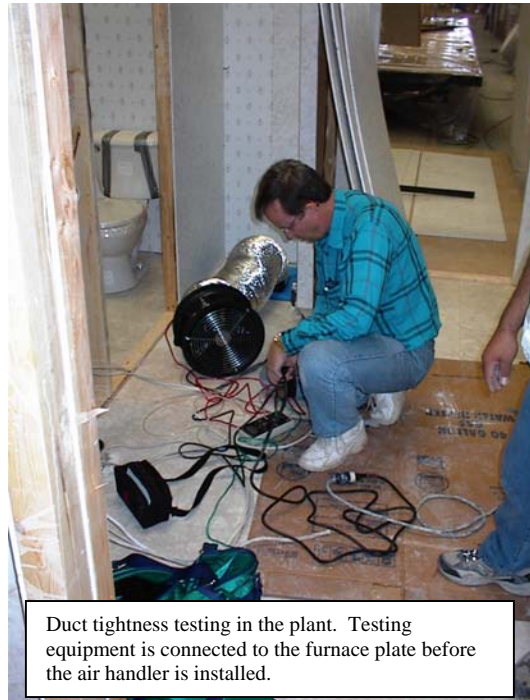
Duct tightness testing in the plant. Testing equipment is connected to the furnace plate before the air handler is installed.

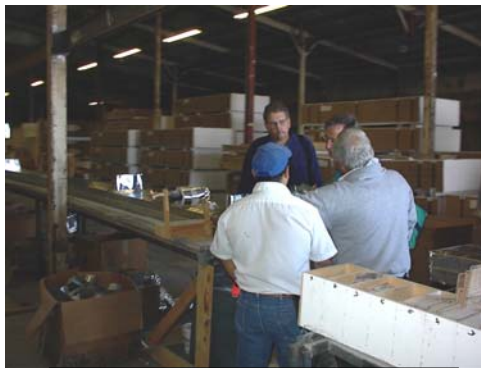
Training plant personnel on the proper application of mastic to the duct system.

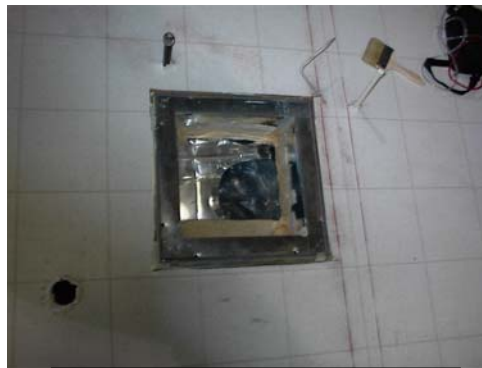
Furnace plate sealed with mastic.

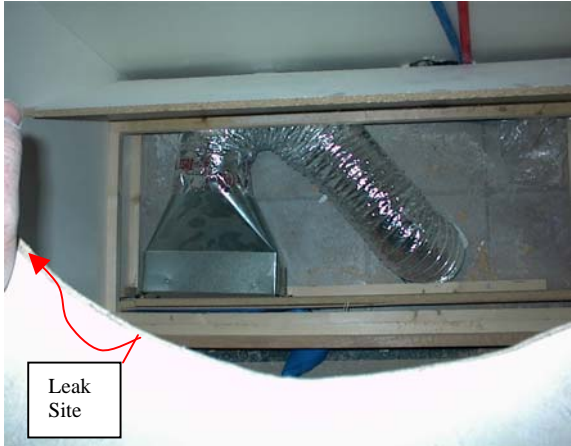
This is a view looking down through a bathroom sink cabinet to the toe-kick supply. This supply was not mounted flush to the cabinet and the cabinet fascia was cracked. By sealing this supply 14 cfm was added to the total duct leakage measurement. In theory this leak would all be eliminated under leakage to the outside test. To fix the problem, screws were used to mechanically fasten the connection and the duct test was repeated.

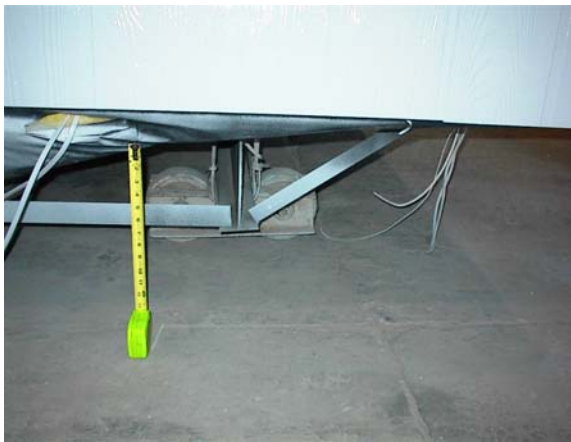
Low clearance under the homes in the plant limited the access to the underside of the homes. The status of the belly and crossover collar cannot be confirmed until the end of the construction process when the home is lifted onto axles.

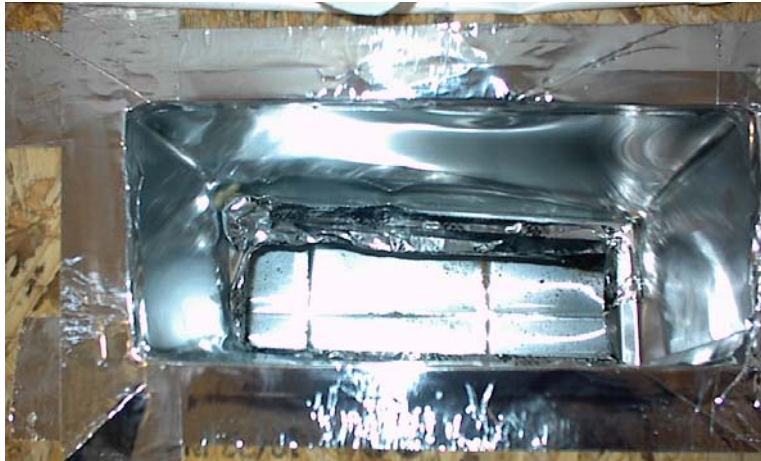
1. It was suspected that the in-line supplies were not well sealed. Homes with more in-line supplies had higher measured duct leakage. Examination of several taped supplies also suggests that this could be a source of significant leakage.

In-line supply connector showing tape at trunk connection. Cutting a properly sized hole and applying mastic to the connector prior to insertion into the floor is the preferred method of insuring a good seal.

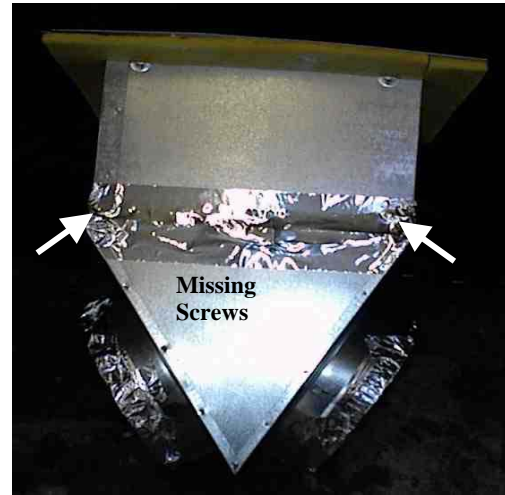
1. The metal “crossover duct splitter box” was not mechanically secured to the “furnace connector boot” in three of four inspected homes. This critical connection was held together with only one layer of foil tape. The crossover duct splitter box could become disconnected from the furnace connector boot due to the weight of the splitter box and crossover duct.. The crossover duct splitter box and furnace connector boot were pre-assembled off line and should have been secured with 4 screws when the furnace was installed. To avoid this oversight, these screws should be installed off line when these duct pieces are first assembled.

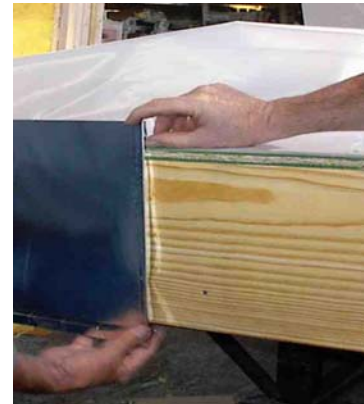
Twelve-inch long connectors being used are too tall for use with the 10” floor joists. The boots extended into the supply trunk blocking airflow and causing duct leakage. As installed, the in-line ducts inspected will significantly restrict supply airflow. Furthermore, the supply riser is not made square to the supply trunk, and in several instances scrap metal cut from the supply trunk was found still partially attached to the trunk further restricting airflow.

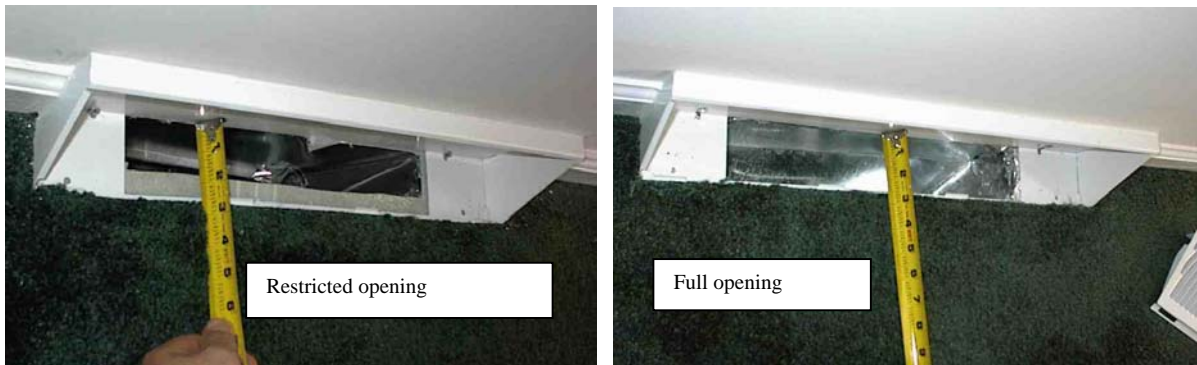
The supply register discharge opening in the floor was often partially blocked by interior walls that overlapped the hole or by poorly cut vinyl flooring.

One solution to these problems is to install wider (4-inch) in-line boots. Another option is to convert the in-line boots to short perimeter type flex duct connections. Investigate using a zip spiral saw for a better method to cut the trunk for the in-line supplies.

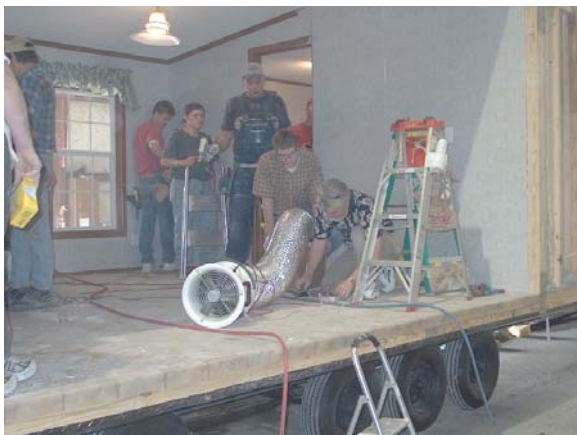
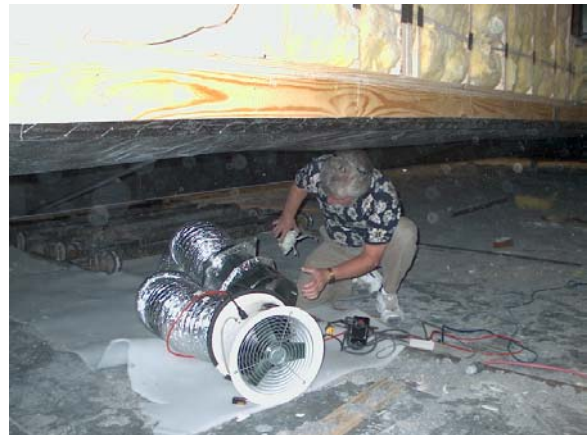
Testing total duct leakage in-the-plant through available openings into the ducts: a supply termination on the floor decking (left) and the crossover collar underneath the home (right) can be used to measure low flows with little loss in accuracy. Total duct leakage can be used to estimate leakage to the outside when the home is set up.

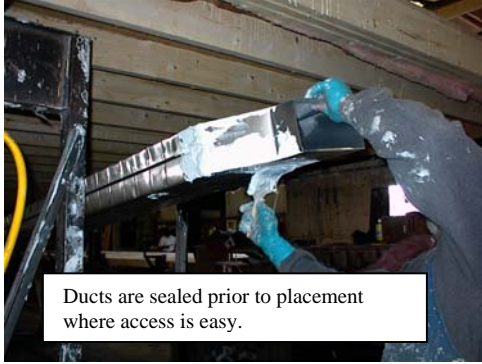
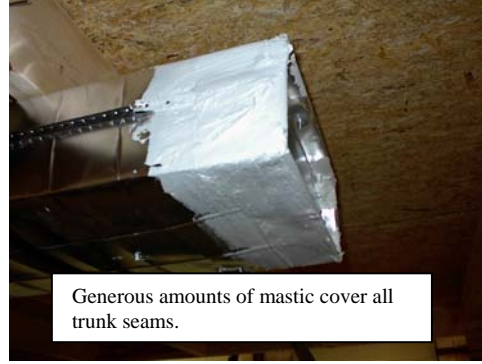
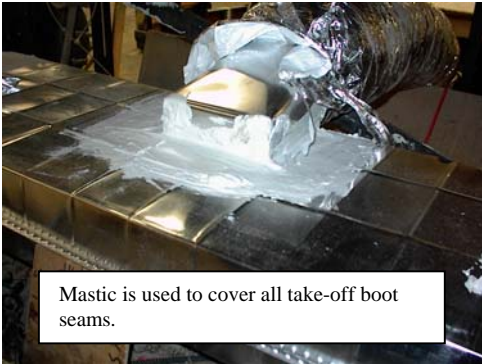
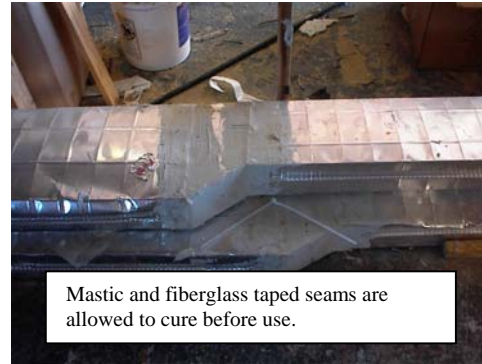
- 1. Maintain excellent duct tightening practices.** The plant is doing many things correctly with regards to duct sealing as part of their manufacturing process. Some examples are illustrated below:

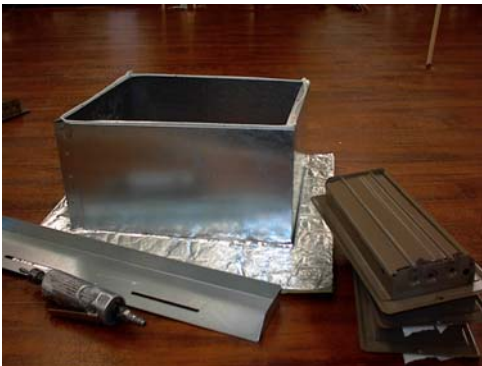
- 2. Maintain furnace plate and duct riser seal.** The furnace plate connection is arguably the most important connection to seal. The plant uses a “caulk and screw down” design for both the furnace plate connection and the straight risers. The trunk is not opened until after the connections are secure – resulting in a perfectly aligned hole.

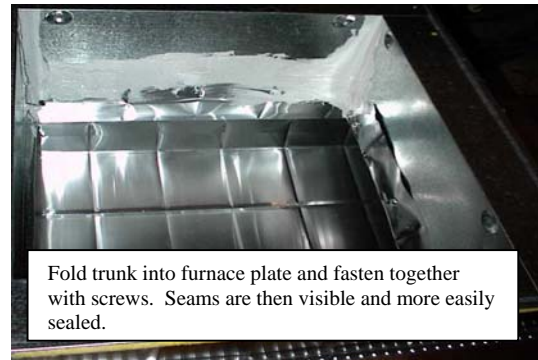
Figure 5.4 Furnace Boot Connections

The following are alternative recommendations for leak free furnace plate assembly: MHRA recommends making a “picture frame cut” into the trunk and screwing it into the side of the furnace base, and sealing with mastic. This is a superior performing and more durable connection. (See Figure 5.4 from MHRA publication *Duct Systems: Guide to Best Practices* for a good illustration.)

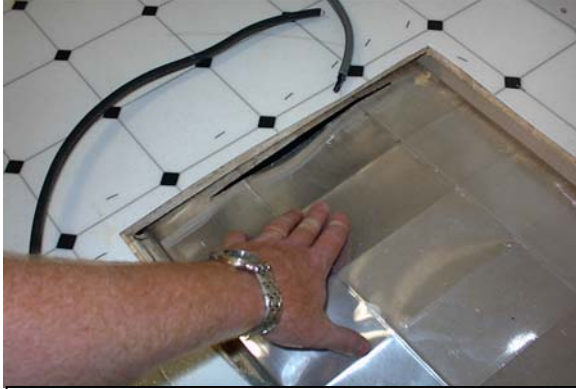
Branch ducts have zero clearance for saw cut through floor sheathing; the picture frame cut cannot be used.

When the furnace is located over a branch duct, cutting through the floor sheathing can result in cutting through the duct, thus preventing the picture-frame-cut fastening method. A cardboard spacer installed earlier in the process will prevent accidental cut-through.

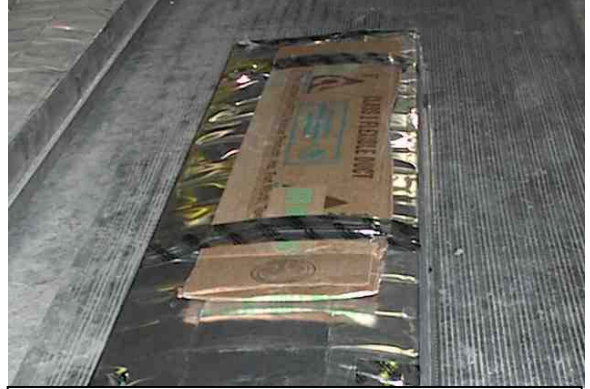
Cardboard spacer provides clearance for later saw cut through floor sheathing.

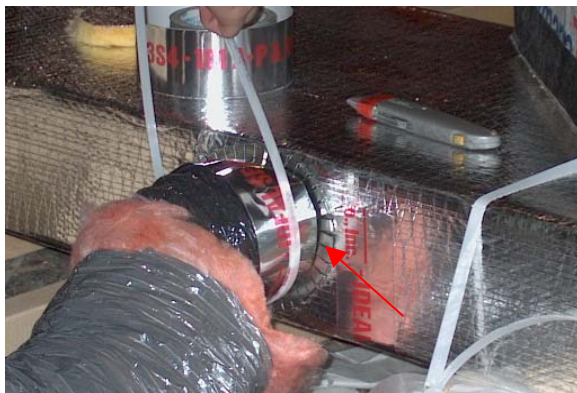
It is difficult to create a durable seal using tape or mastic alone.

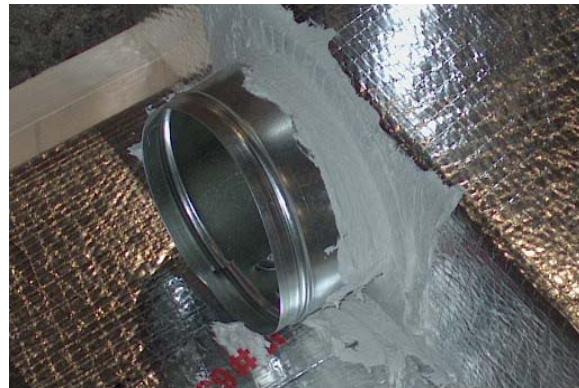
Applying tape as a temporary seal then covering the seam and tape with mastic will result in a superior and durable seal.

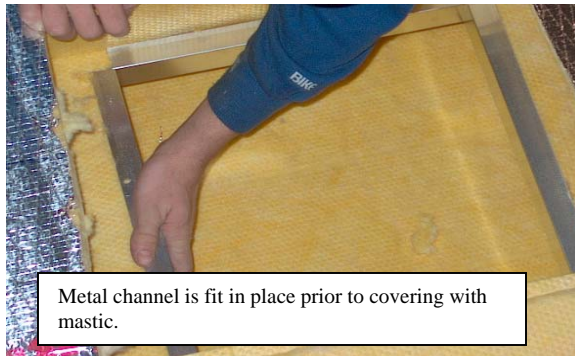
3. **Use care and attention to detail in crossover branch connections.** This is a critical area for leak prevention. Apply a good quantity of mastic between the mating surfaces of each trunk. Accurately cut the holes and use metallic channel to serve as a mechanical attachment. The channel should be sealed with mastic along all exposed edges. Strap the two trunks securely to prevent any movement of the duct until the mastic has had sufficient time to cure. Installers should be made aware that the mating surfaces are relatively fragile and may open if any pressure is applied to either trunk prior to curing.

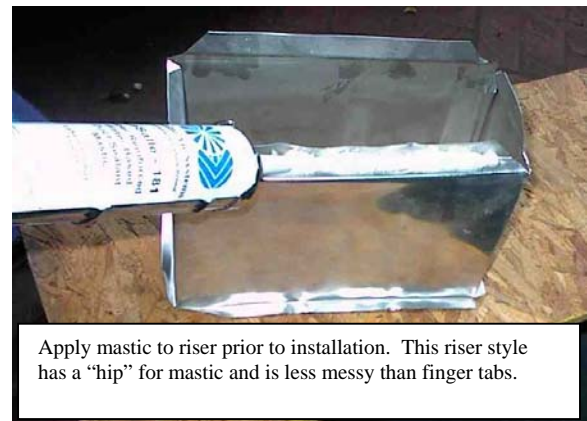
All openings between the boot and the floor should be sealed. These small holes can add up to significant duct leakage.

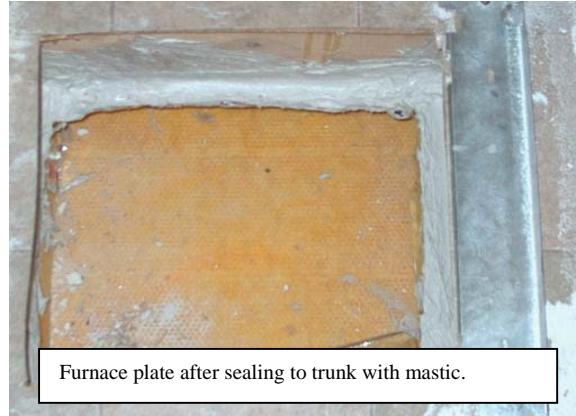
5. **Redesign the furnace plate/plenum to the duct board connection.** The furnace connection is often the leakiest site in the duct system. One option is to manufacture a metal channel designed to attach the inside of the duct board material and the plenum sidewall. The channel should be secured with screws and sealed with mastic.

Other manufacturers are having success using liberal amounts of mastic applied by gloved hand to the folded finger tabs of the existing furnace plate.

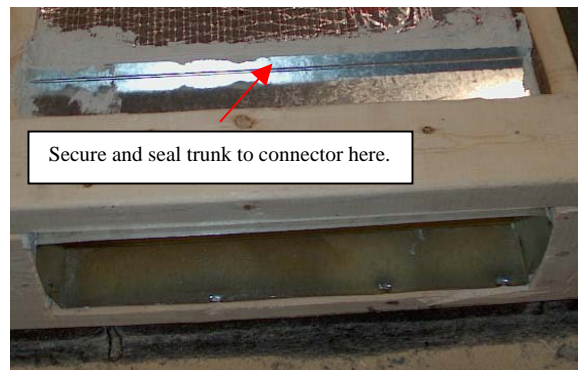
6. **Use care and attention to detail in crossover connections termination in the rim joist.** Care must be taken to insure that the duct board material is not pushed away from the metal connector or duct leakage will be excessive. A heavy application of mastic is recommended on both sides of all mating surfaces to assure proper sealing. Tape may be used to hold the material together while the mastic is curing. Cover all tape edges with mastic.

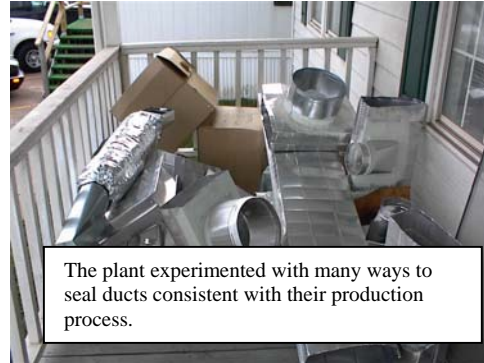
The plant experimented with many ways to seal ducts consistent with their production process.

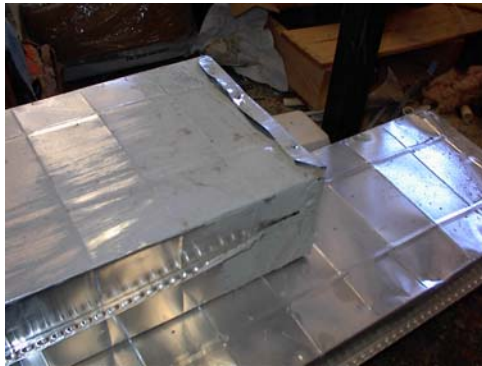
2. **Don't overuse fiberglass tape.** Fiberglass tape is used to strengthen a connection. There is no need to strengthen the end cap connections. The tape can hide a poorly sealed seam. End cap seams will be better sealed by mastic alone.
