CHAPTER VIII

**CHAPTER VIII****MATERIALS CLEANING ANALYSIS****ON-SITE COLLECTION OF PHYSICAL DATA****DESCRIPTION OF STAINS AND SOILING**

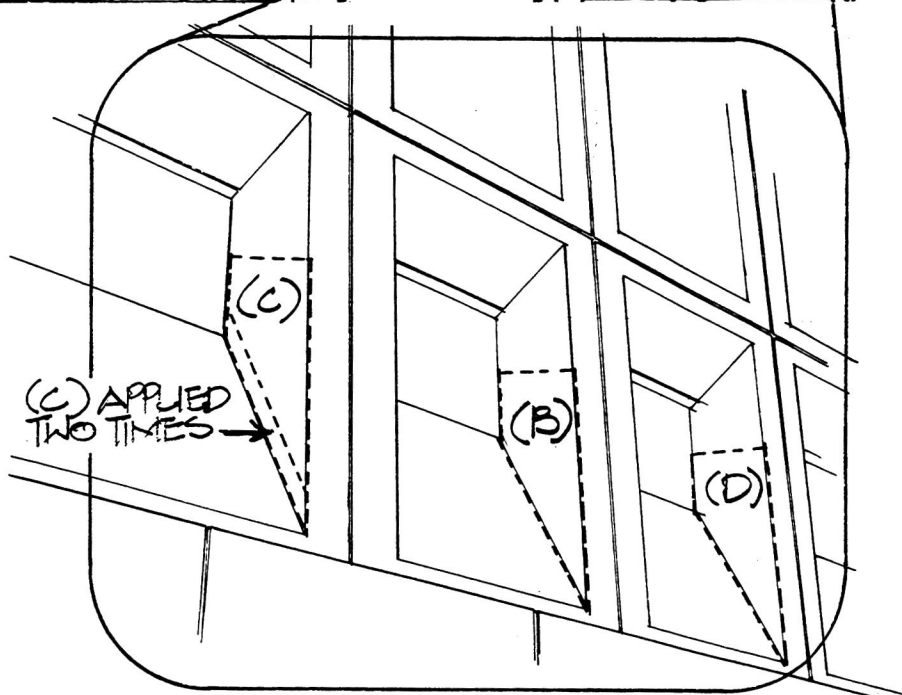
Illustration No. 8-1

Housing and Urban Development Building, south end of west elevation (section through building looking south). Exterior precast concrete wall panel cleaning test location sketch showing: (B) High Pressure Water wash (C) Acidic Wash diluted 3:1 with water and (D) Alkaline Cleaner with an Acidic Rinse. Acidic wash was applied two times on bottom portion of panel.

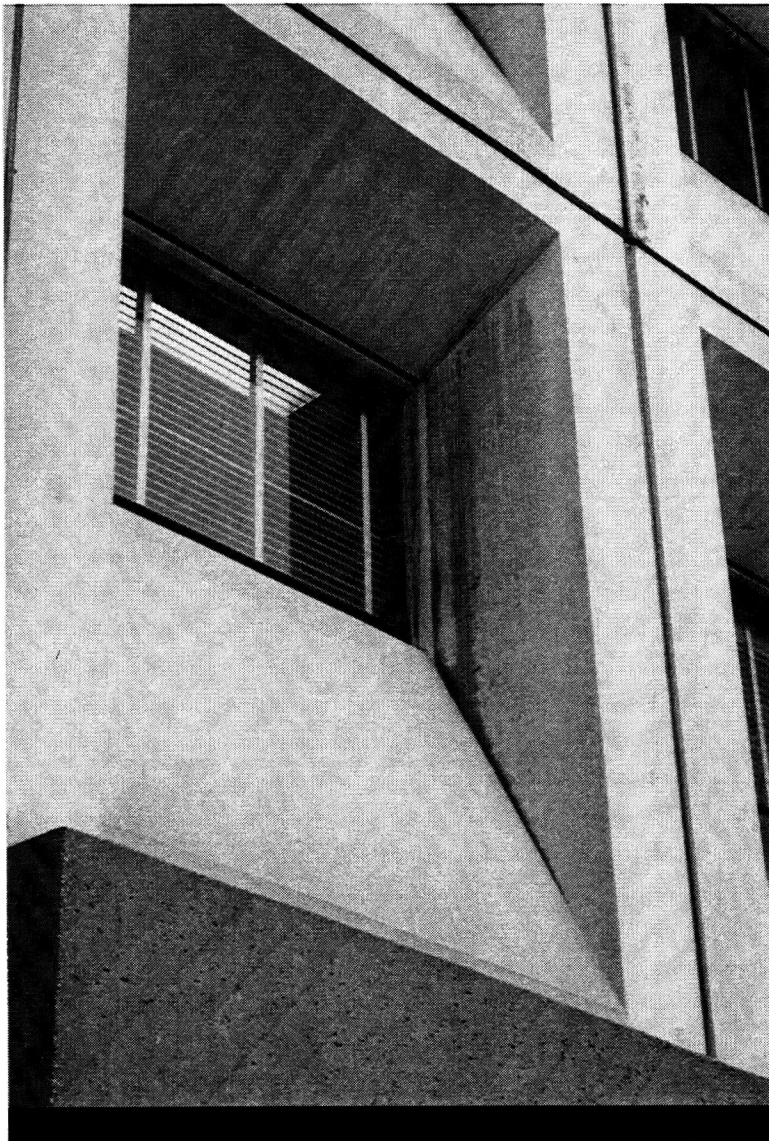
Illustration No. 8-2

Subject: Housing and Urban Development Building, south end of west elevation at second floor

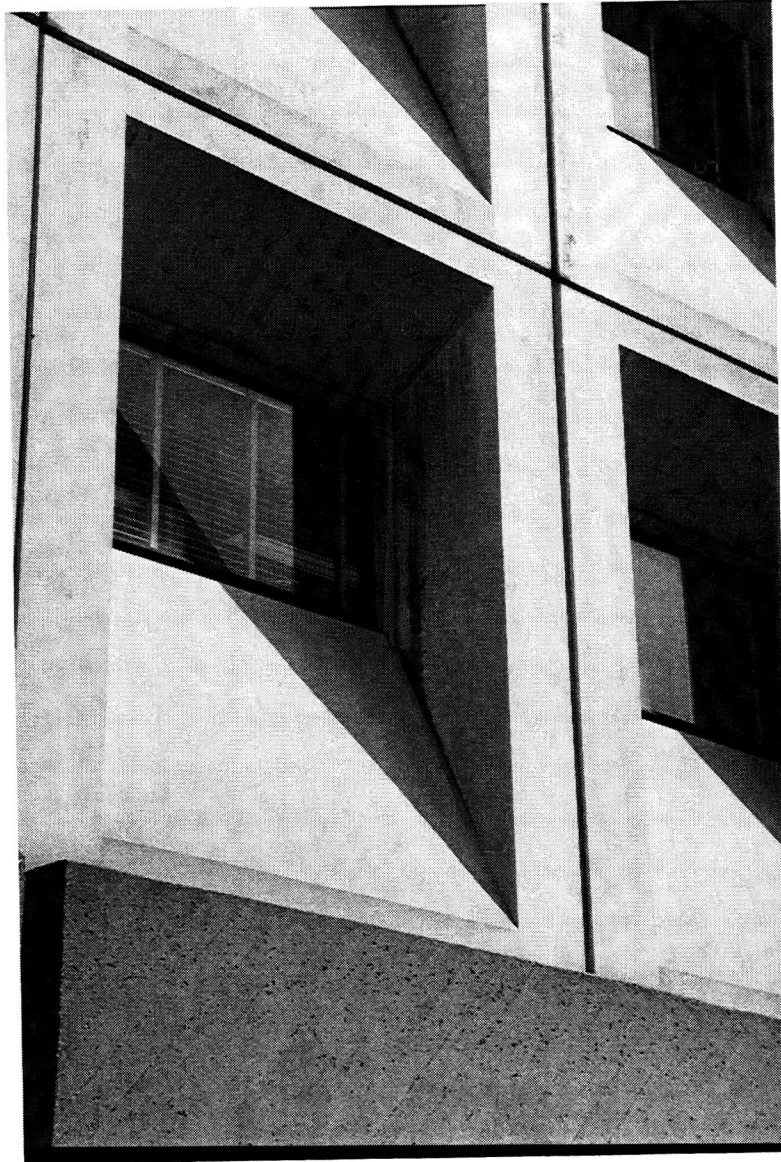
Illustration No. 8-3

Subject: Housing and Urban Development Building, south end of west elevation at second floor

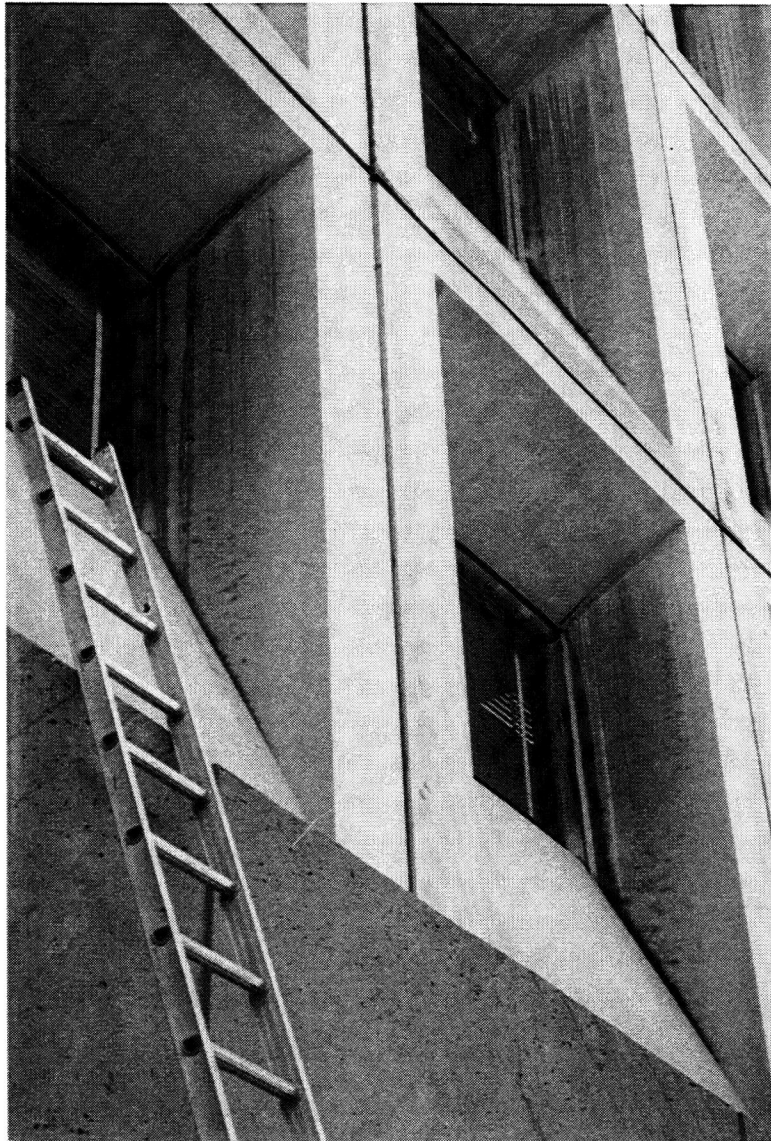
Illustration No. 8-4

Subject: Housing and Urban Development Building, south end of west elevation at second floor

- (A) Medium pressure warm water wash (500 psi; 4 gpm) with minimum 25 degree fan spray tip. This cleaning method was not effective in removing the soiling or staining from the concrete (Illus. Nos. 8-8, 8-9), bluestone (Illus. Nos. 8-21, 8-22) or plaster ceiling (Illus. Nos. 8-23, 8-24).
- (B) High pressure warm water wash (1200 psi, 4 gpm) with minimum 25 degree fan spray tip. This cleaning method did not remove the staining and soiling from the concrete (Illus. Nos. 8-4, 8-5, 8-8, 8-9, 8-10 and 8-11). The High Pressure Water

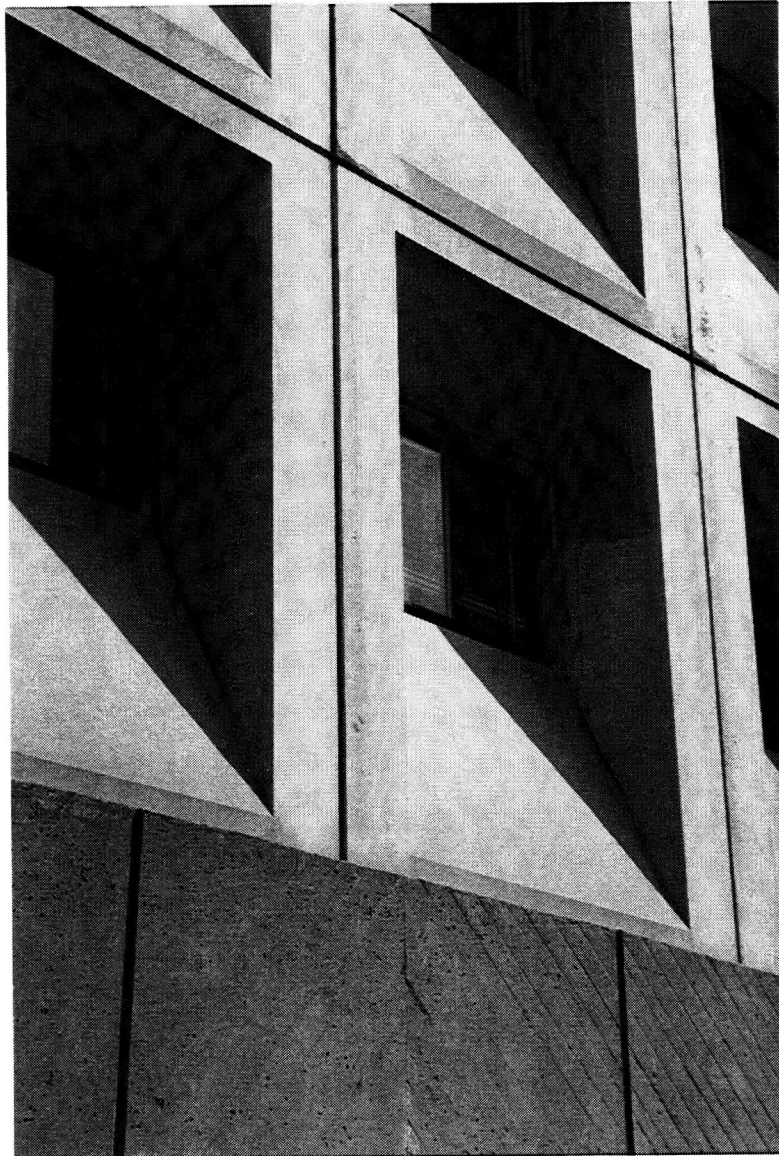
Illustration No. 8-5

Subject: Housing and Urban Development Building, south end of west elevation at second floor

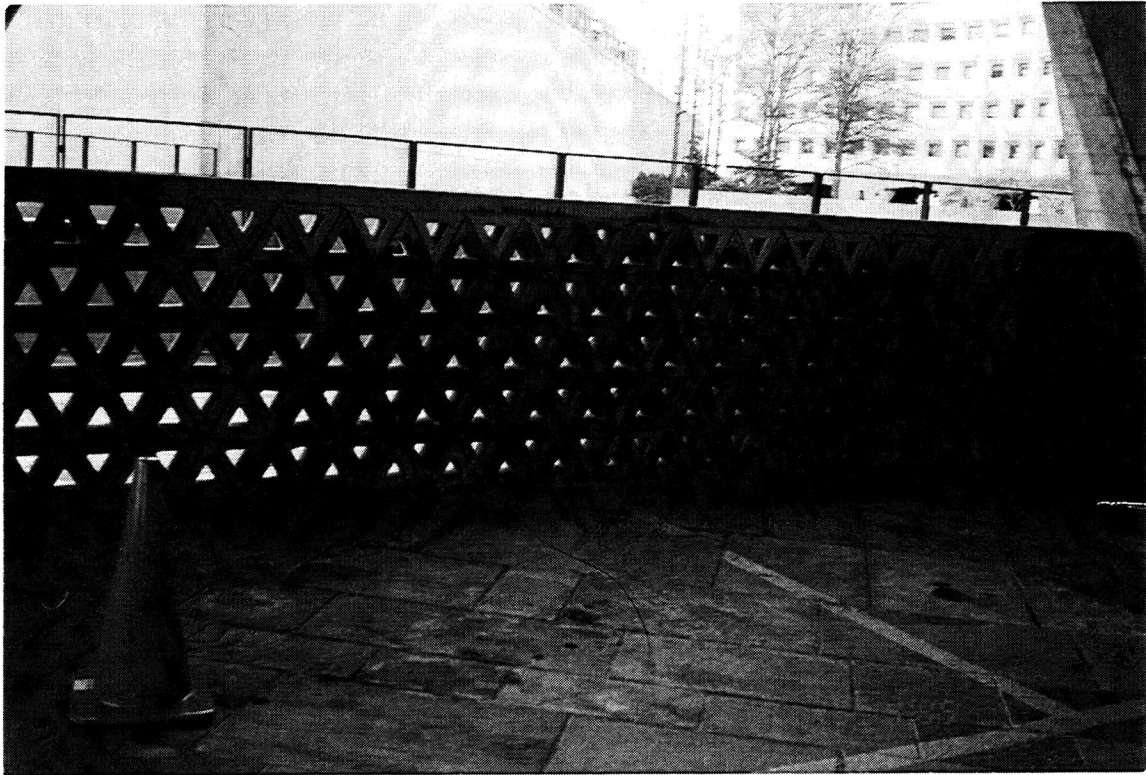
Illustration No. 8-8

Subject: Housing and Urban Development Building, precast concrete screen wall at first floor, southwest corner of building.

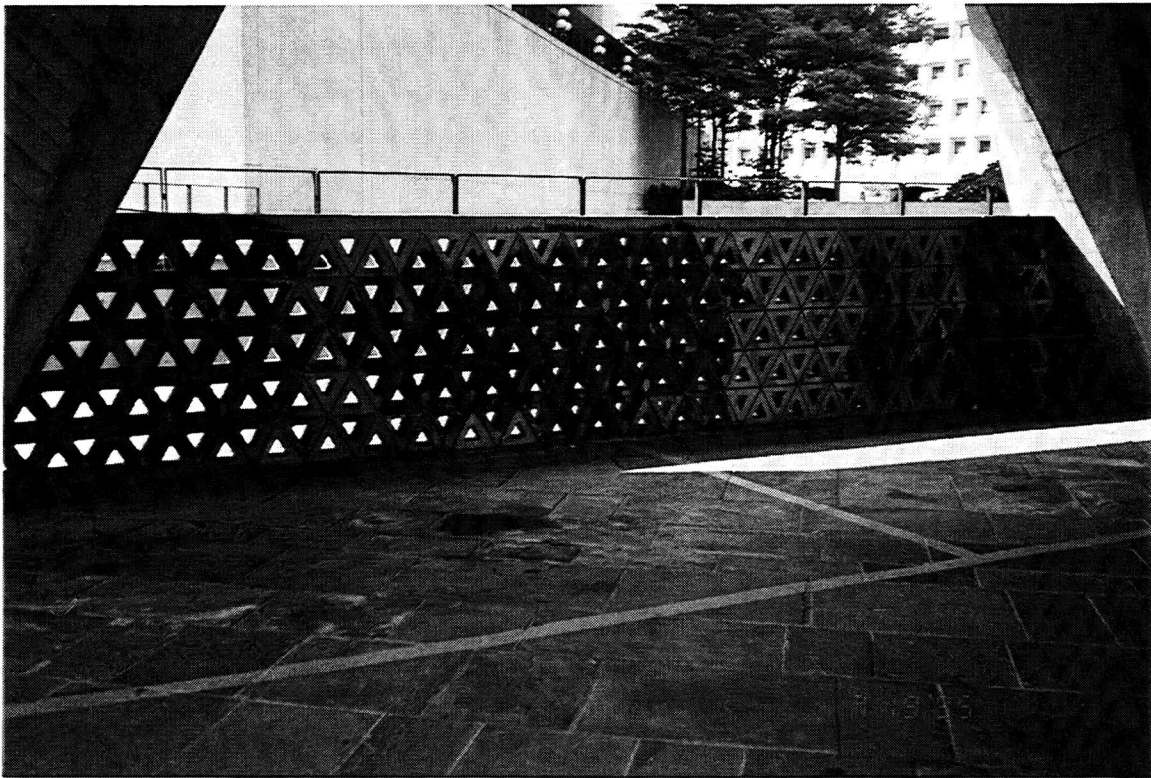
Illustration No. 8-9

Subject: Housing and Urban Development Building, precast concrete screen wall at first floor, southwest corner of building

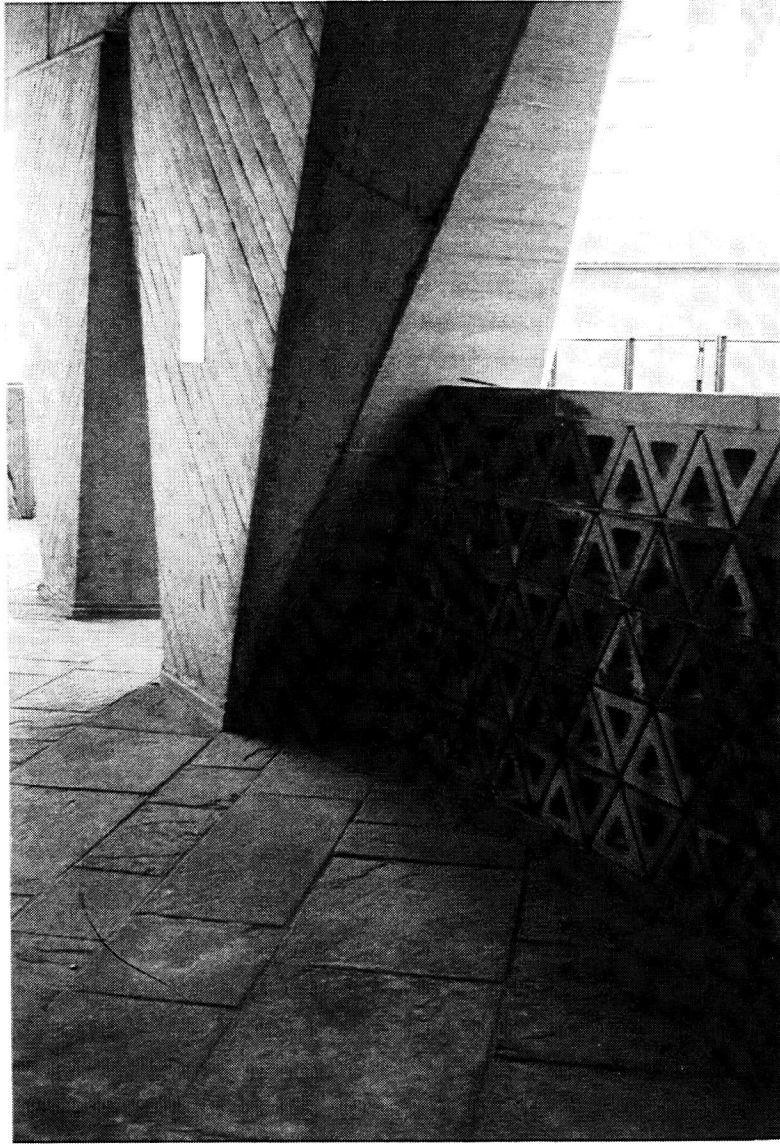
Illustration No. 8-10

Subject: Housing and Urban Development Building, cast-in-place concrete pilotis at first floor, southwest corner of building

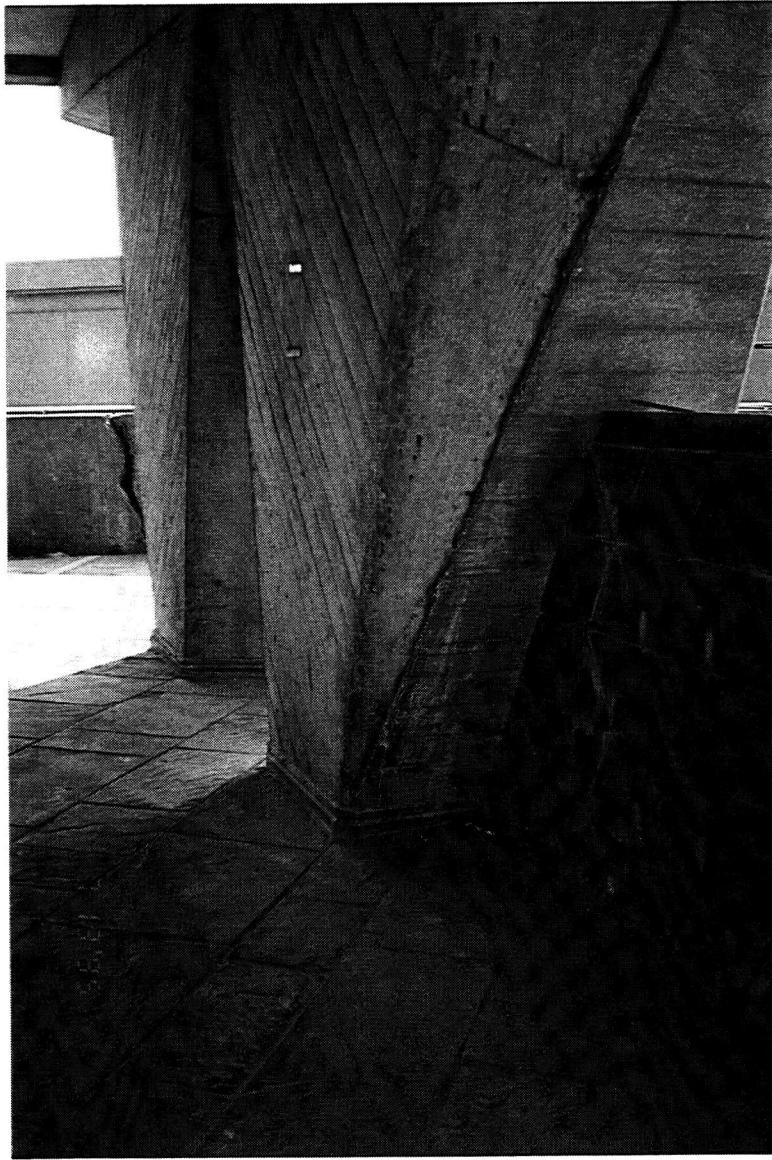
Illustration No. 8-11

Subject: Housing and Urban Development Building, cast-in-place concrete pilotis at first floor, southwest corner of building

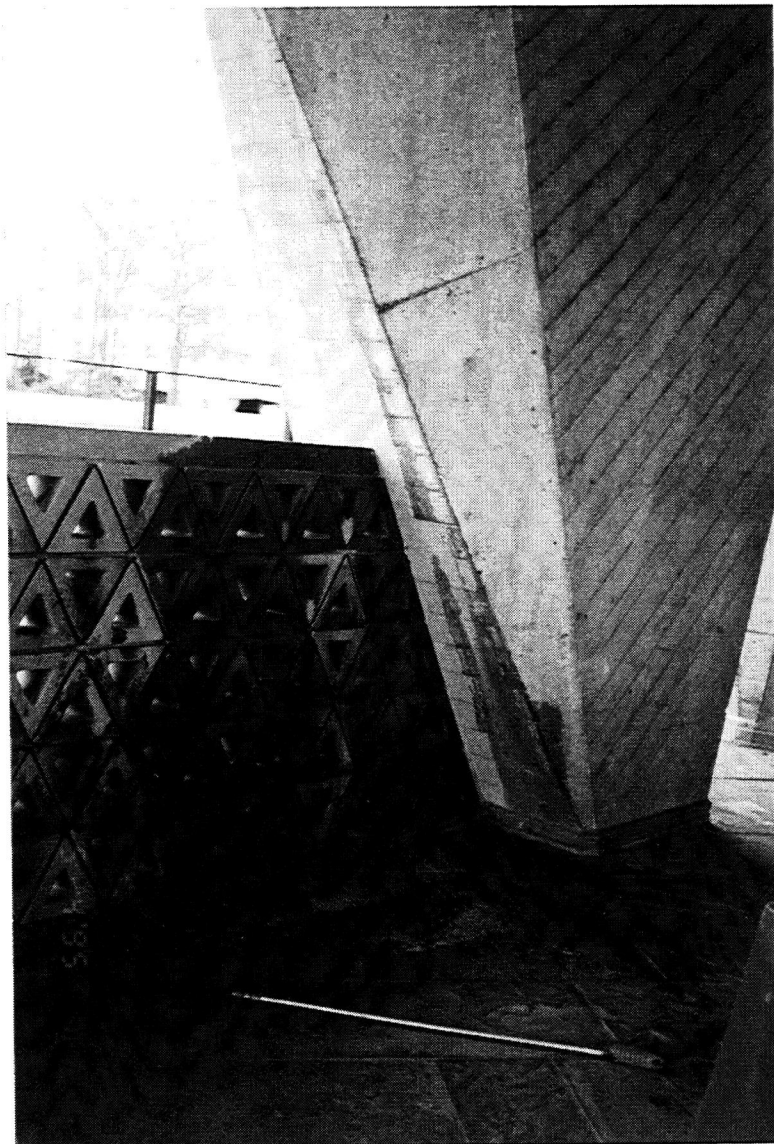
Illustration No. 8-12

Subject: Housing and Urban Development Building, cast-in-place concrete pilotis at first floor, southwest corner of building

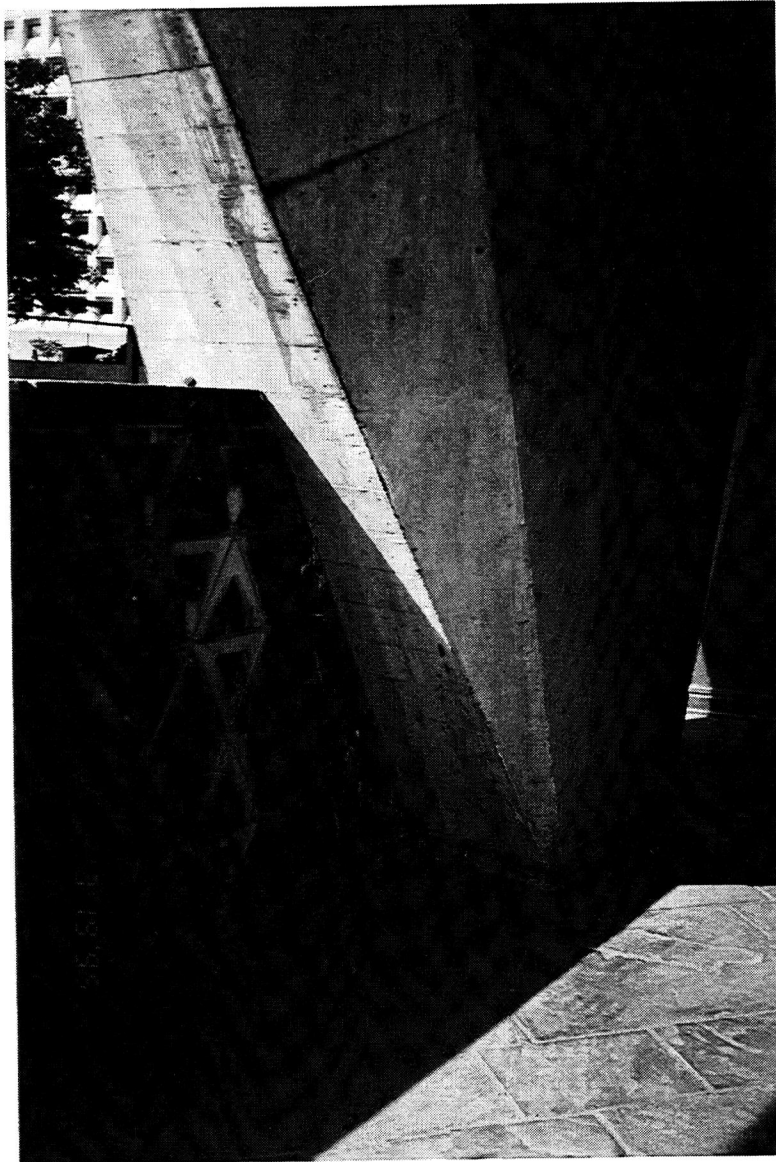
Illustration No. 8-13

Subject: Housing and Urban Development Building, cast-in-place concrete pilotis at first floor, southwest corner of building

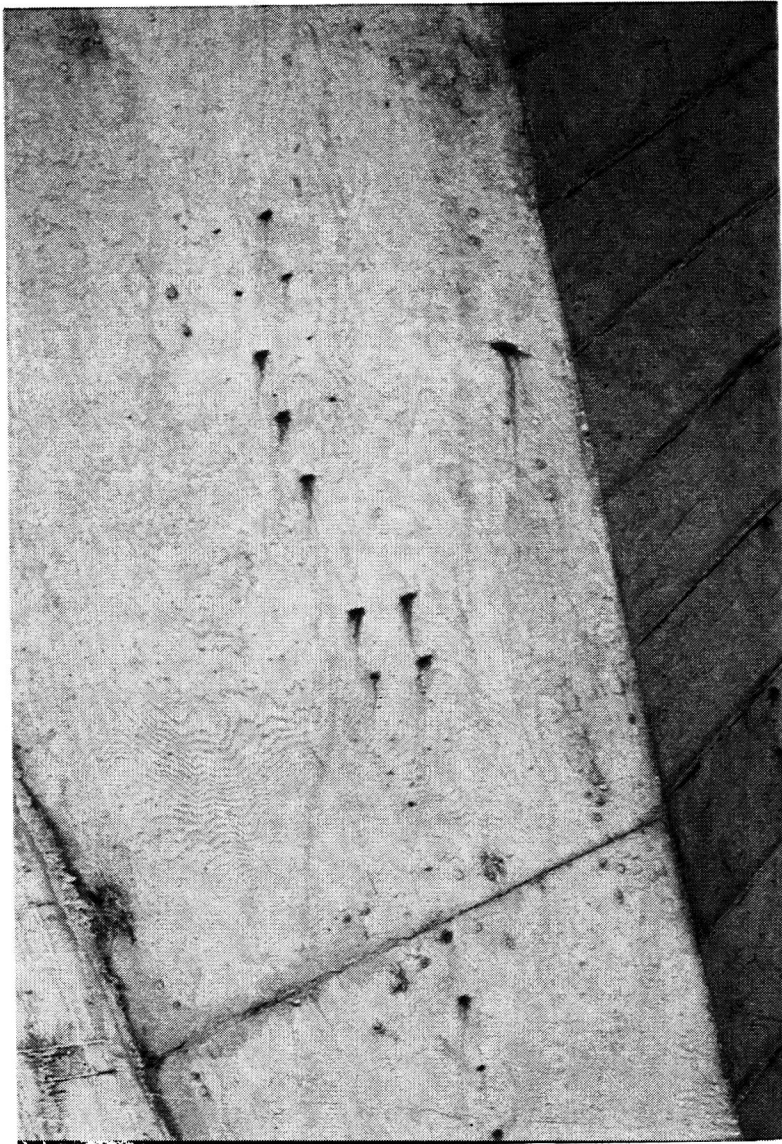
Illustration No. 8-14

Subject: Housing and Urban Development Building, cast-in-place concrete pilotis at first floor, southwest corner of building

- (F) Ferrous Stain Remover (by ProSoCo) was not effective in removing the rust stains (Illus. Nos. 8-14, 8-15). While the concrete surface was wet it appeared that the stain remover had removed some of the rust stains caused by the corroding steel reinforcing supports. The use of the stain remover in combination with a poultice may be necessary to remove the rust stains.

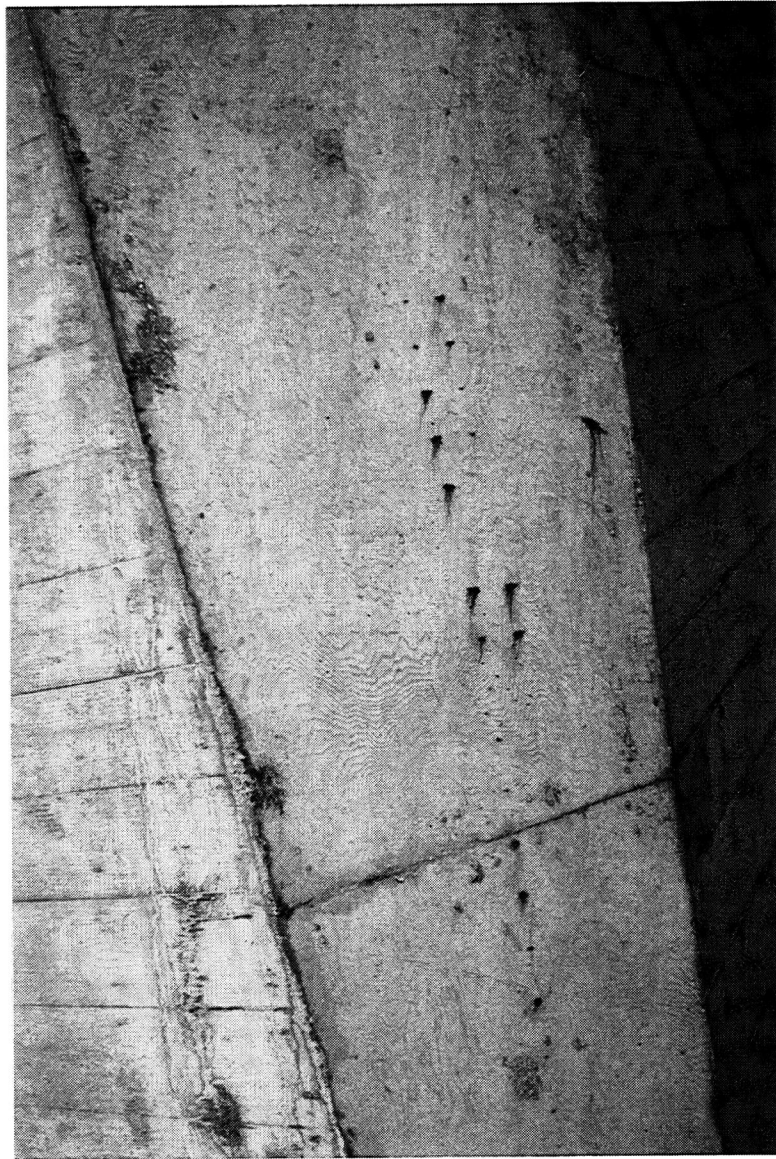
Illustration No. 8-15

Subject: Housing and Urban Development Building, cast-in-place concrete pilotis at first floor, southwest corner of building.

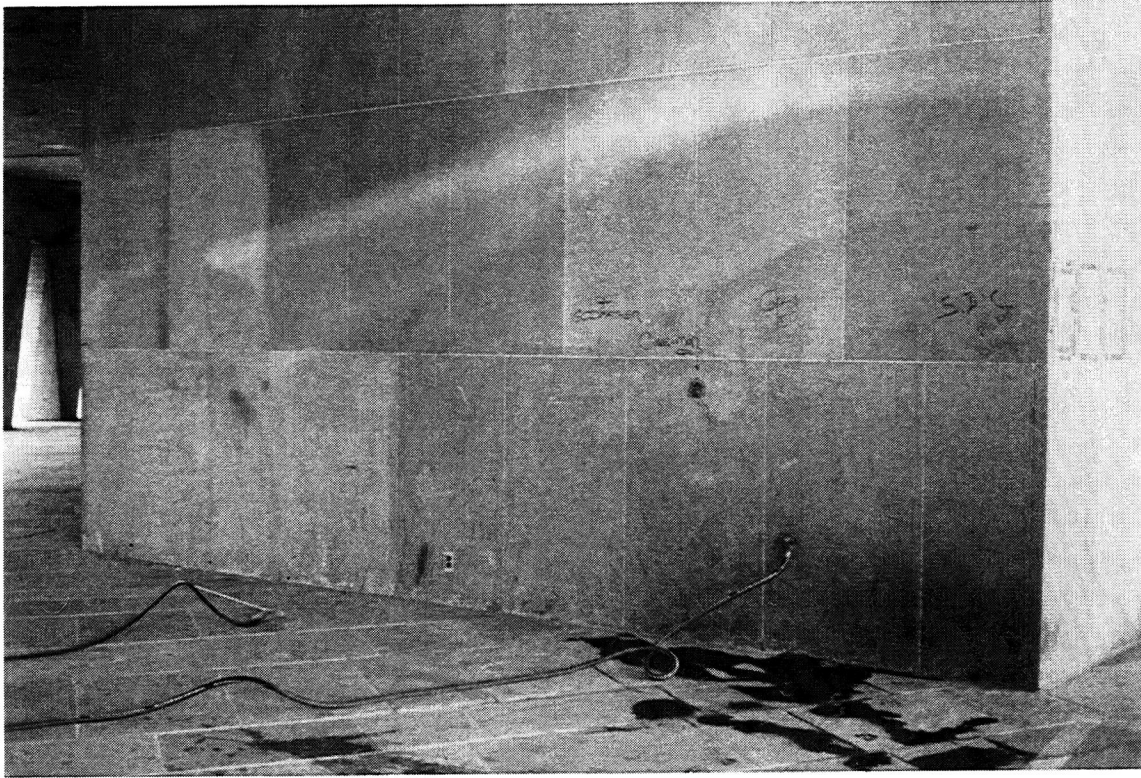
Illustration No. 8-17

Subject: Housing and Urban Development Building, granite wall at southwest corner of first floor.

- (G) Asphalt and Tar Remover (by ProSoCo) was not effective in removing the tape stains or graffiti (Illus. Nos. 8-17, 8-19, 8-20).

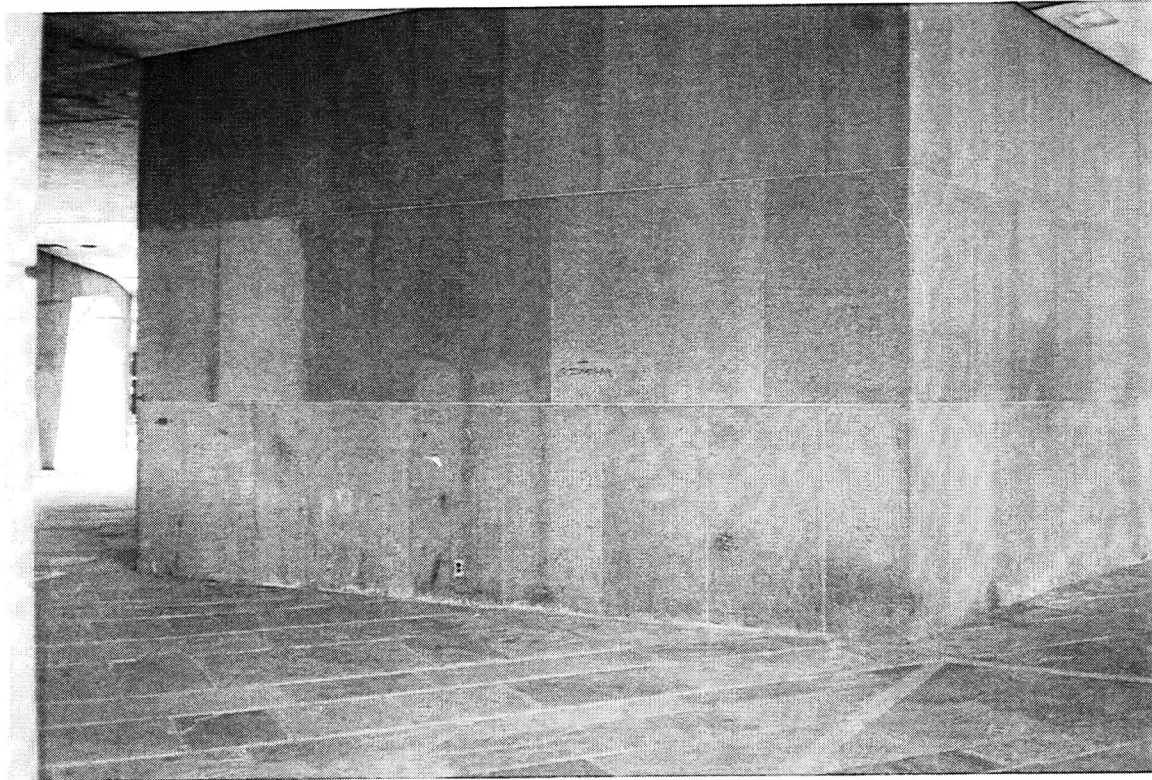
Illustration No. 8-18

Subject: Housing and Urban Development Building, granite wall at southwest corner of first floor

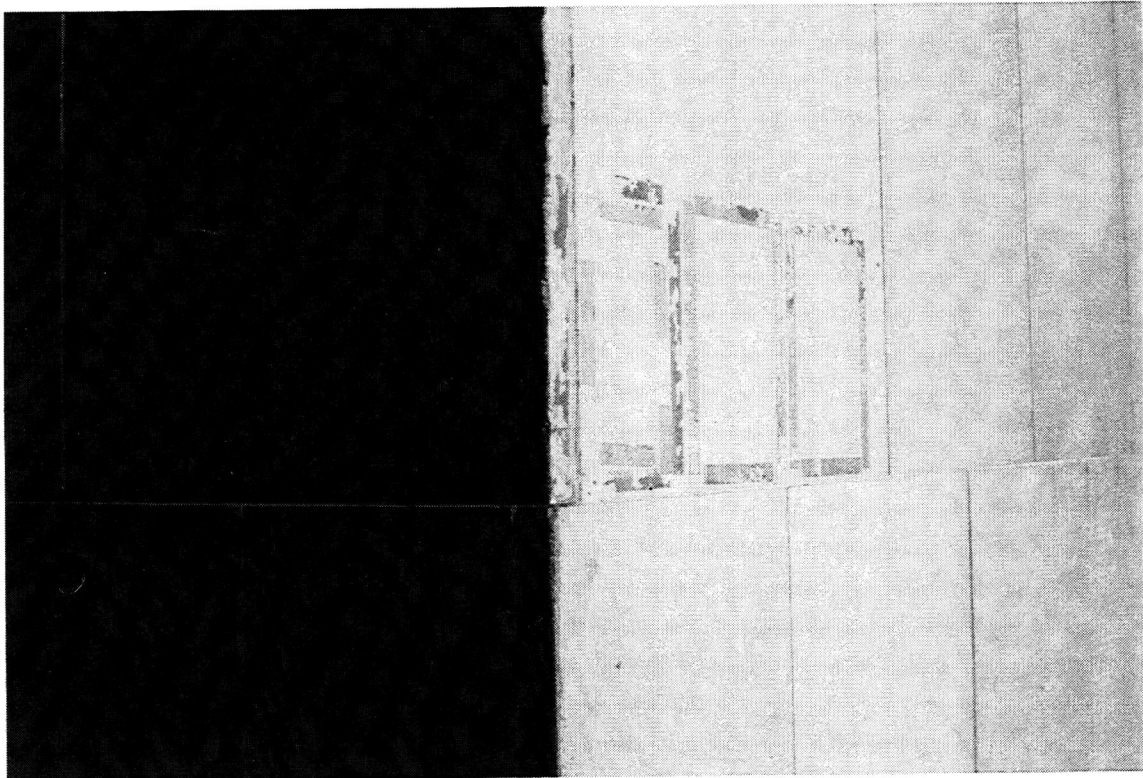
Illustration No. 8-19

Subject: Housing and Urban Development Building, graffiti and stains on granite wall at southwest corner of first floor

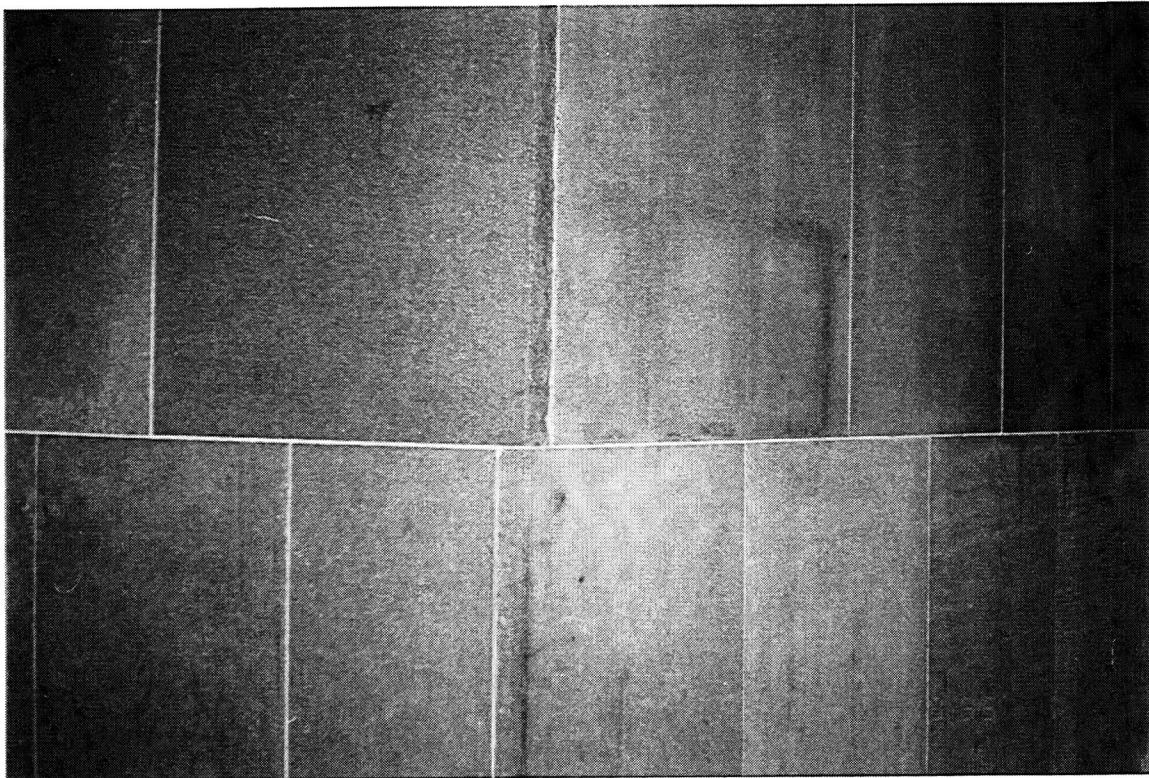
Illustration No. 8-20

Subject: Housing and Urban Development Building, graffiti and stains on granite wall at southwest corner of first floor

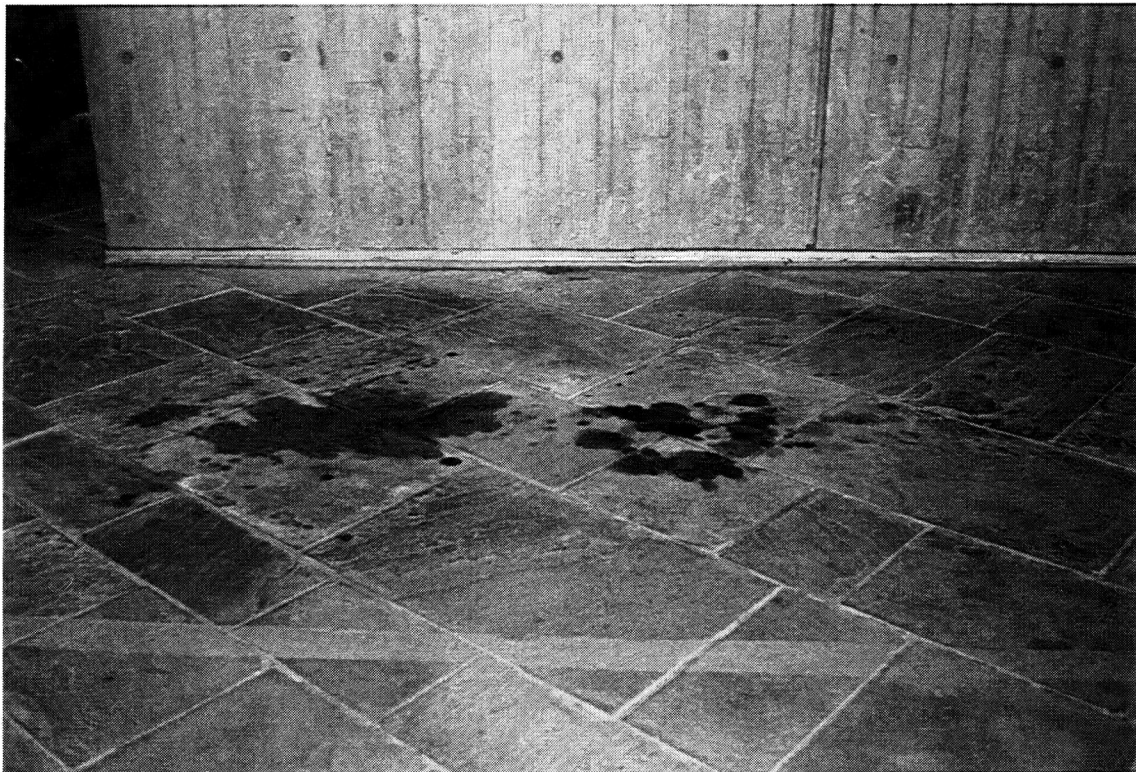
Illustration No. 8-21

Subject: Housing and Urban Development Building, bluestone paving with oil and grease stains at southwest corner of first floor.

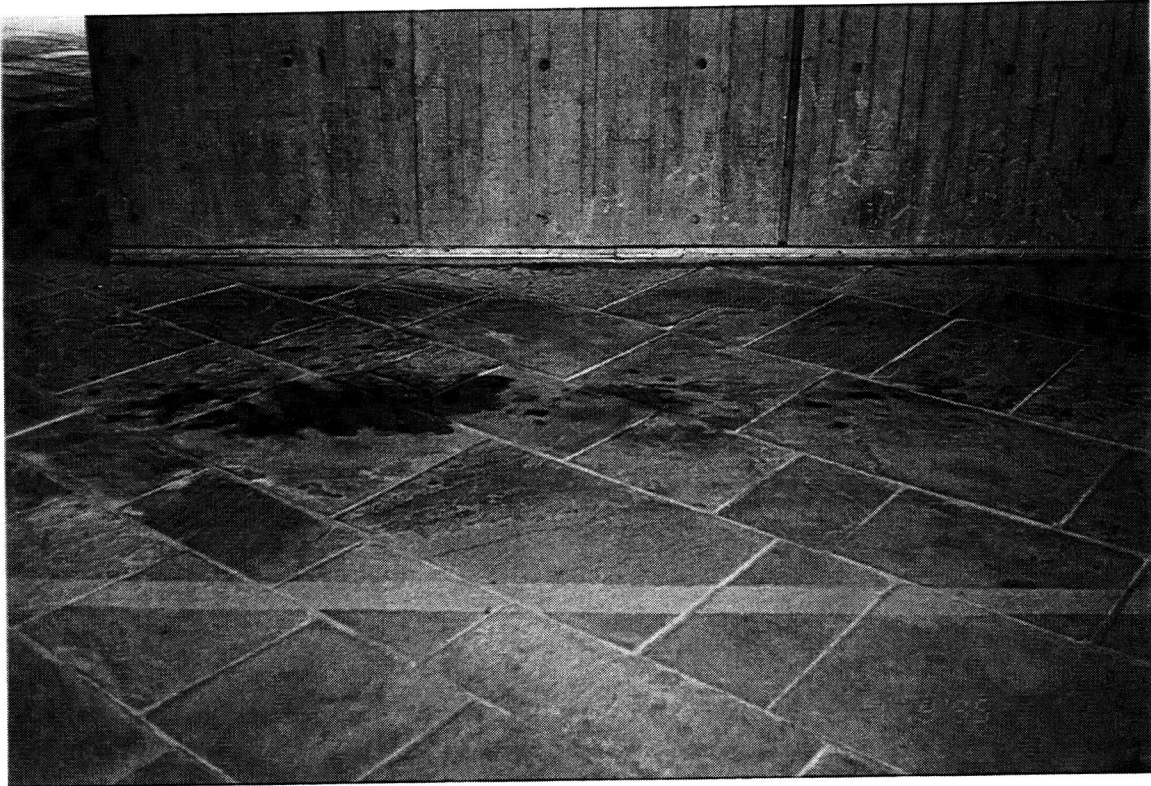
Illustration No. 8-22

Subject: Housing and Urban Development Building, bluestone paving with oil and grease stains at southwest corner of first floor

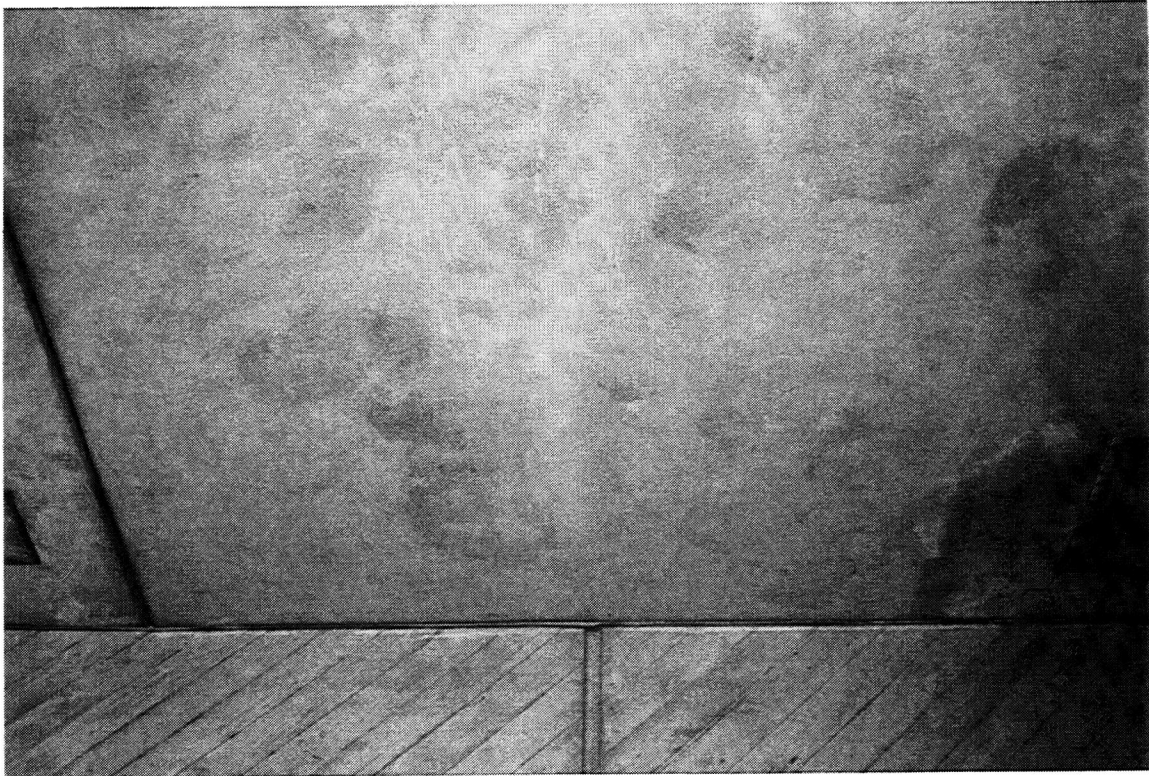
Illustration No. 8-23

Subject: Housing and Urban Development Building, soiled plaster ceiling at southwest corner of first floor

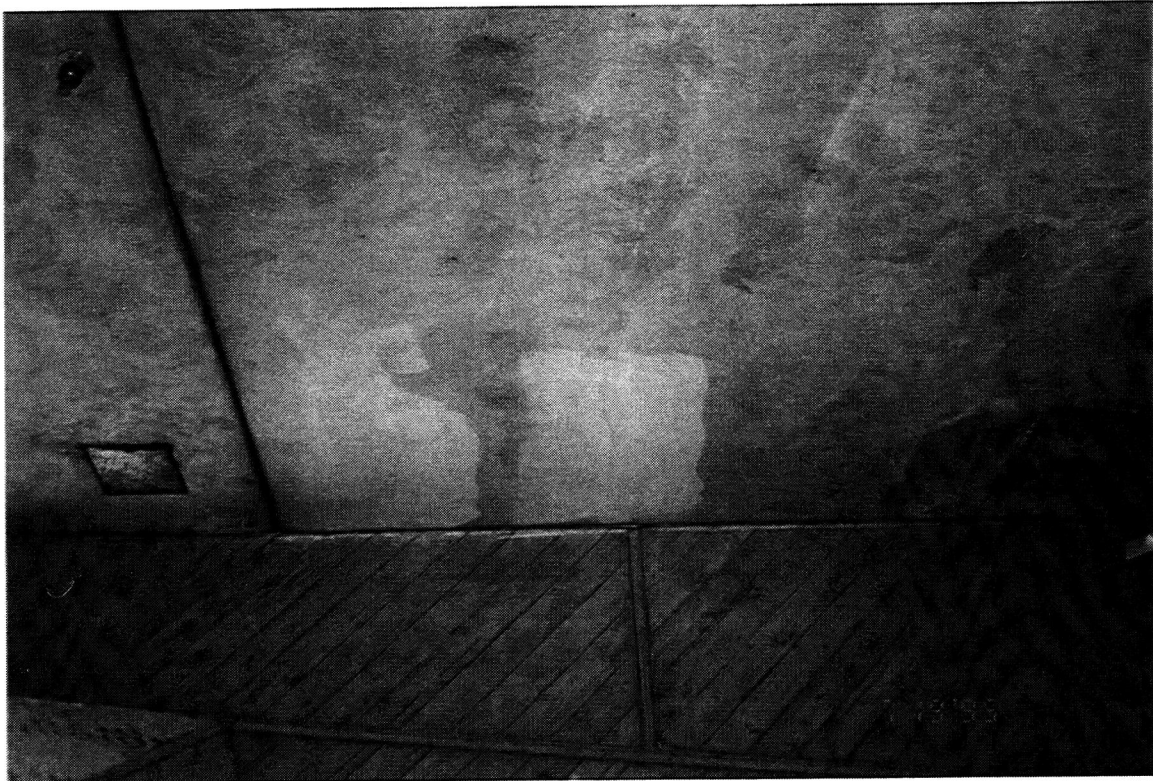
Illustration No. 8-24

Subject: Housing and Urban Development Building, soiled plaster ceiling at southwest corner of first floor.

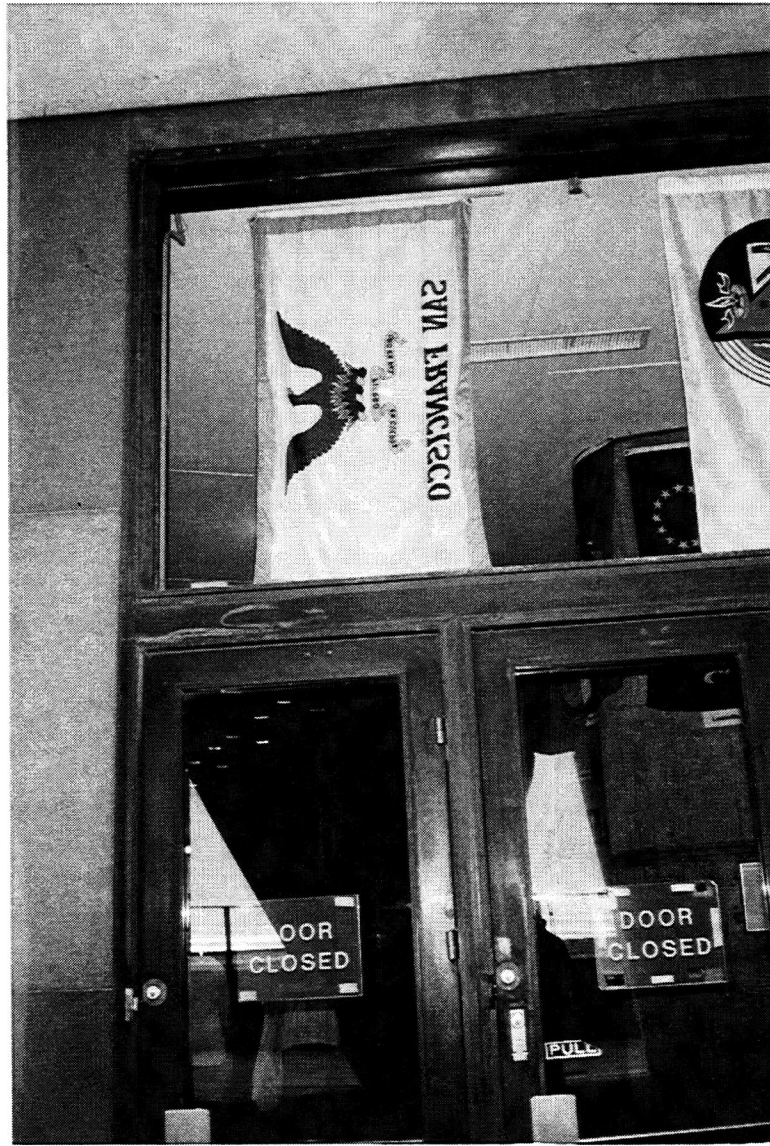
Illustration No. 8-25

Subject: Housing and Urban Development Building, soiled anodized aluminum entrance doors and frames at south end of west elevation

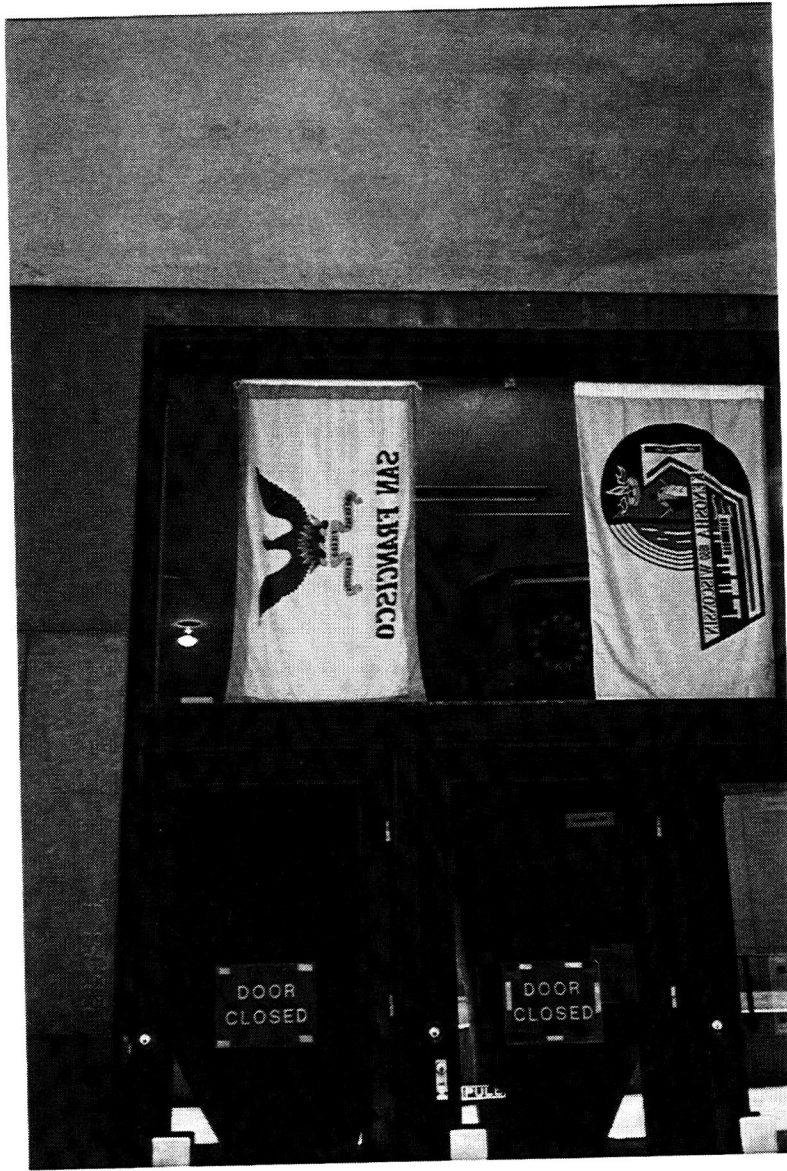
Illustration No. 8-26

Subject: Housing and Urban Development Building, soiled anodized aluminum entrance doors and frames at south end of west elevation

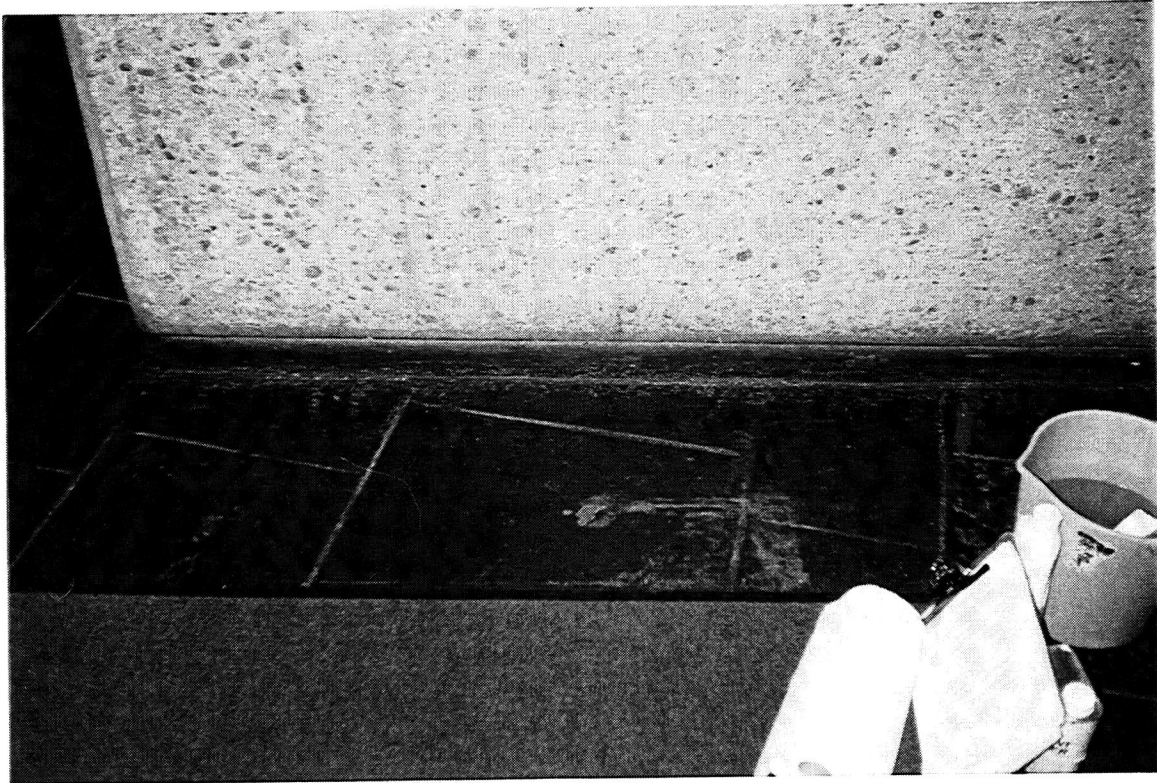
Illustration No. 8-27

Subject: Housing and Urban Development Building, first floor bluestone flooring in South Lobby adjacent to Cafeteria doors
