CHAPTER VIII

**CHAPTER VIII****MATERIALS CLEANING ANALYSIS****ON-SITE COLLECTION OF PHYSICAL DATA****DESCRIPTION OF STAINS AND SOILING**

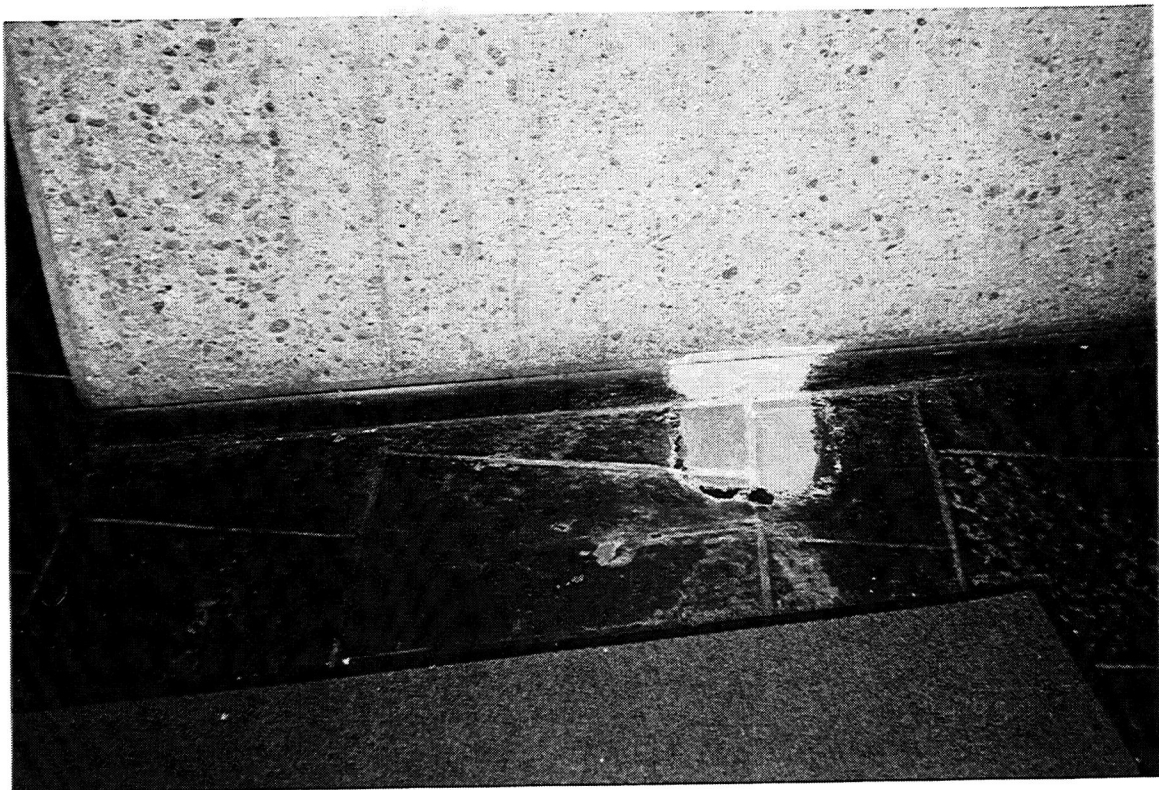
Illustration No. 8-28

Subject: Housing and Urban Development Building, first floor bluestone flooring in South Lobby adjacent to Cafeteria doors

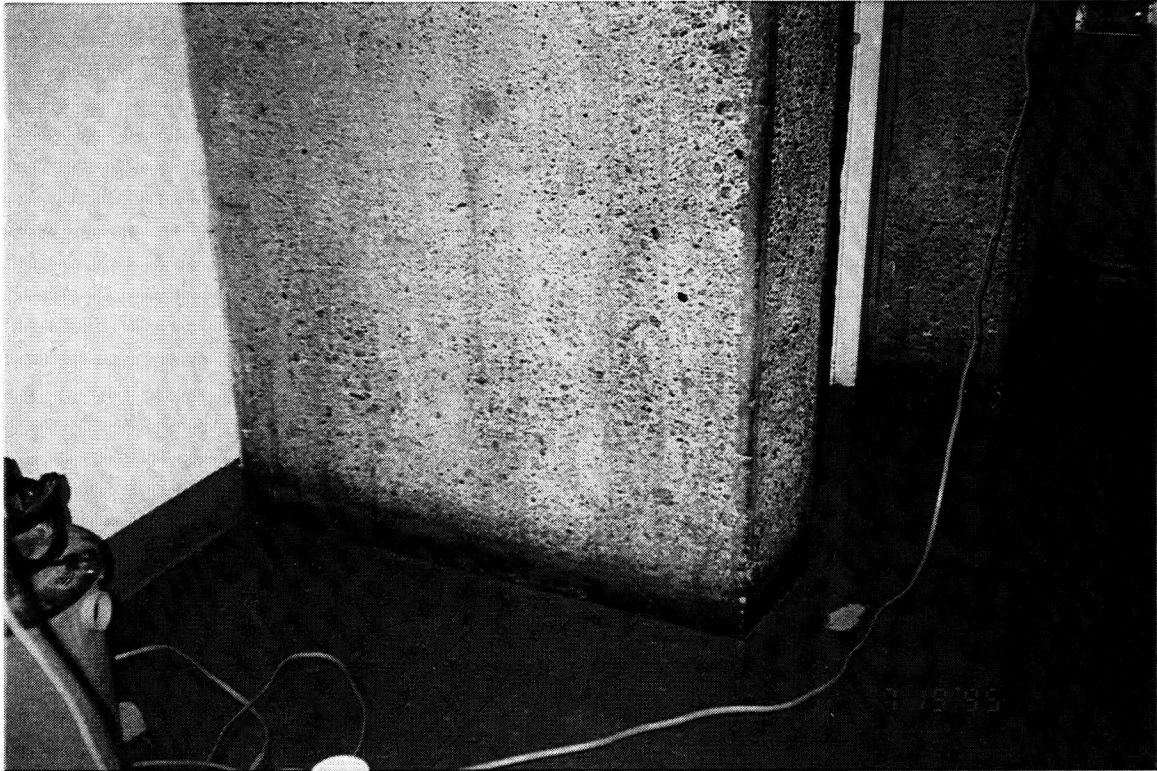
Illustration No. 8-29

Subject: Housing and Urban Development Building, basement floor, north core adjacent to service elevator door showing soiled concrete

- (H) Detergent cleaning using Trisodium Phosphate (TSP) cleaner on the interior concrete left the surface uniformly clean. The surface of the concrete was rinsed several times to remove the white residue of the TSP cleaner (Illus. Nos. 8-29, 8-30). The plaster ceiling of the arcade was also cleaned removing most of the soiling and leaving the plaster surface a slightly grey (Illus. Nos. 8-23, 8-24).
- (I) Acid cleaner, Interior Stone Cleaner (by ProSoCo), was as effective as the (H) Detergent in cleaning the interior concrete. It removed the staining at the outside corner of the concrete but had no effect on the wax build-up at the recessed concrete base (Illus. Nos. 8-29, 8-30).
- (J) Warm Water Wash had almost no effect on the cleaning of the interior concrete walls (Illus. Nos. 8-29, 8-30).

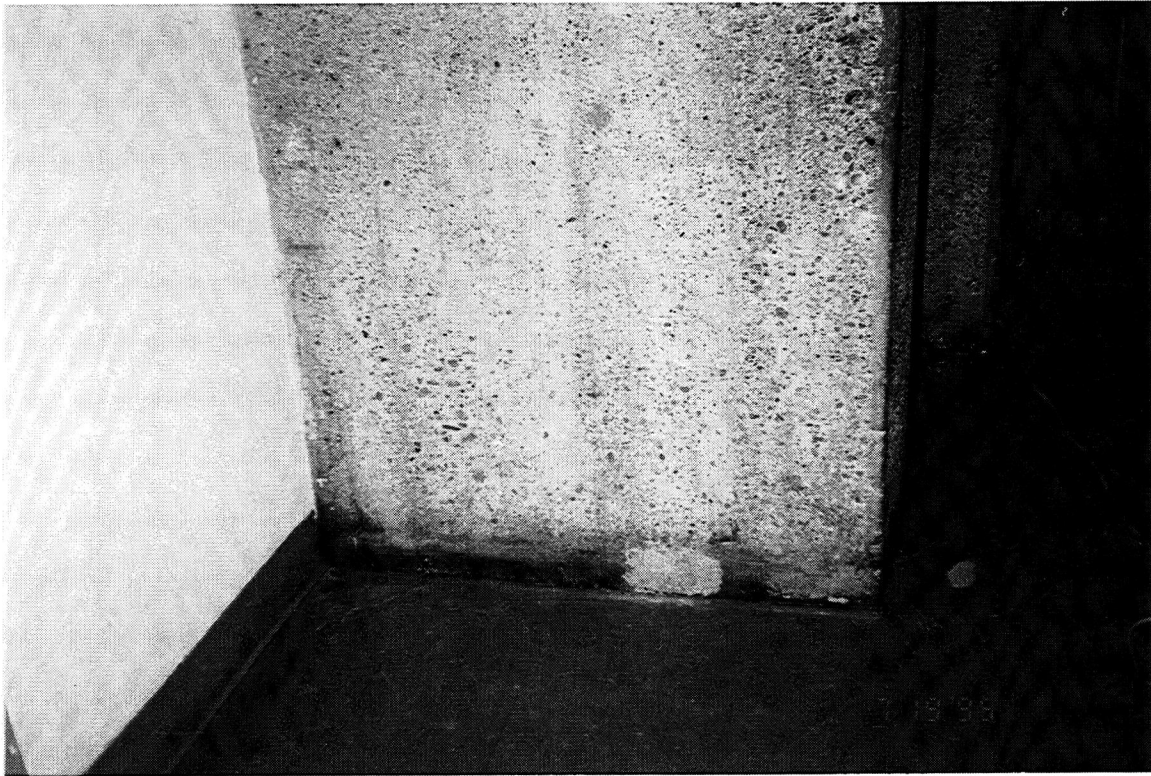
Illustration No. 8-30

Subject: Housing and Urban Development Building, basement floor, north core adjacent to service elevator door showing soiled concrete at bottom of wall.

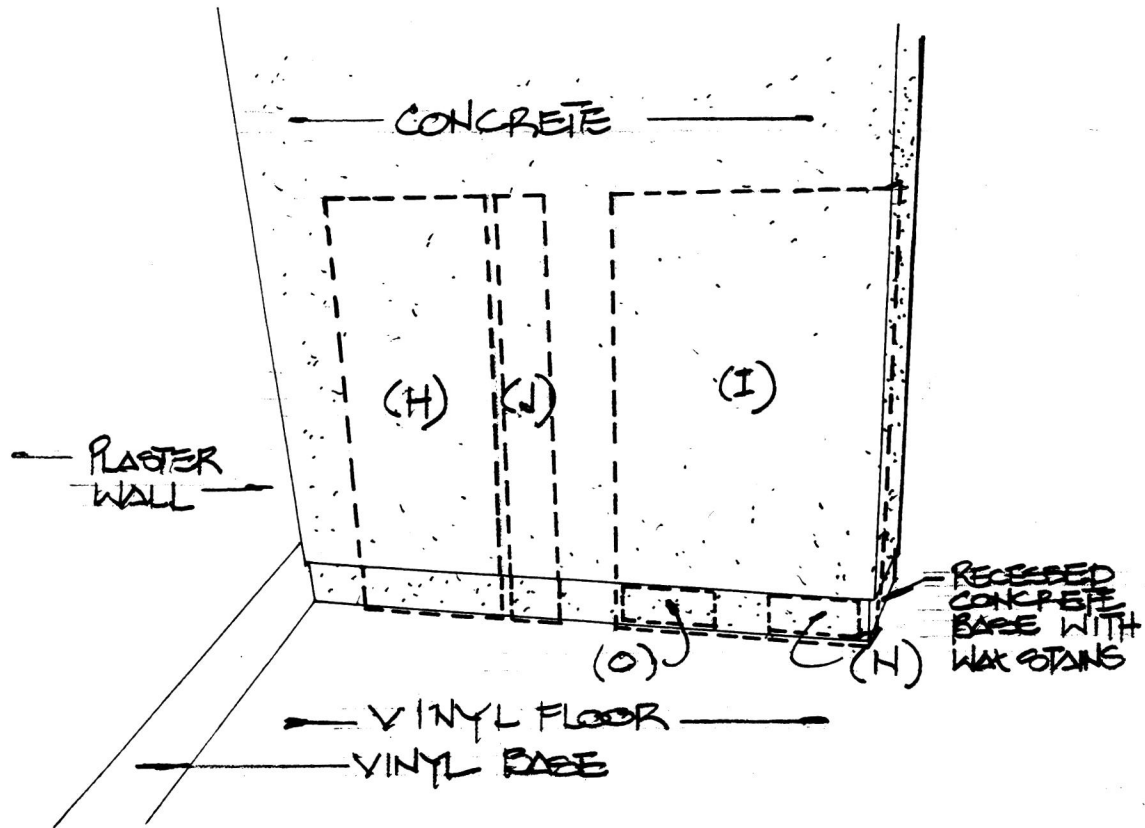
Illustration No. 8-31

Housing and Urban Development Building, sketch showing the location of each cleaning test application on the concrete wall and base at the basement floor, north core adjacent to service elevator door. Cleaning tests included: (I) Interior Stone Cleaner, (J) Warm Water and (H) Detergent, (N) Wax Remover and (O) Stripper. See Illus. Nos. 8-29 and 8-30 for "before" and "after" photographs.
