OPERATION  
BREAKTHROUGH

U.S. Department of  
Housing and Urban  
Development

A COMPENDIUM  
OF THE PERFORMANCE  
TESTING PROGRAM

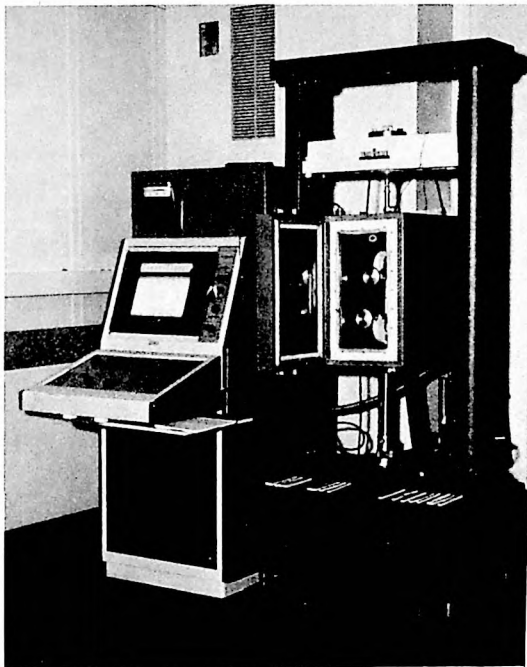
FIGURE 36  
CONTROLLED HUMIDITY CHAMBER  
USED FOR TESTING STRENGTH OF  
ADHESIVE USED IN PANELS WITH FIBERGLASS  
REINFORCED POLYESTER SKINS

The shear strength of the adhesive bond was determined on specimens cut from full panels in the area where the core was bonded to the face sheet. These specimens were tested in two ways: with short term loading applied with a testing machine, and with sustained loading applied by suspended dead weights. (See figs. 36 and 37.)

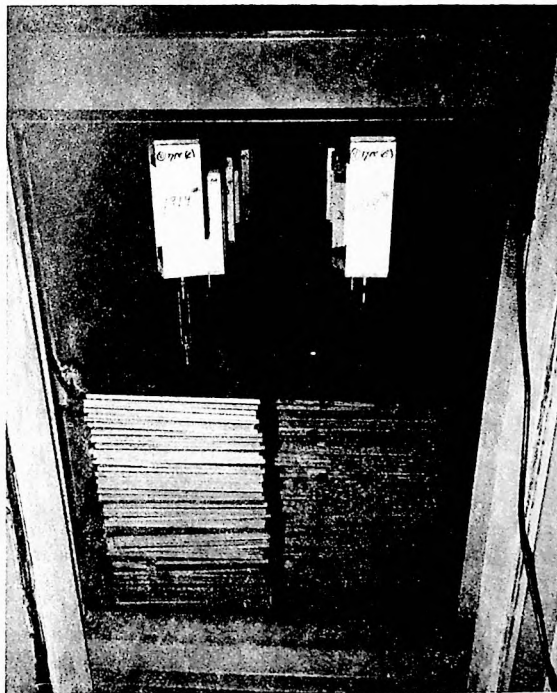
FIGURE 53  
LONG TERM TEST  
OF ADHESIVE USED IN  
MODULES SHOWN IN FIG. 51

The last series of tests was made to investigate short and long term strength. Specimens were made by bonding two of the polyester shells to two pieces of lumber to form a hollow box. Test loads were applied by pulling against the wood members, thus putting the joints in shear. Short term loads were performed in a testing machine at room temperature and humidity; the specimens had been conditioned at 35°C (95°F) and 90% relative humidity for three days, in most cases. The long term or creep tests were made by suspending weights from the specimens. (See fig. 53.)

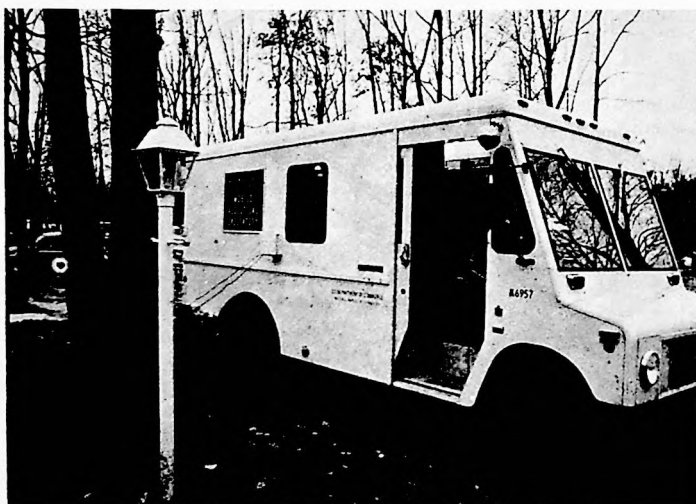
FIGURE 56  
MOBILE ACOUSTIC  
TEST LABORATORY

did not lend themselves to analysis could have a significant effect on actual acoustic performance. For this reason a series of field studies was undertaken to measure inter-dwelling and intra-dwelling noise isolation in several Operational BREAK-THROUGH housing systems and to assemble data that would be useful in making a comparison with conventional housing. An on-site mobile acoustical laboratory was used to make impact and sound transmission measurements in accordance with the procedures given in ASTM E 336, ASTM E 413, ASTM RM 14-4 [51], ASTM C 423 [52], and American Standards Institute (ANSI) S1.2. [53]. (See fig. 56.)
