HUD-0006262 Hurr. Andrew

U.S. Department of Housing and Urban Development
Office of Policy Development and Research

Assessment of Damage to Single-Family Homes Caused by Hurricanes Andrew and Iniki

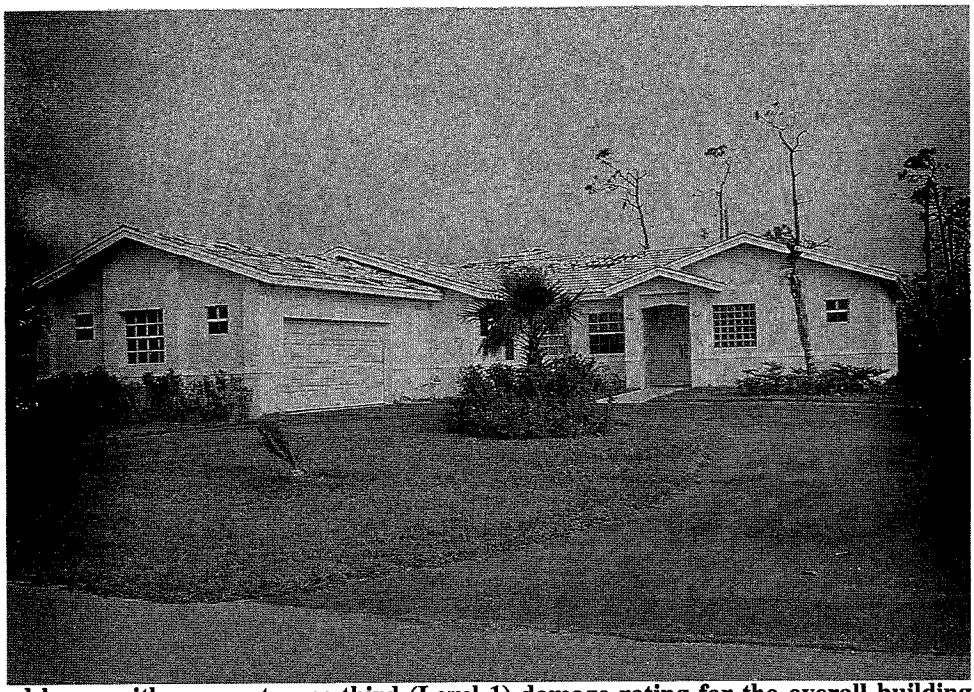
DAMAGE RATING SUMMARY	
OVERALL	1
ROOF	1
WALLS	1
INTERIOR	X
FOUND.	1
GRID	B

Figure 10. Wind-damaged home with a none to one-third (Level 1) damage rating for the overall building condition. This house had an open inland exposure to the wind. Only one window was broken and the garage door was dented. ("X" means not specified or not accessible to the grader.)

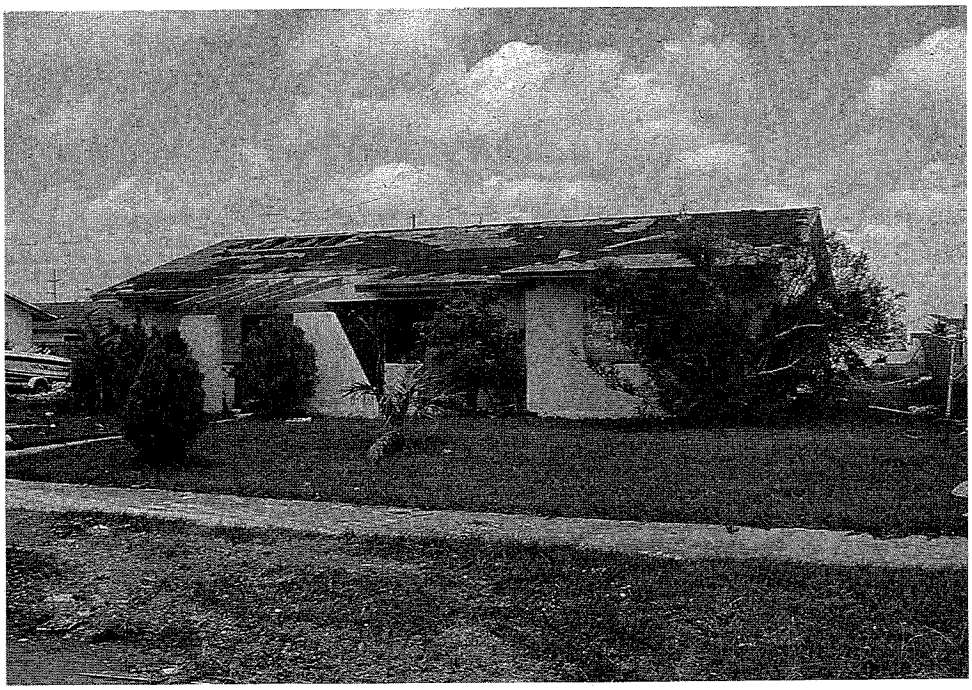
DAMAGE RATING SUMMARY	
OVERALL	2
ROOF	2
WALLS	1
INTERIOR	3
FOUND.	1
GRID	H

Figure 11. Wind-damaged home with a one-third to two-thirds (Level 2) damage rating for the overall building condition. This level of damage is considered representative of the overall damage to the housing stock in the survey.

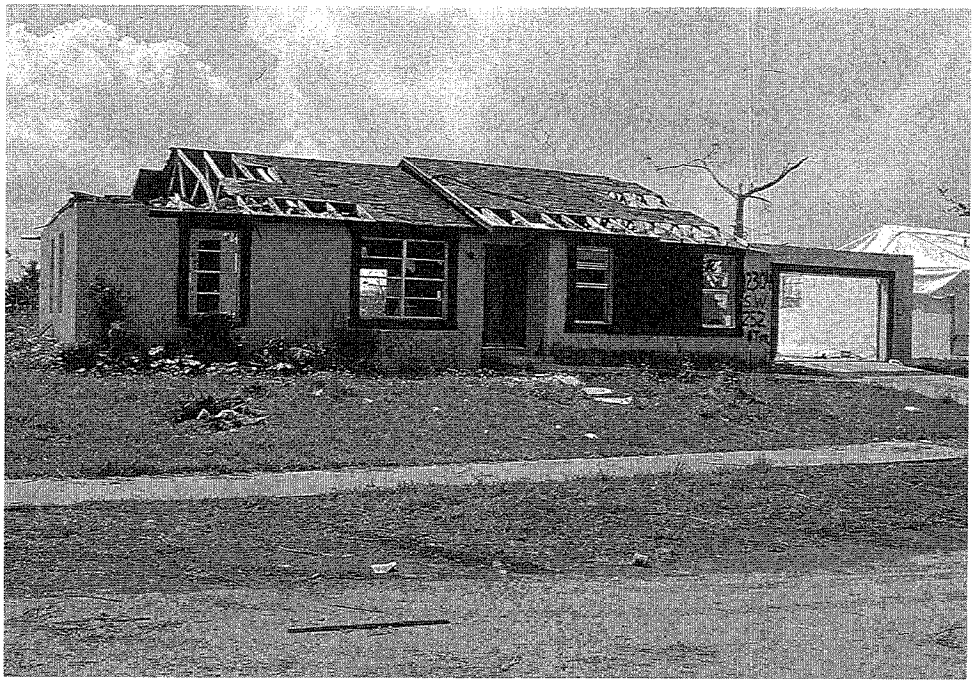
DAMAGE RATING SUMMARY	
OVERALL	3
ROOF	3
WALLS	1
INTERIOR	3
FOUND.	1
GRID	E

Figure 12. Wind-damaged home with over two-thirds (Level 3) rating for the overall building condition. Both gable ends are destroyed, the roof over the garage is gone, many pieces of sheathing are missing, and all doors and windows were severely damaged.

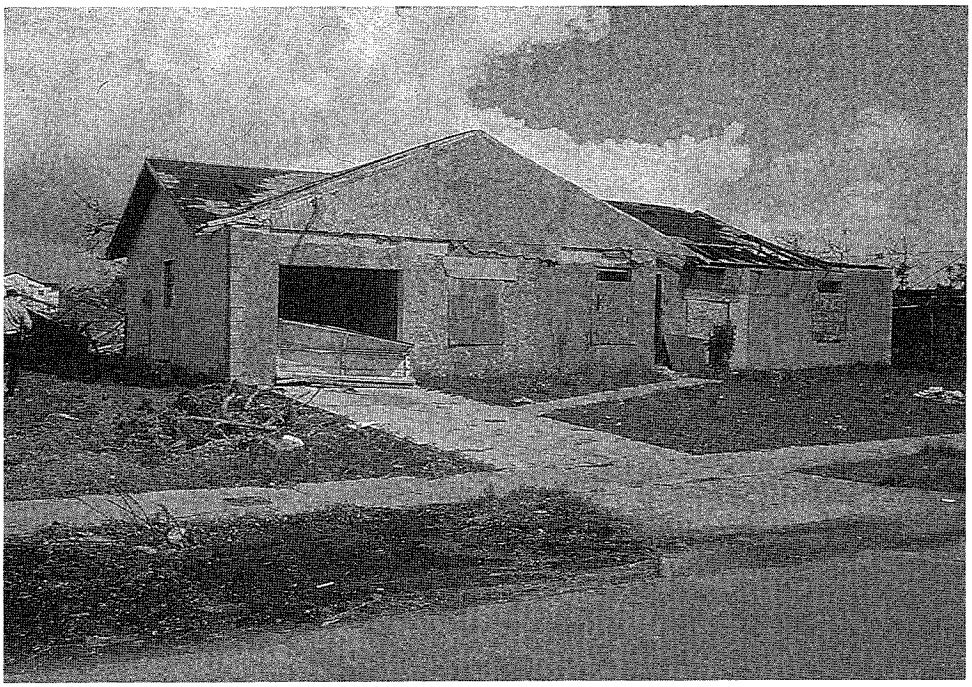
DAMAGE RATING SUMMARY	
OVERALL	3
ROOF	3
WALLS	1
INTERIOR	3
FOUND.	1
GRID	E

Figure 14. Example of a one-story, wind-damaged house. This home had three gable-end walls of which two failed.

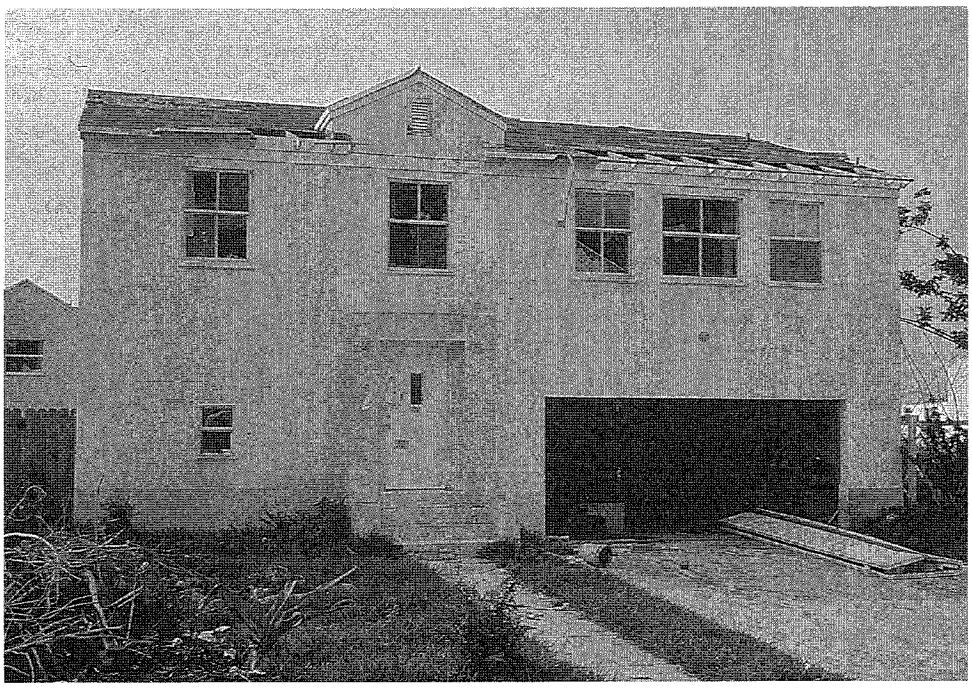
DAMAGE RATING SUMMARY	
OVERALL	3
ROOF	3
WALLS	1
INTERIOR	3
FOUND.	1
GRID	F

Figure 15. Example of a two-story, wind-damaged house (concrete block). It was noted that all windows were broken and that sheathing was lost from the roof perimeter. The gable ends did not collapse, but the water damage was substantial due to stripped shingles, broken windows, and lost sheathing.

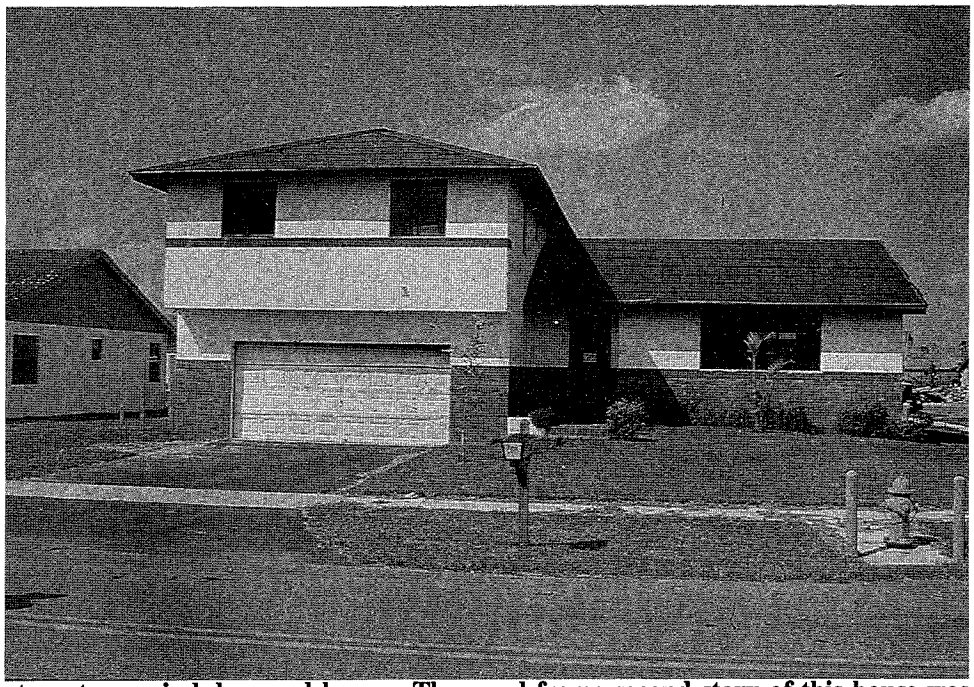
DAMAGE RATING SUMMARY	
OVERALL	2
ROOF	2
WALLS	1
INTERIOR	3
FOUND.	1
GRID	G

Figure 16. Example of a two-story, wind-damaged house. The wood-frame second story of this house was stressed, but it survived. The crucial damage was from water entering through broken windows, damaged roof coverings and some lost sheathing panels.

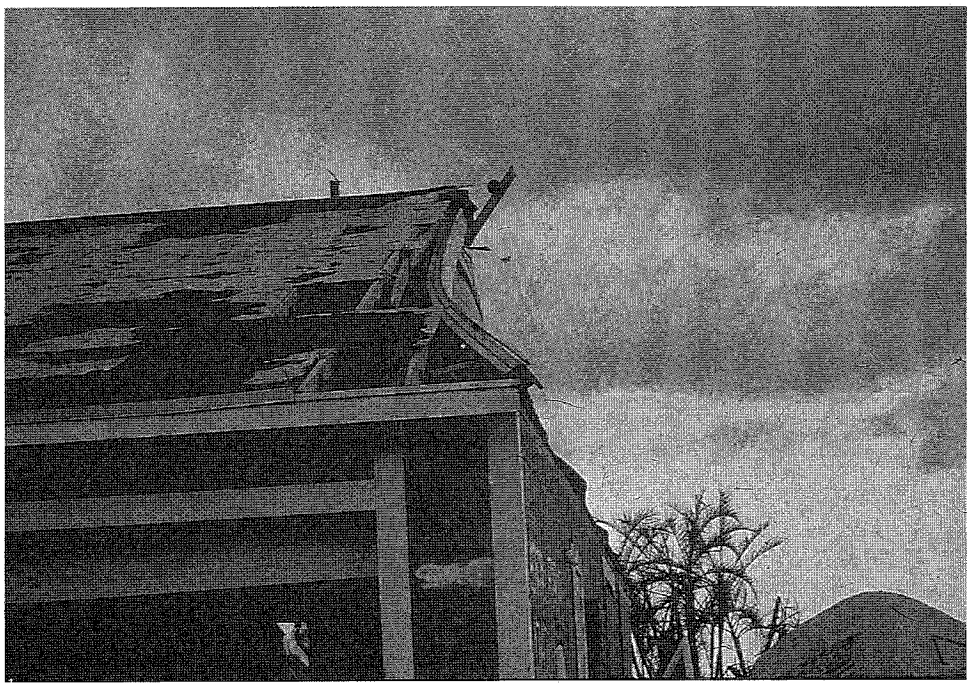
Figure 19. Wind damaged gable end wall. This home was not part of the random sample.

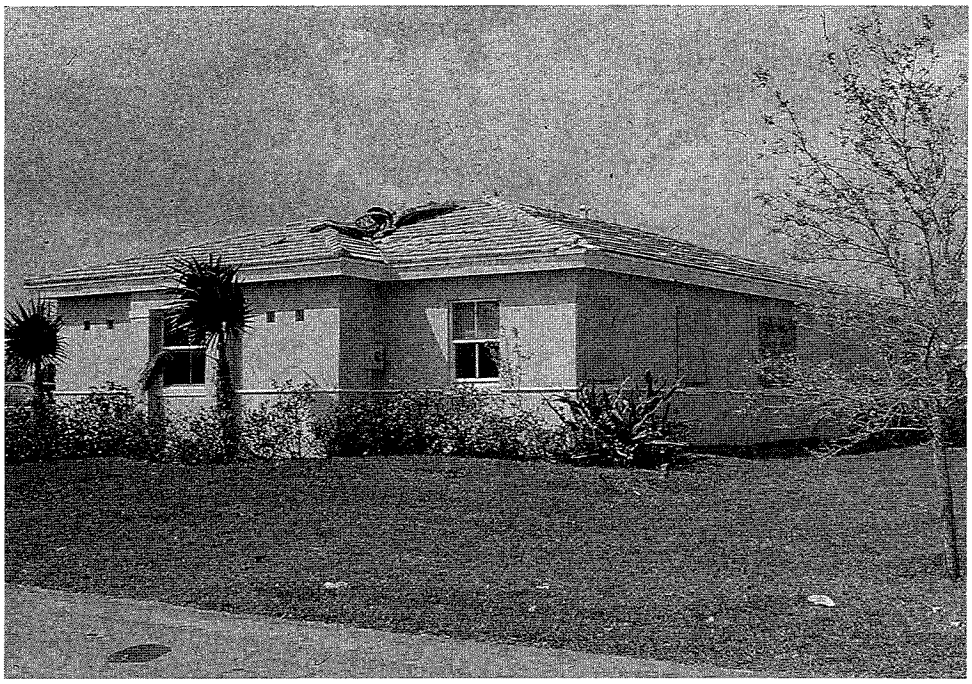
DAMAGE RATING SUMMARY	
OVERALL	1
ROOF	1
WALLS	1
INTERIOR	1
FOUND.	1
GRID	A

Figure 20. A low-profile hip roof with minimal wind damage. Loss of unprotected windows was the primary reason for the limited water damages noted on the survey sheet.

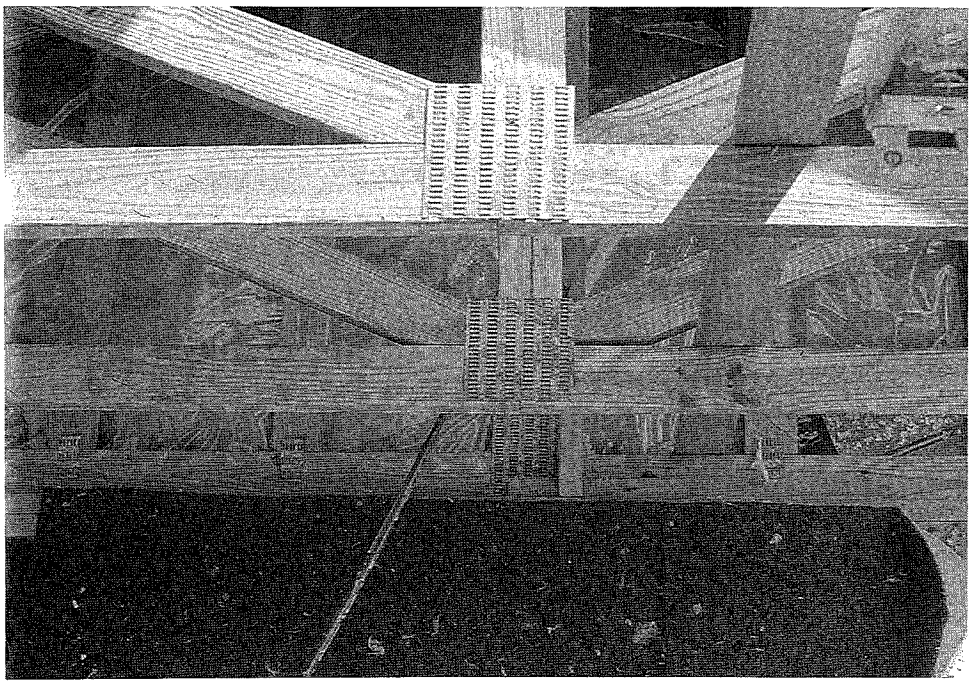
Figure 23. Misplaced (or undersized) steel connection plates on wood trusses.

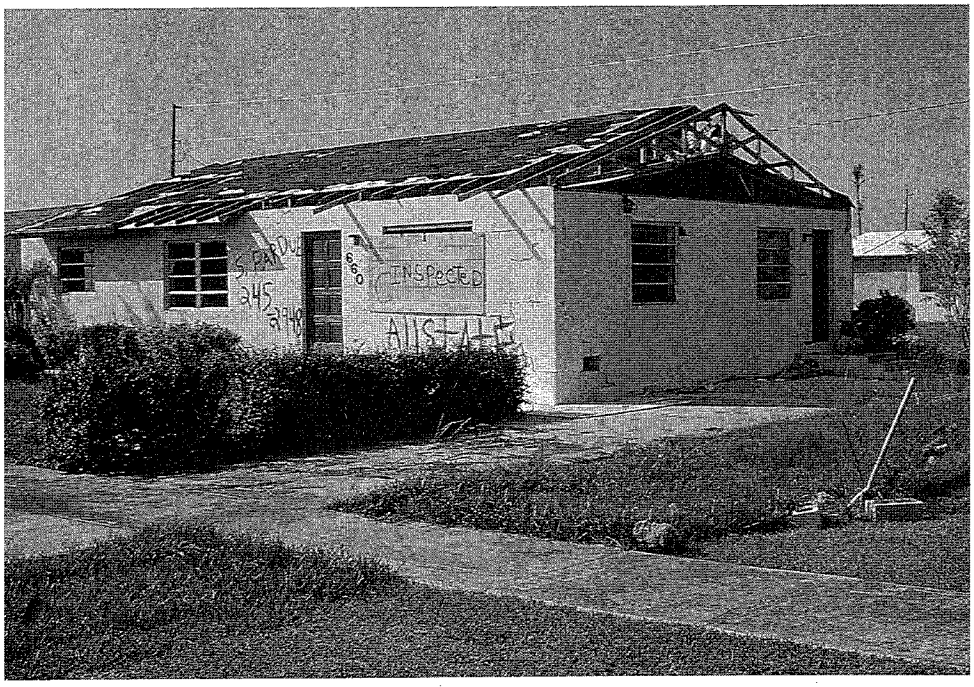
DAMAGE RATING SUMMARY	
OVERALL	3
ROOF	3
WALLS	3
INTERIOR	3
FOUND.	1
GRID	1

Figure 26. Loss of roof sheathing in high-pressure areas of the roof, especially at gable ends where rake overhangs were commonly framed for appearance and not for strength. Note also the fracturing of the block wall.

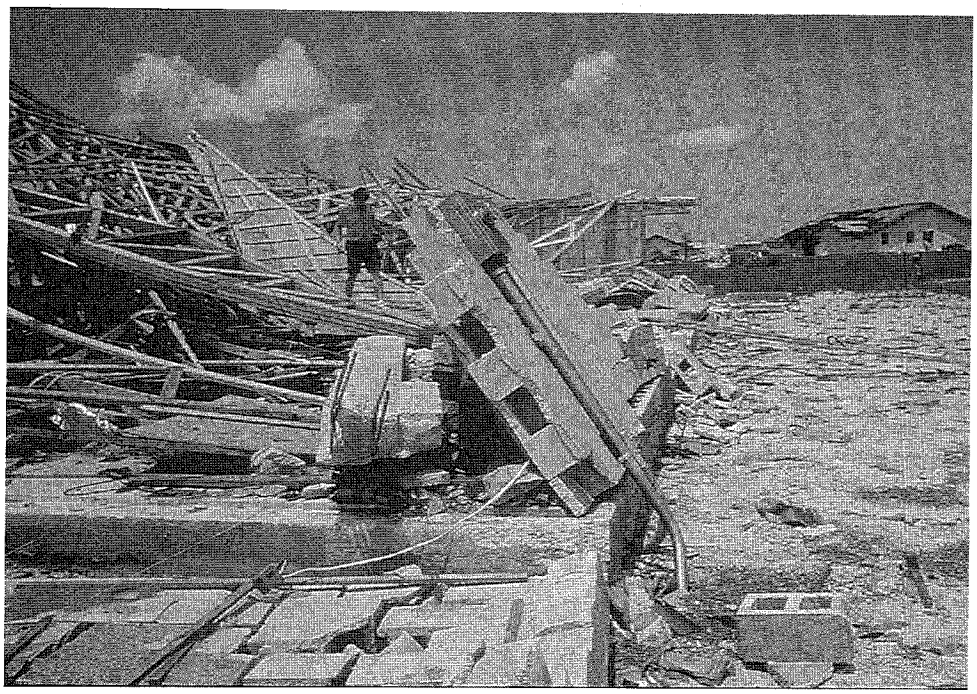
Figure 27. Wind damage to a CBS wall under construction. Note the rebar withdrawal at the corner of the concrete tie beam and the absence of rebar for the wall in the foreground.

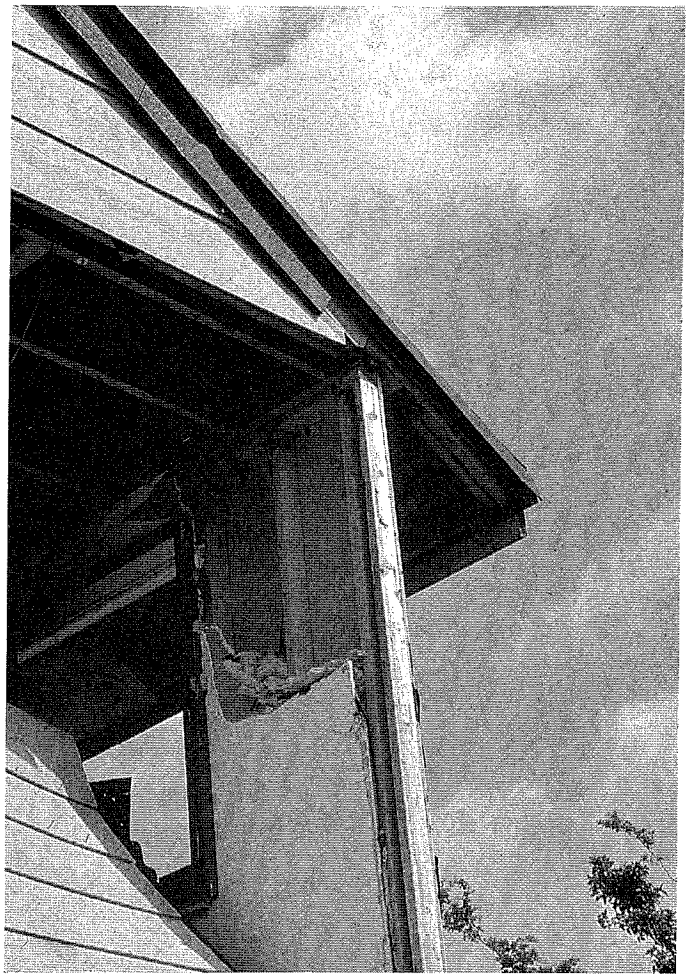
Figure 28. Wind damage to a wood-frame wall (two-story) showing improperly connected corner.

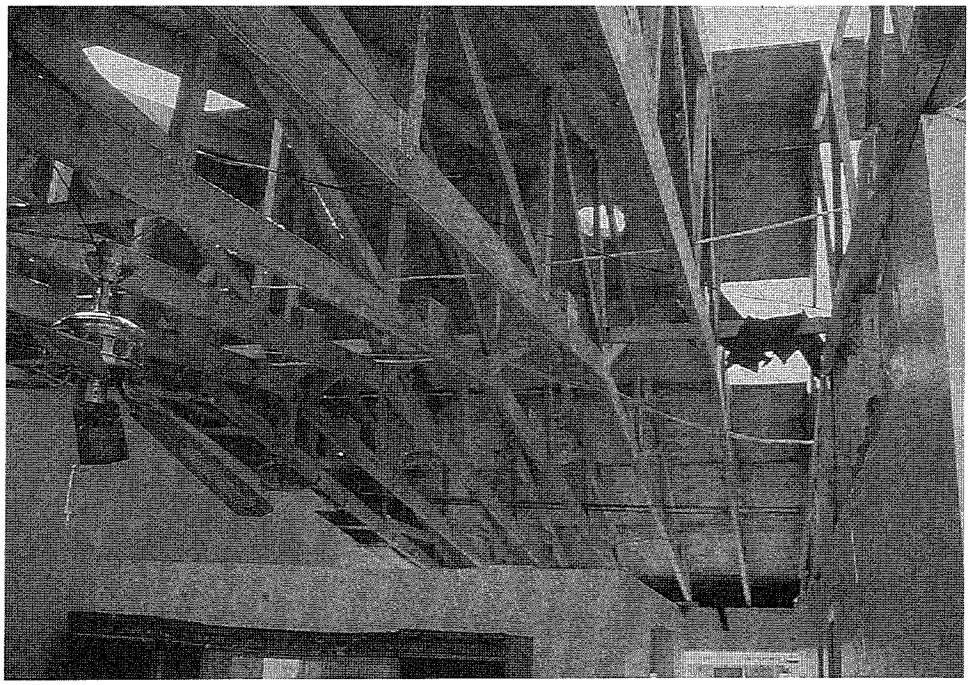
Figure 31. Illustration of a collapsed drywall ceiling from water damage.

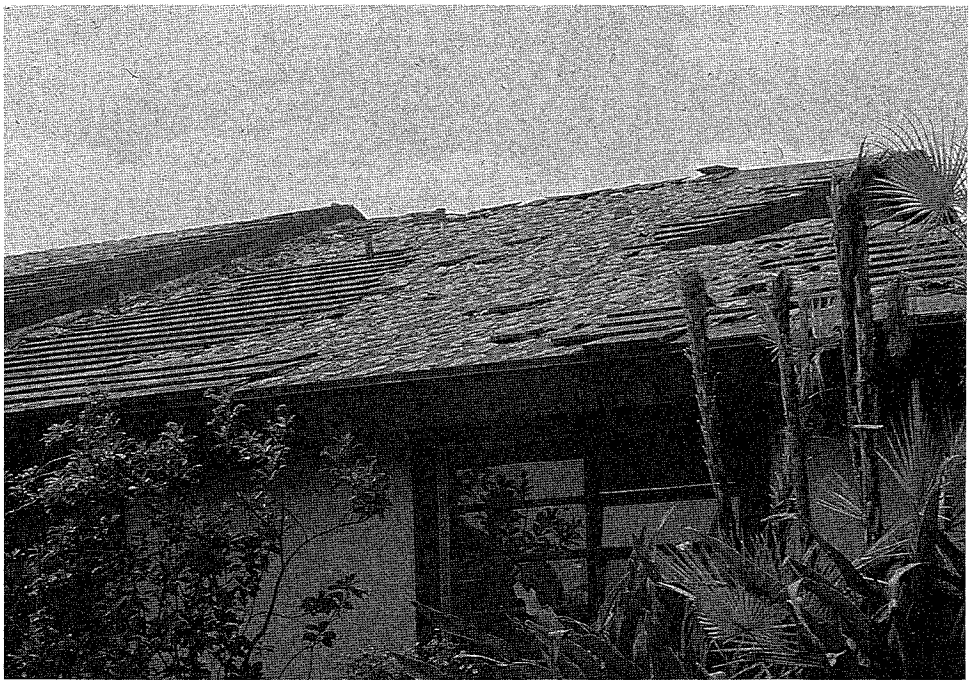
DAMAGE RATING SUMMARY	
OVERALL	1
ROOF	1
WALLS	1
INTERIOR	1
FOUND.	1
GRID	B

Figure 33. Wind damage to a flat tile roof. In part, the use of insufficient beds of cement mortar contributed to this unusual level of damage for flat tile roofing. Roofing underlayment prevented serious water damage. The "Roof" damage rating includes all elements of structural integrity along with water resistance.

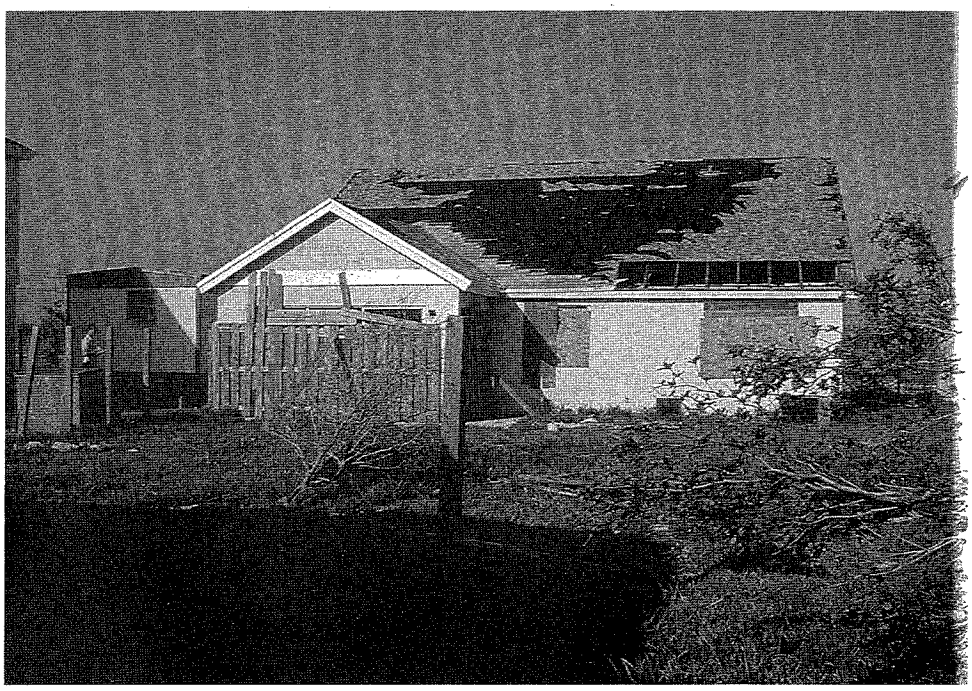
DAMAGE RATING SUMMARY	
OVERALL	3
ROOF	2
WALLS	1
INTERIOR	3
FOUND.	1
GRID	C

Figure 35. Wind damage to a composition shingle roof. Composition shingles were almost completely removed on many homes by Andrew's winds. The extensive water damage overrides the relatively sound structural condition of this house.

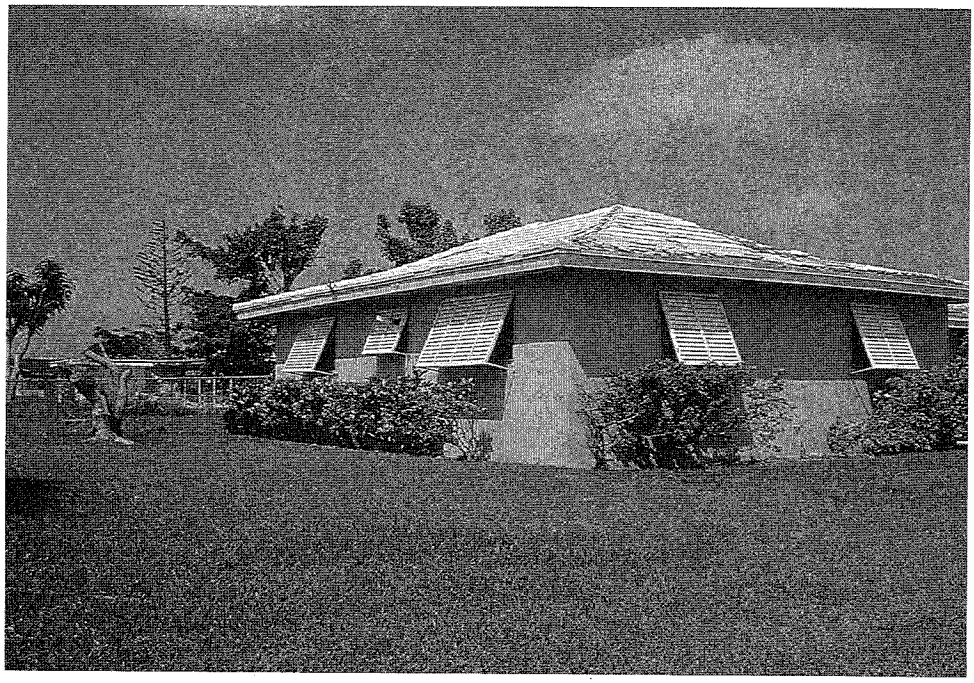
DAMAGE RATING SUMMARY	
OVERALL	1
ROOF	2
WALLS	1
INTERIOR	1
FOUND.	1
GRID	B

Figure 39. Simple hurricane shutters provided adequate window protection for this home. Water damage was minimal.

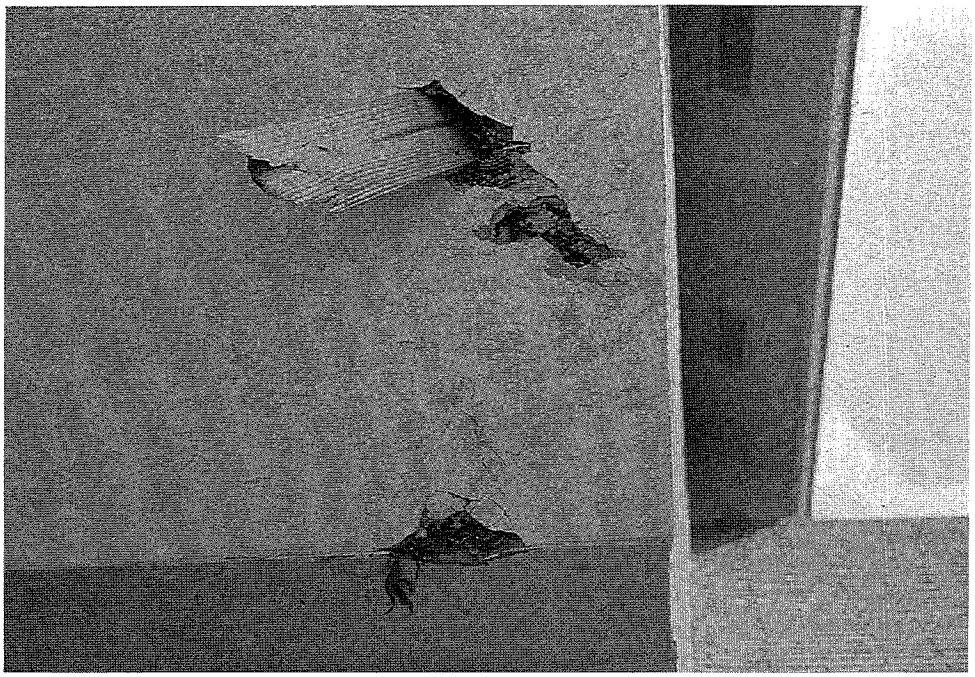
Figure 43. An example of projectile damage—a 1x fence board pierces the stucco finish and sheathing on a wood-framed wall.

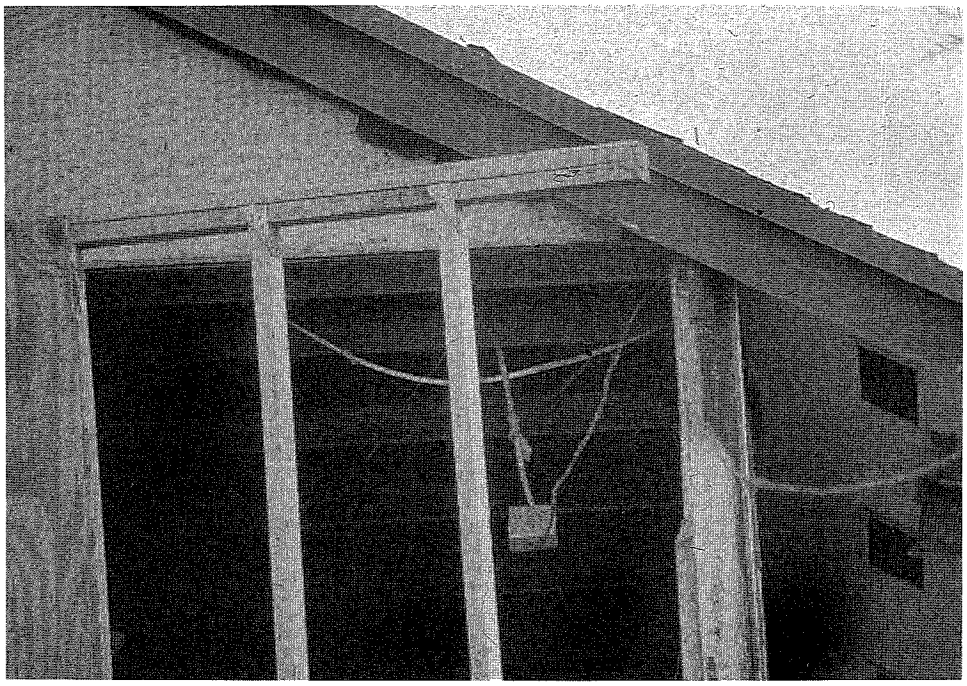
Figure 46. Improper connection of a corner in a blown-out wall section.

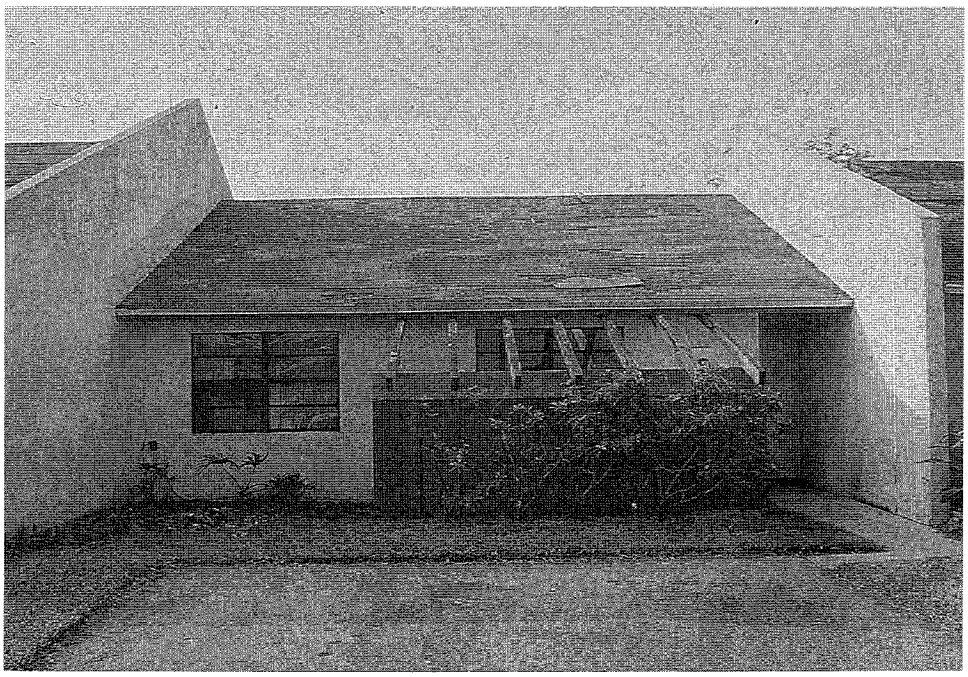
Figure 49. Typical damage to the middle unit of one-story town houses.

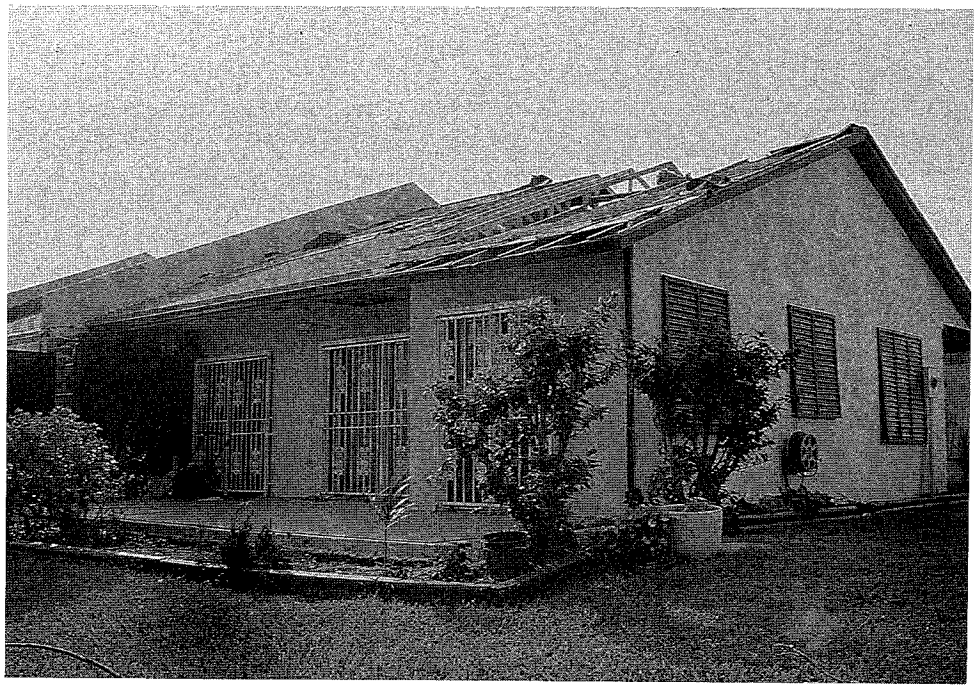
Figure 50. Damage to the end unit of a group of one-story town houses.

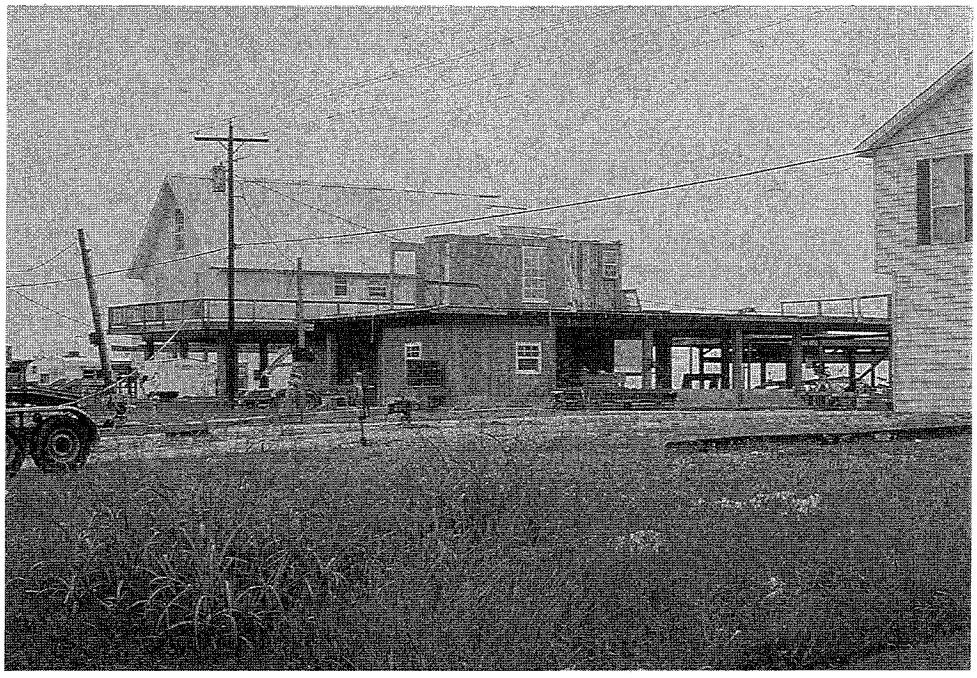
Figure 52. Destroyed coastal home on a concrete pier and heavy timber foundation.

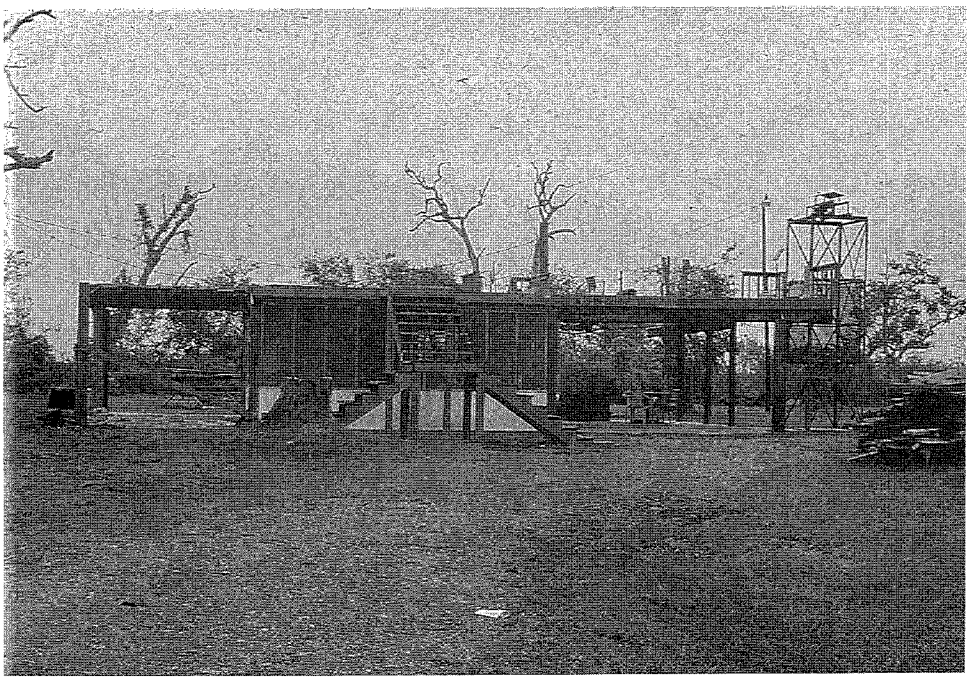
Figure 56. The manufactured (mobile) home, once positioned on this elevated foundation with an open exposure on the coast, was found some distance downwind.

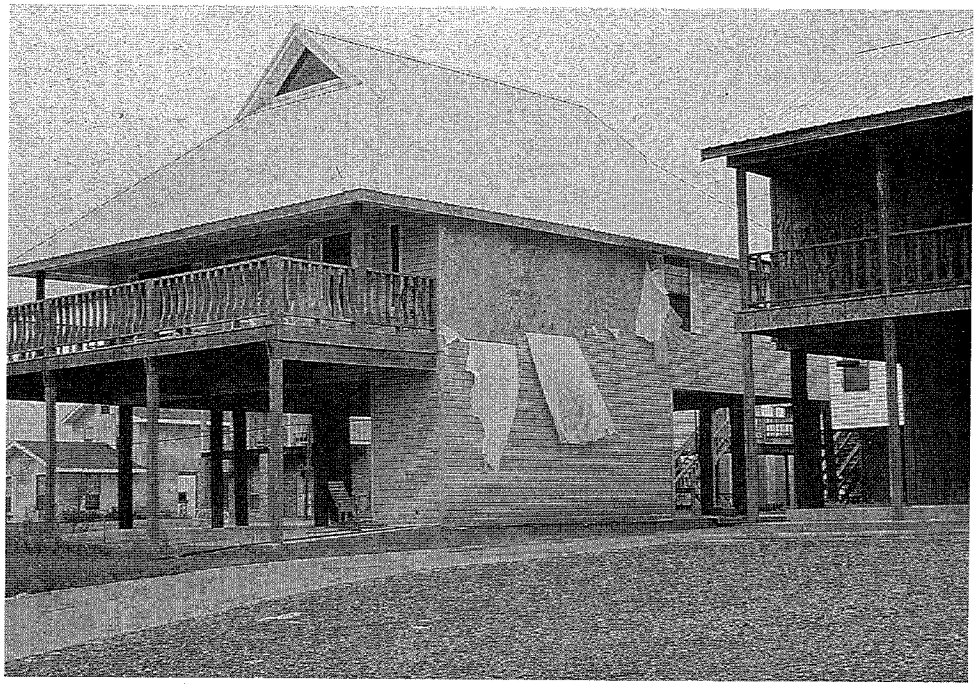
Figure 57. Vinyl siding and trim was cited as a special problem by one builder.

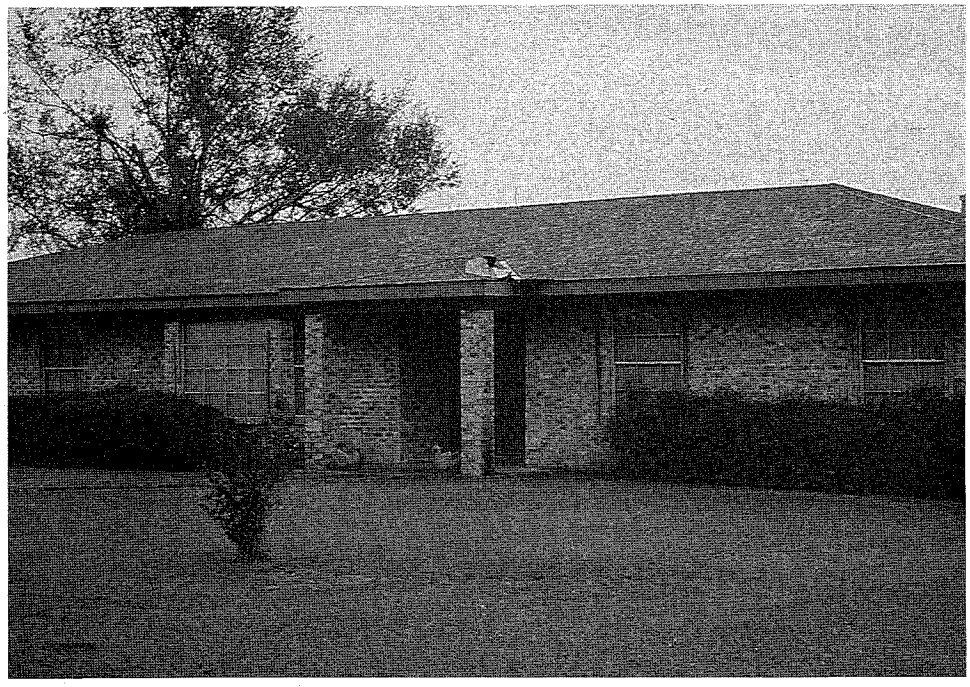
Figure 59. Inland home with minimal damage to roof shingles.

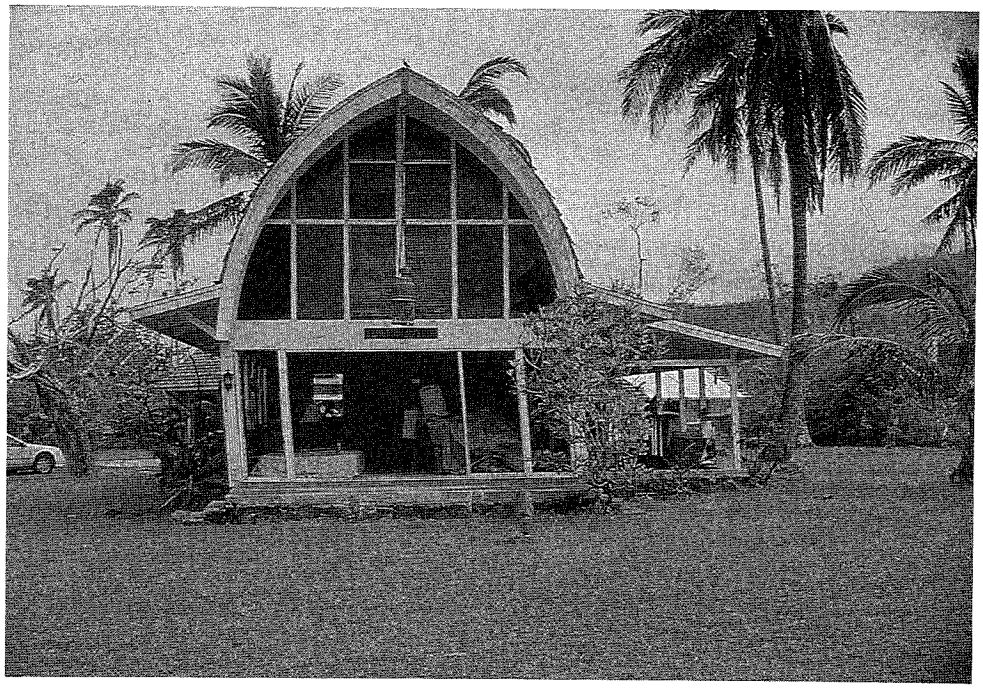
Figure 63. Wind-damaged home with a Level 2 damage rating for overall building condition. This custom home was built in 1965 using site-built, nail-laminated arches (not be confused with modern glue-laminated arches). The roof (and wall) was made of wood decking fastened to the arches and wood shingle roofing. As shown, this home suffered severe racking as a result of delamination of the arches and insufficient lateral bracing. The racking appears to have broken some of the glazing. The slab-on-grade foundation was unharmed. ("X "means the wall rating was combined with roof for this home.)

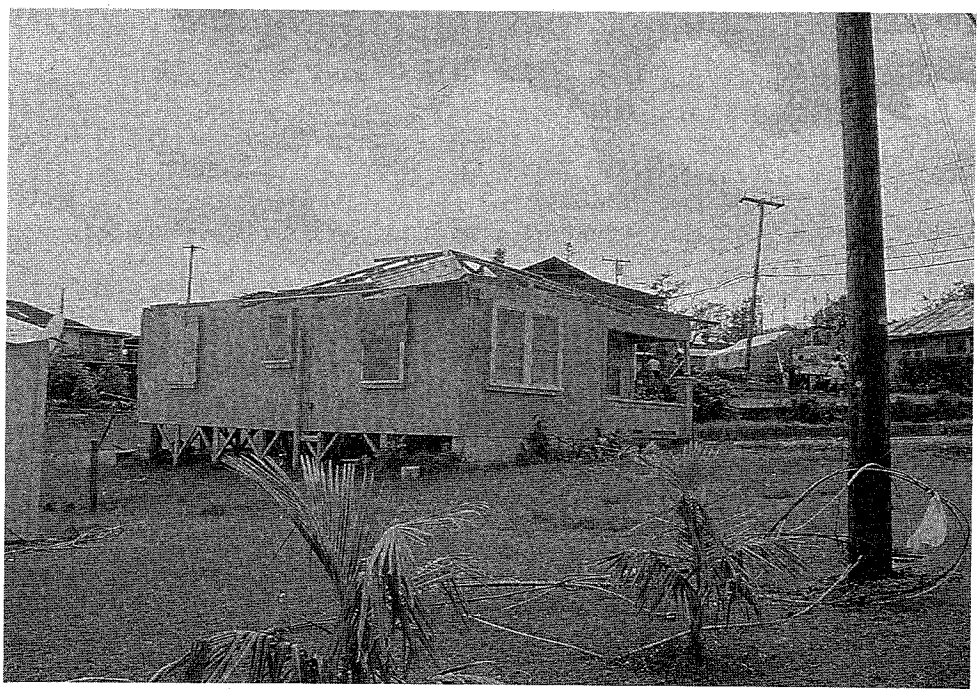
Figure 64. Wind-damaged home with a Level 3 damage rating for overall building condition. This single-wall home suffered severe damage to the roof—both structurally (roof framing) and in envelope soundness (loss of metal sheathing/roofing). Though interior water damage was severe, the exterior walls and foundation remained intact.

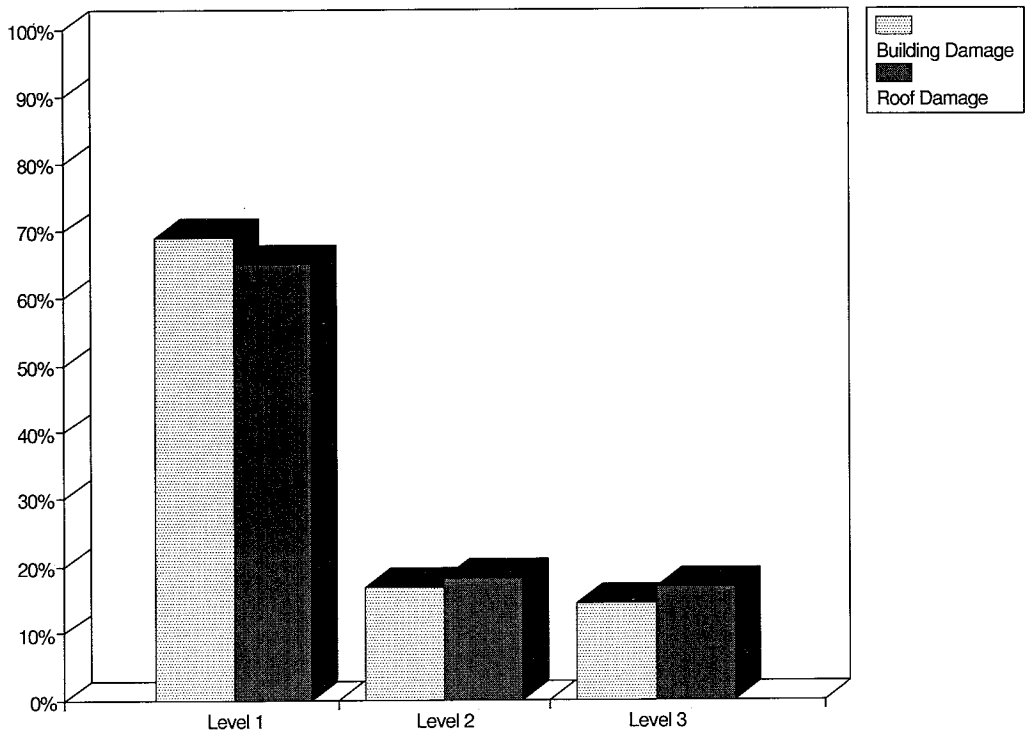
The overall roof damage recorded for all one-story homes in the survey is shown in Figure 68. Some of the observed problems in roof framing are illustrated in Figures 69 to 74. Similar to that found in the Florida survey, roof damages were responsible for 70 percent or more of the overall structural damages observed in Kauai (see Appendix D, Table D-8).

Figure 68. Distribution of overall roof damage to all homes surveyed.

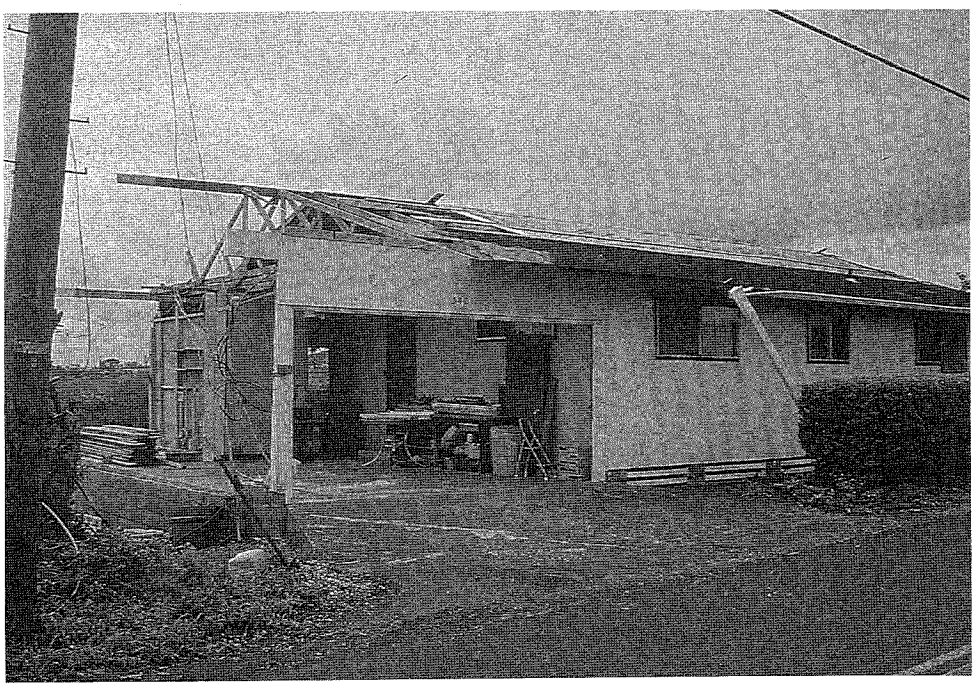
Figure 69. Site-built trusses on a single-wall home with lapped and nailed joints in lieu of metal or plywood gusset plates.

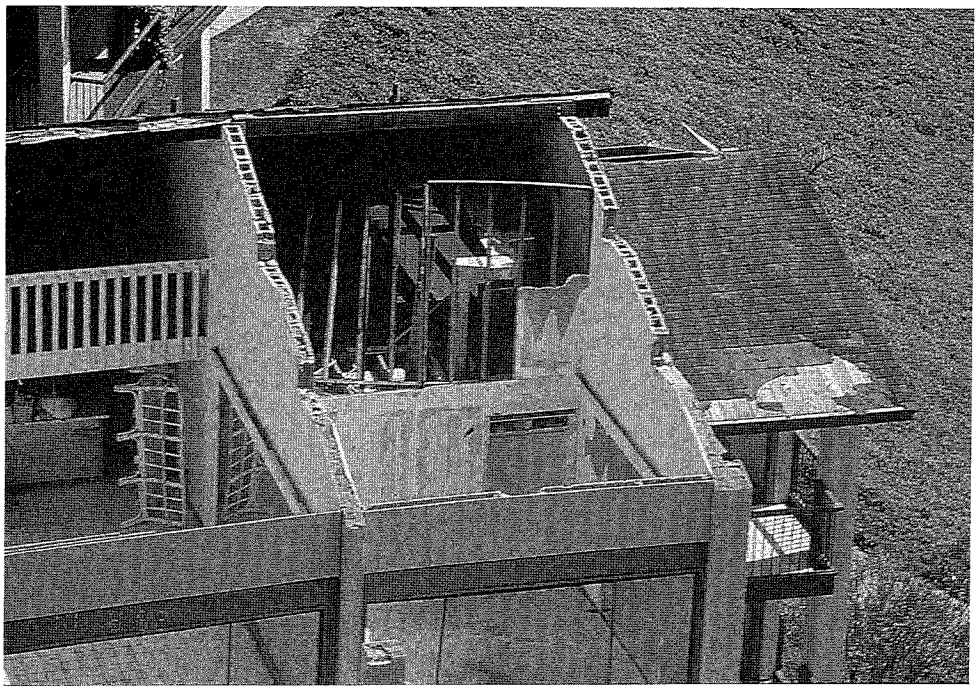
Figure 70. Heavy timber and plank roof blown away due to inadequate tie downs.

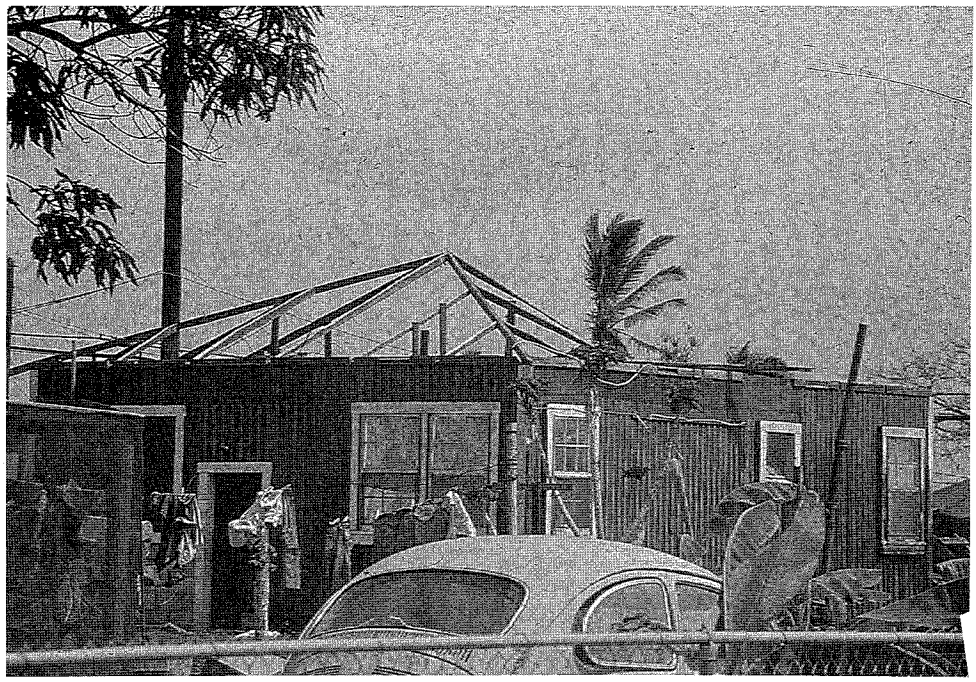
Figure 72. Light-frame wood roofs with corrugated metal roofing on single-wall homes did not fare well.

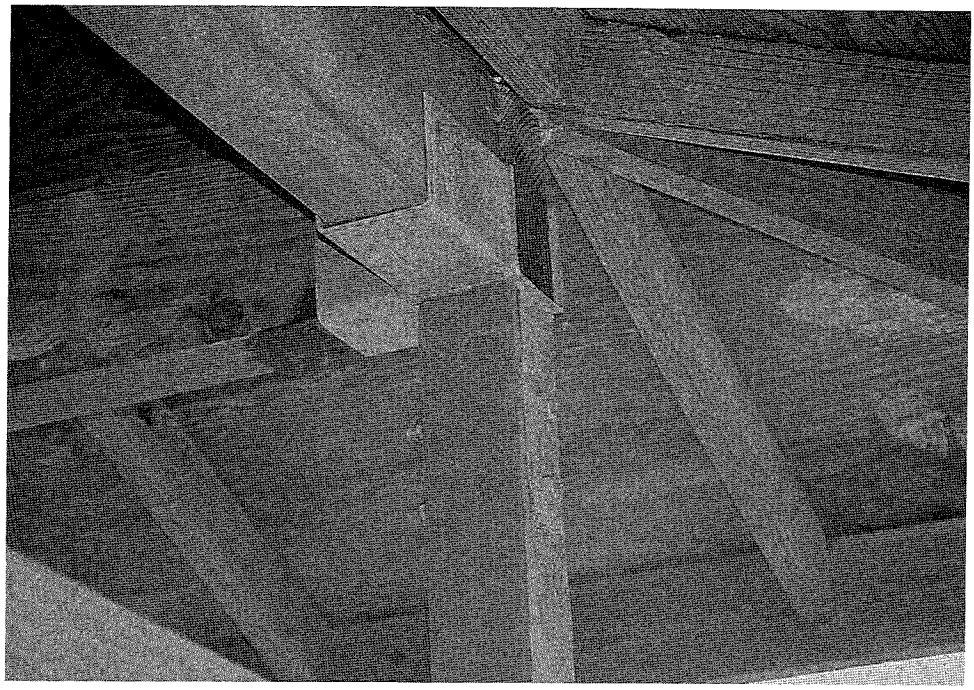
Figure 74. This roof beam connection to a column provided resistance against uplift and also created a stiff joint for lateral forces.
