HUD-0006262 Hurr. Andrew

U.S. Department of Housing and Urban Development
Office of Policy Development and Research

Assessment of Damage to Single-Family Homes Caused by Hurricanes Andrew and Iniki

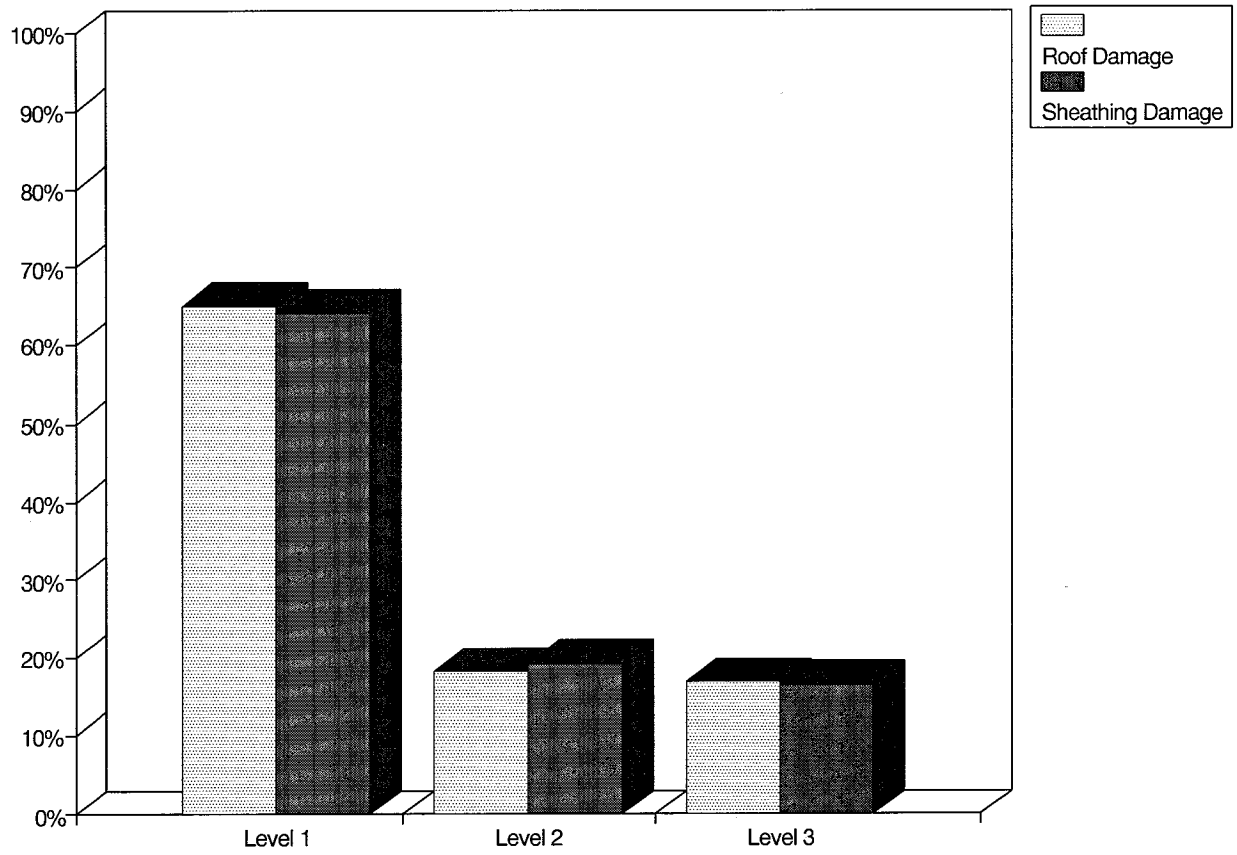
The distribution of roof sheathing damage relative to overall roof damage is shown in Figure 76. About 38 percent of the surveyed homes were rated in the higher levels (Levels 2 and 3) of roof sheathing damage, which implies at least one lost or severely damaged sheathing panel. Roof sheathing loss was notable in Kauai because of inadequate connections or materials, particularly in higher wind pressure locations on the roofs such as overhangs. Common problems with roof sheathing are shown in Figures 77 and 78. As in Florida, much of the roof structural damages can be related to the detachment of roof sheathing. But, other factors such as inadequate continuous vertical load paths were notable mainly in the older homes on Kauai.

Figure 76. Distribution of roof sheathing damage and overall roof damage for all homes surveyed.

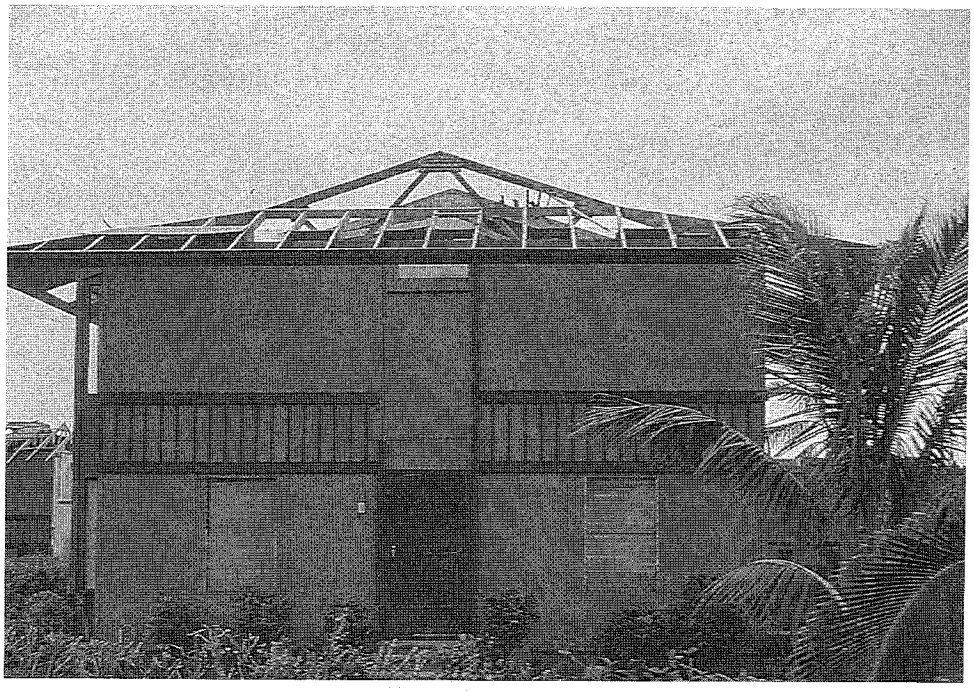
Figure 77. Severe loss of plywood roof sheathing indicating inadequate connections.

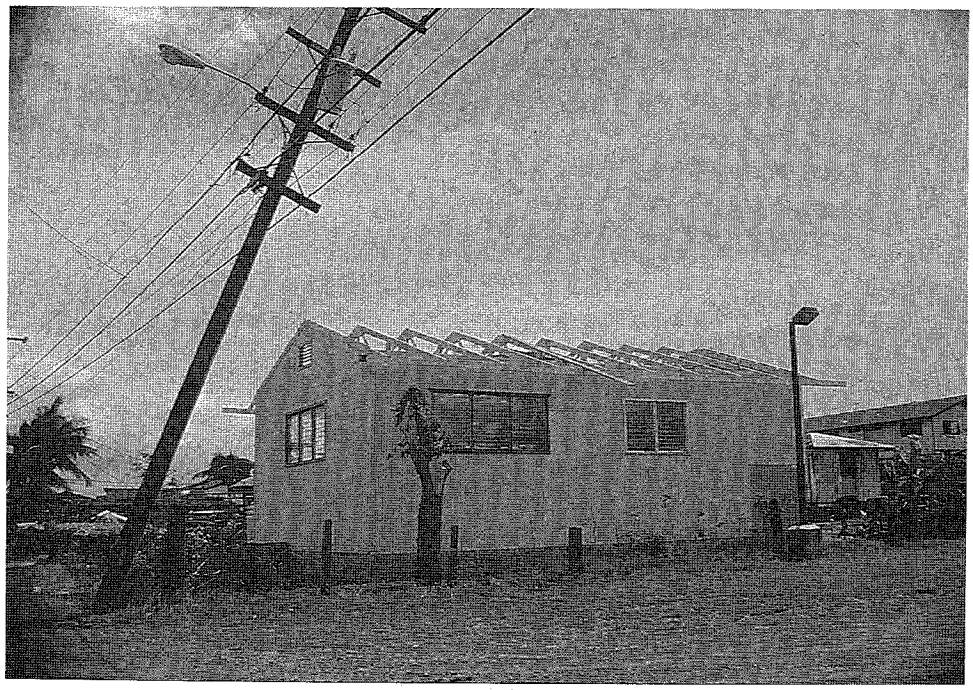
Figure 78. Roof purlins stripped from roof along with metal roofing. Purlins were commonly fastened to trusses with only one nail at each intersection.

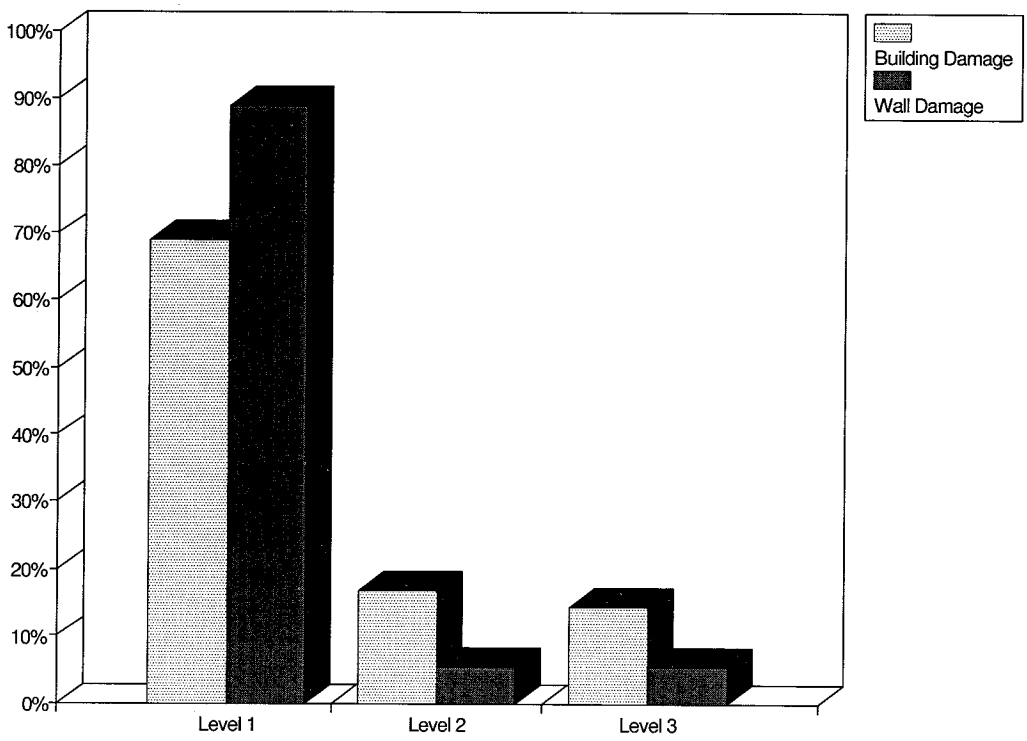
The distribution of wall damage is shown in Figure 80. About 88 percent of the surveyed homes were rated in the lowest category (Level 1) for wall damage. Some examples of the wall construction variations and damages are shown in Figures 81 through 86. Examples of deficient design and construction were found in all wall types surveyed, including wood, steel, and masonry. Some coastal homes on elevated foundations did experience problems with continuous load paths or structural connections from the wall to the foundation members (see Figure 86).

Figure 80. Wall damage distribution for all homes surveyed.

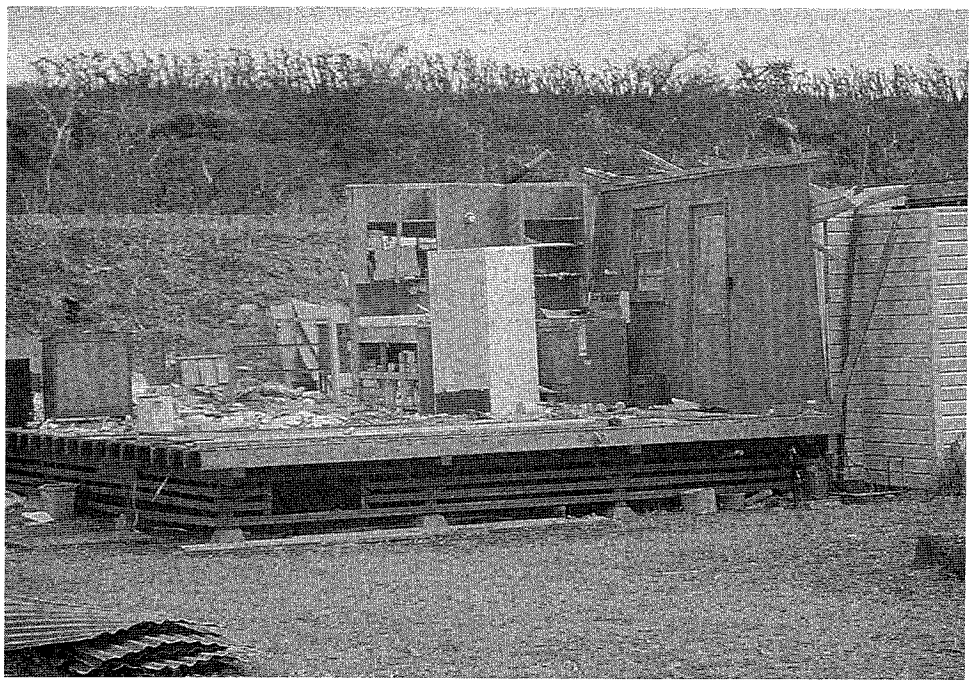
Figure 81. Damaged house showing the vulnerability of single-wall construction.

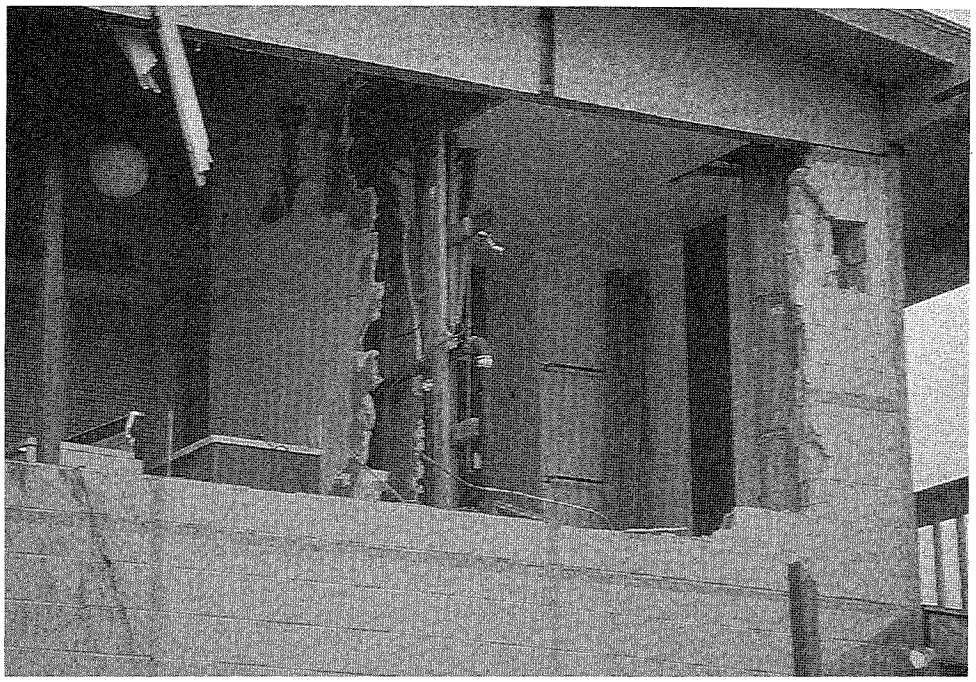
Figure 82. Blown out concrete block end wall that lacked a concrete tie beam and proper reinforcing.

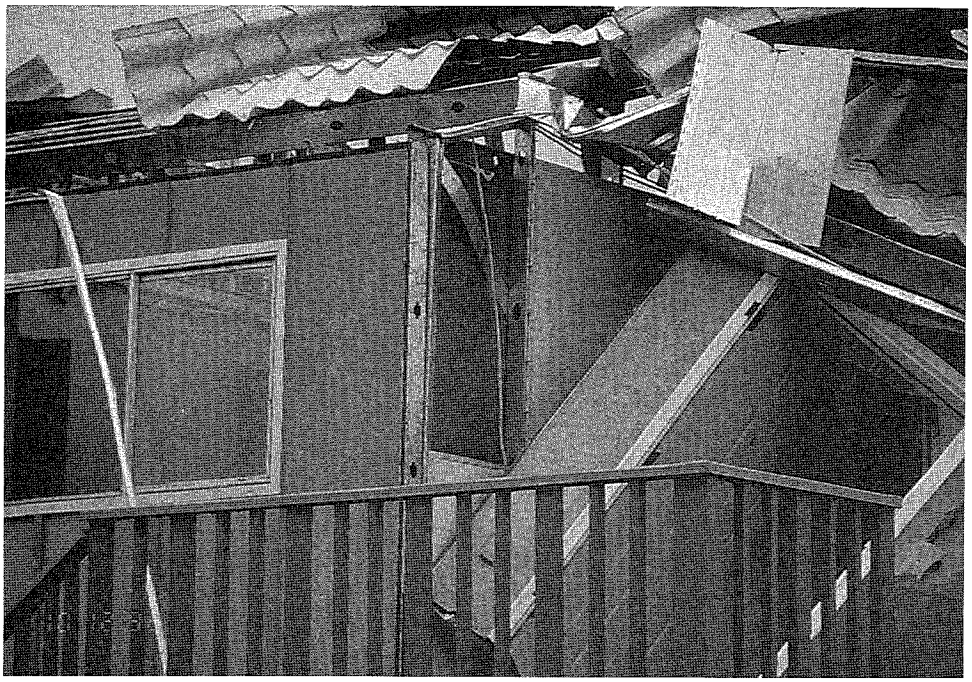
Figure 84. Light-gauge steel framing was also subject to severe damage.

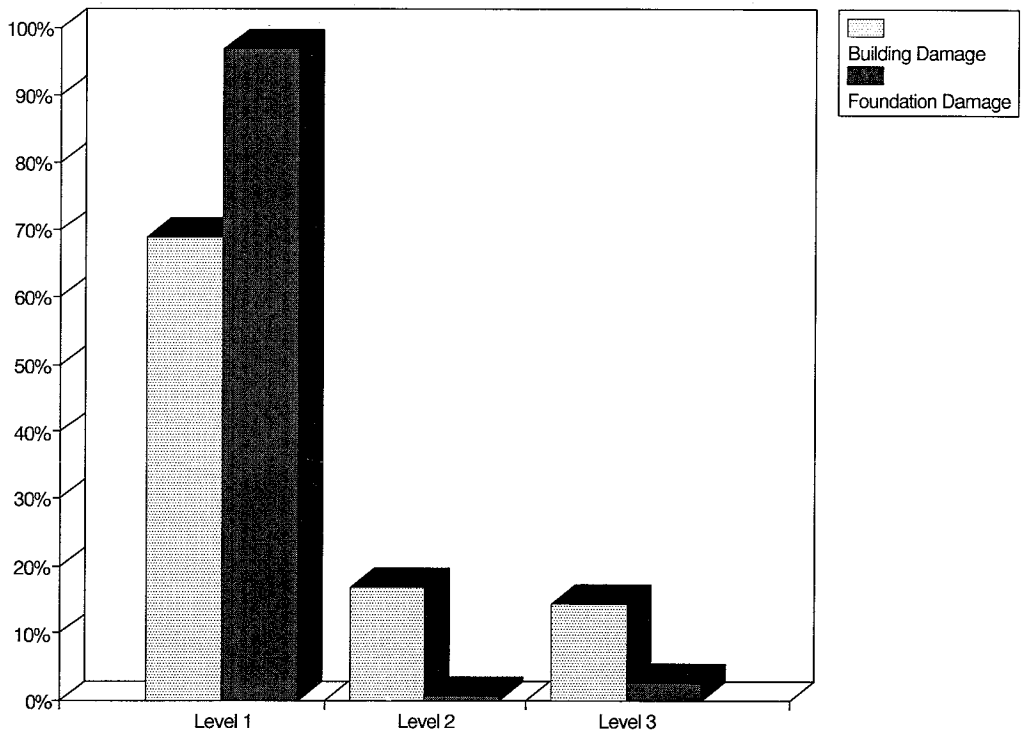
The distribution of damage to the foundations of all homes surveyed is shown in Figure 88. About 97 percent of the surveyed homes were ranked in the lowest category (Level 1) for foundation damage. Though infrequent, foundation-related failures of overturning, uplift, and sliding were observed in post and pier foundations (see Figures 89 through 93). These were generally the result of inadequately designed, installed, or maintained foundations with deficient lateral bracing or load paths to the super-structure. Foundations for coastal homes were often not elevated or otherwise designed to prevent damage from storm surge (Figure 94). Storm surge damage is discussed in detail in a later section. As in Florida, slab-on-grade foundations performed very well when not subject to storm surge.

Figure 88. Foundation damage distribution of all homes surveyed.

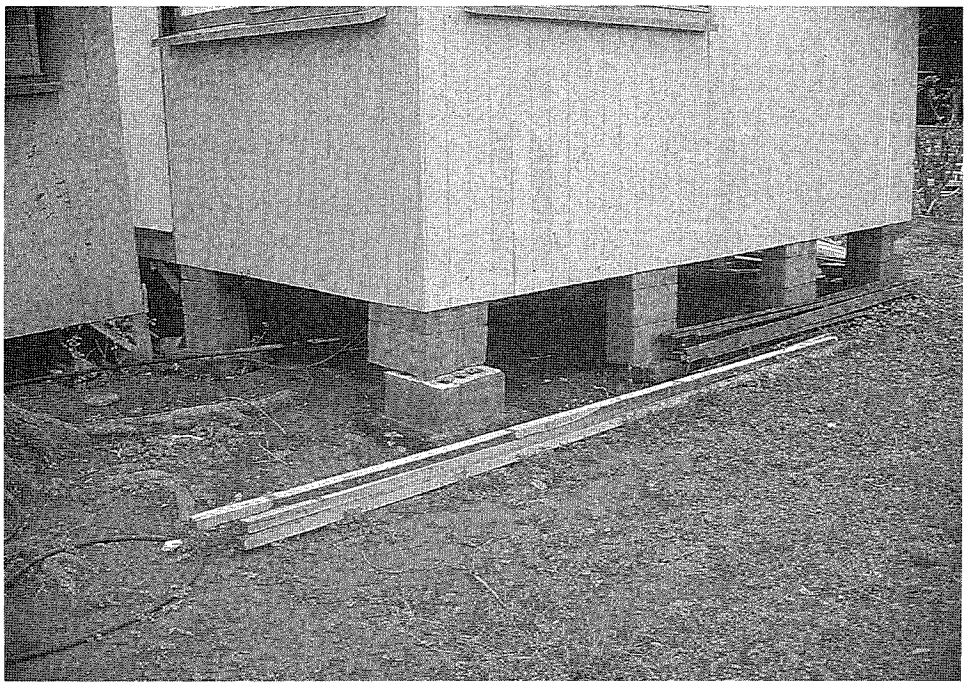
Figure 89. Shear slippage of an unreinforced CMU pier foundation.

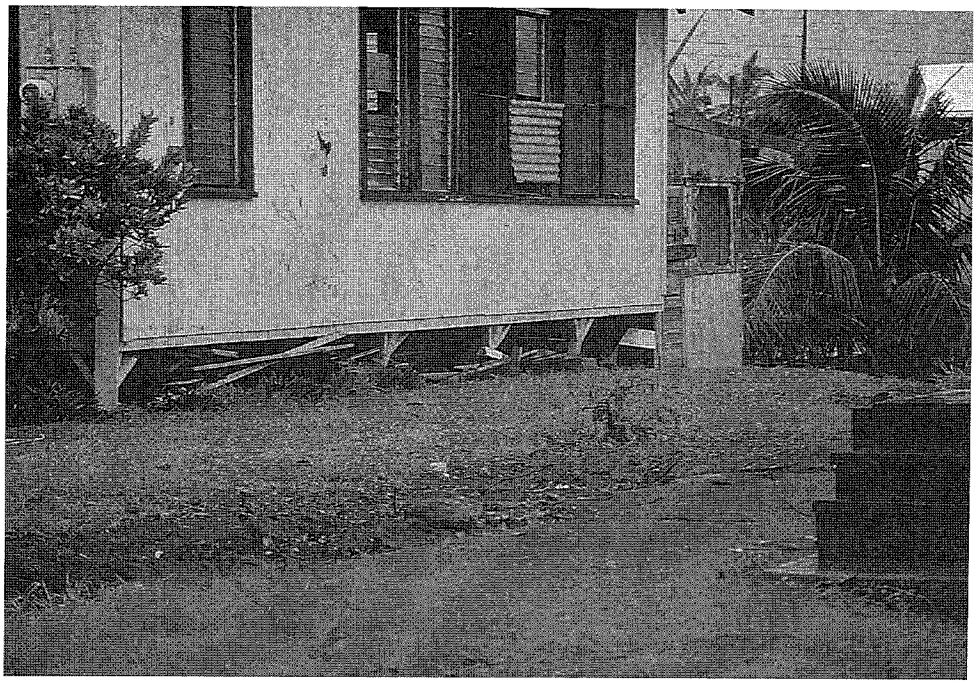
Figure 91. Wood pier foundation shifts under the shear forces created by the wind.

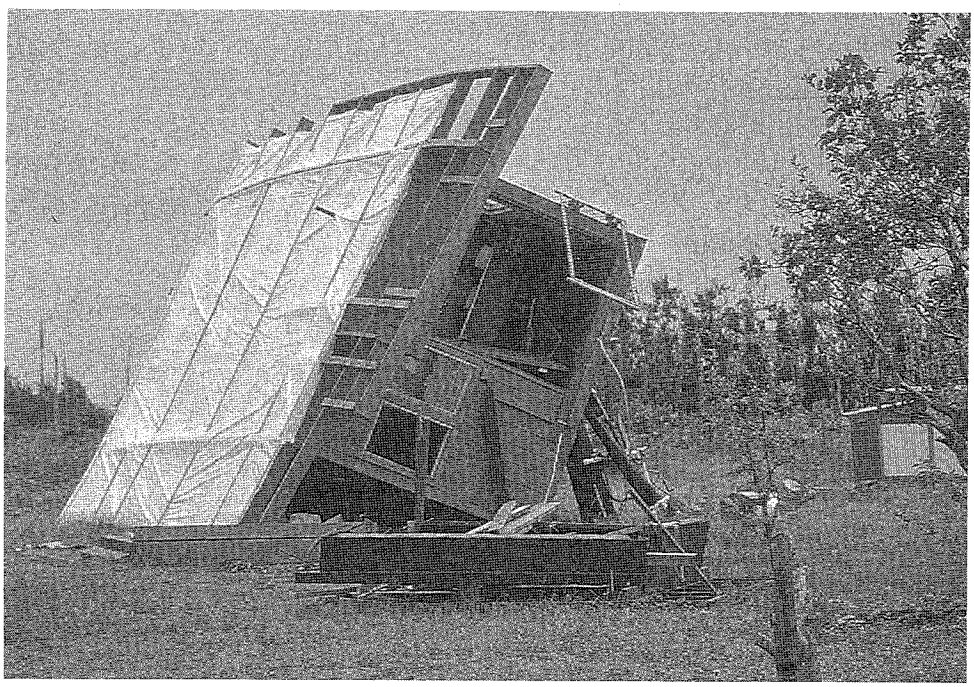
Figure 92. With its large overhangs and lacking connection to a foundation, this small home was lifted and moved several feet from its original location.

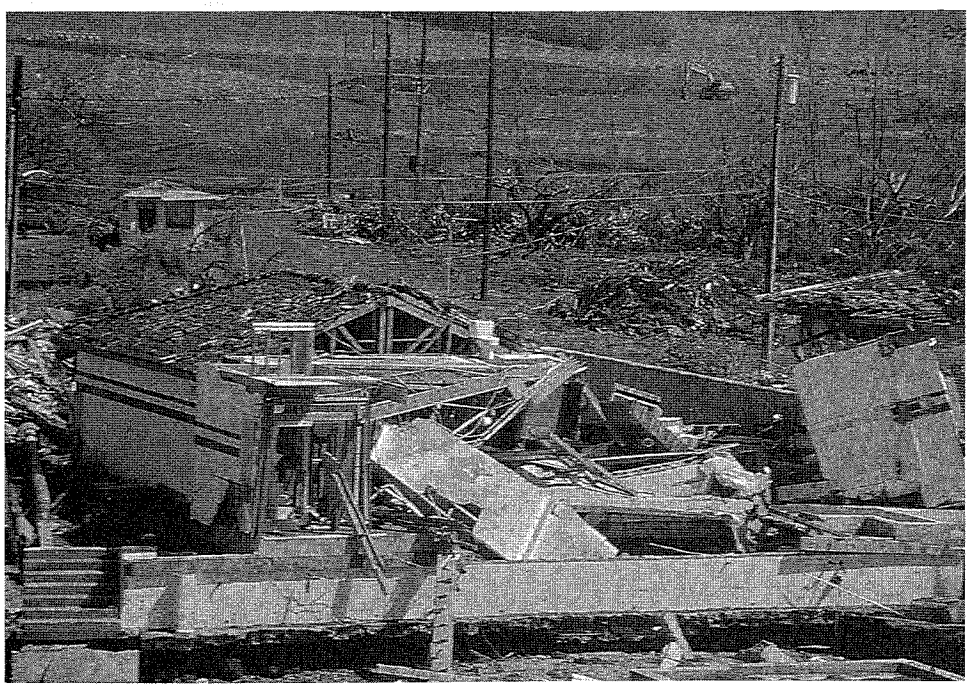
Figure 94. Slab-on-grade foundation survives the storm surge but the remainder of the home was demolished by storm surge. Away from the coastal flood plain, slab-on-grade foundations performed well.

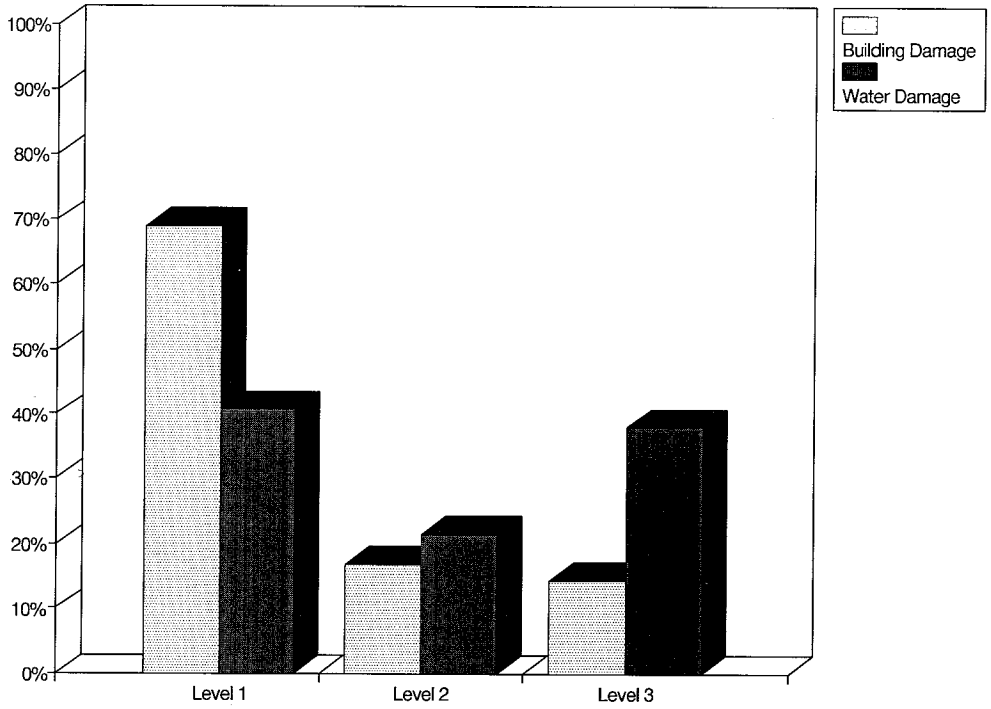
Water Damage - The level of water damage for all homes surveyed is shown in Figure 95. The water damage rating reflects the ability of the structure to maintain a water-proof envelope and protect the building contents during and after a hurricane. Water damage commonly resulted from failure of the roof covering or windows, not necessarily associated with structural damage. The "U" shape of the damage distribution may be attributed to the influence of homes with corrugated metal roofing, which tended to suffer greater roofing loss. As in the Hurricane Andrew assessment, the influence of water damage on the overall building damage was substantial. Nearly 40 percent of the accessible homes experienced a severe level (Level 3) of water damage. Many of the older single-wall homes suffered heavy water damage due to a complete loss of their roof coverings.

Figure 95. Distribution of water damage to all homes surveyed.

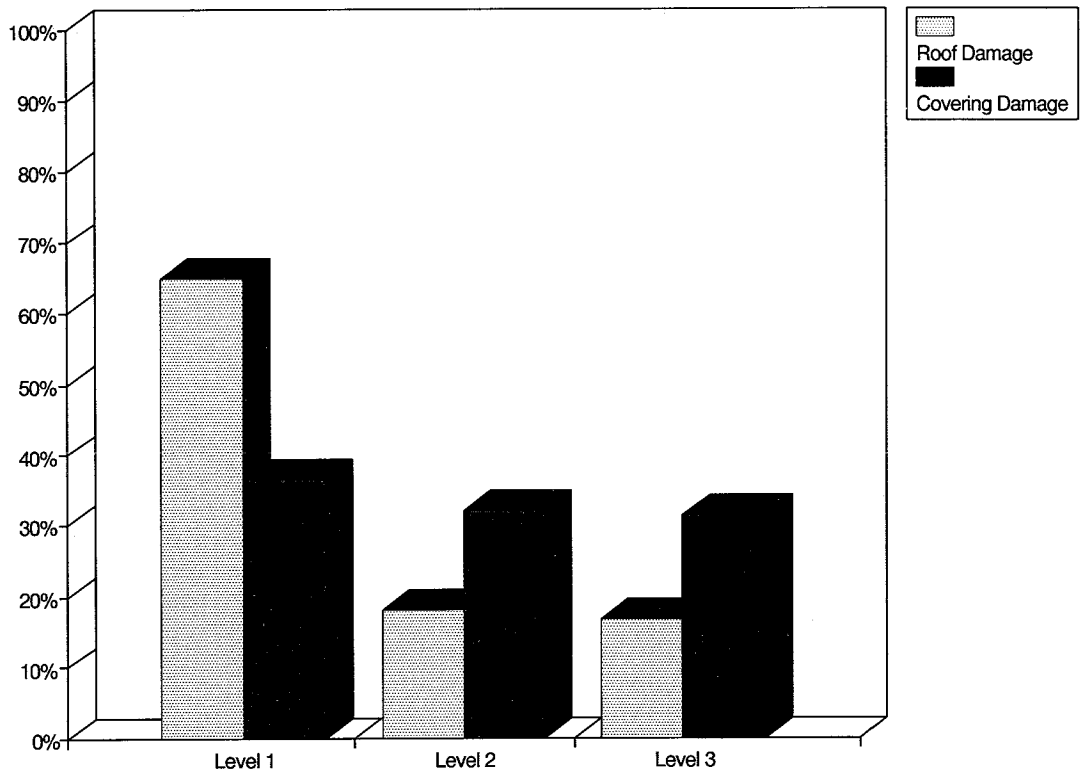
Roof Covering - The survival of roof coverings is one of the most important factors (along with windows) in mitigating widespread water damage to homes during and after a hurricane. Kauai differed from Florida in that a higher proportion of the homes had metal roofing, particularly single-wall homes, and a lower proportion had composition shingles (Figure 96). Figure 97 shows the distribution of roof covering damage relative to overall roof damage. About 64 percent of the homes surveyed experienced high levels (Levels 2 and 3) of roof covering damage.

Figure 97. Distribution of roof covering damage and overall roof damage for all homes surveyed.

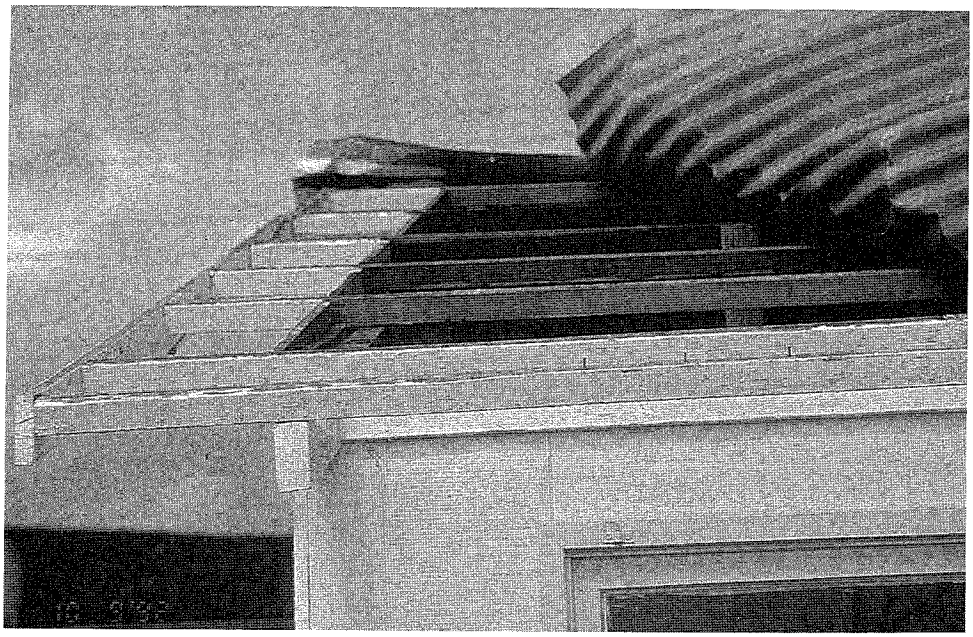
Many homes in Kauai had roofs covered with corrugated sheet metal on wood purlins. Frequently, the sheet metal roofing was completely stripped and often the purlins as well. Purlin-to-truss connections and metal roofing-to-purlin connections both appeared to be weak points. When metal roofing was stripped, the homes lost their structural sheathing as well as their water resistance.

Figure 98. Steel roofing torn from the roof of a single-wall home. The wood purlins often went with the roofing.

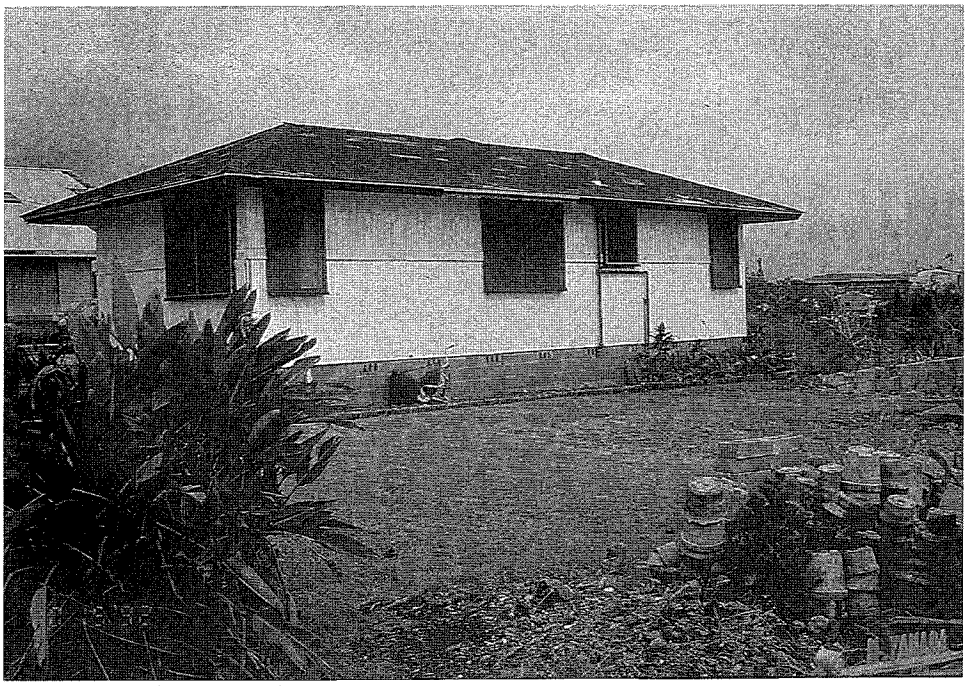
Figure 99. Typical damage to composition roof shingles.

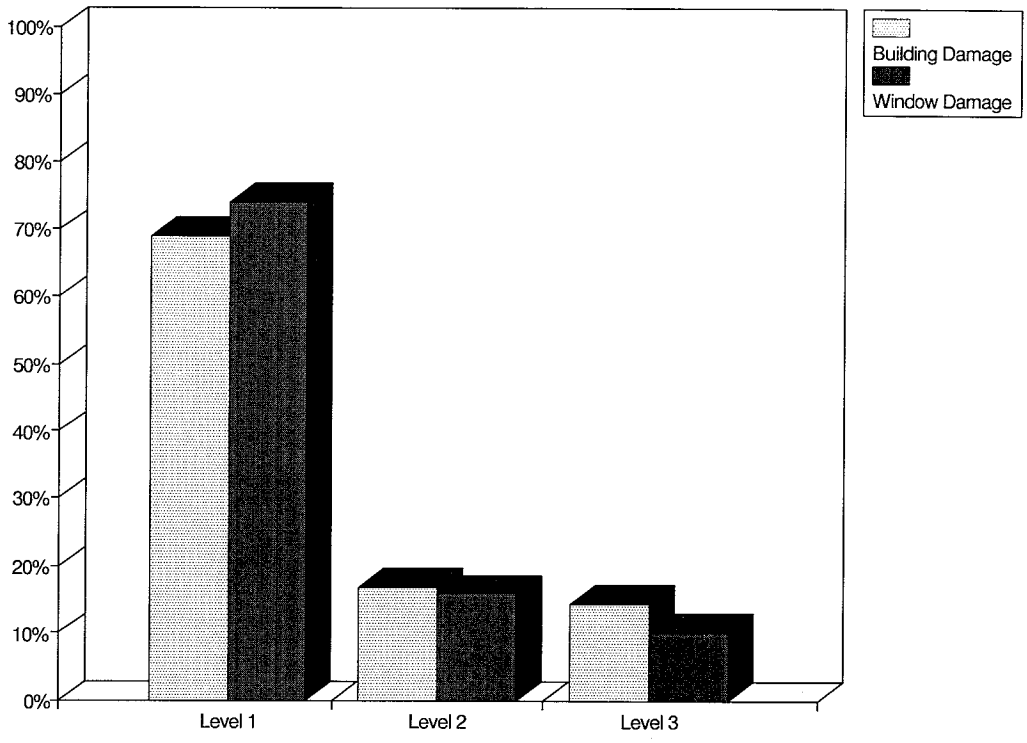
Projectile Damage - As with Hurricane Andrew, projectile damage and associated window damage was a serious issue. The distributions of window damage and projectile damage are shown in Figures 101 and 102, respectively. About three-quarters of the surveyed homes were rated in the lowest category (Level 1) for both window and projectile damage.

Figure 101. Distribution of window damage for all homes surveyed.

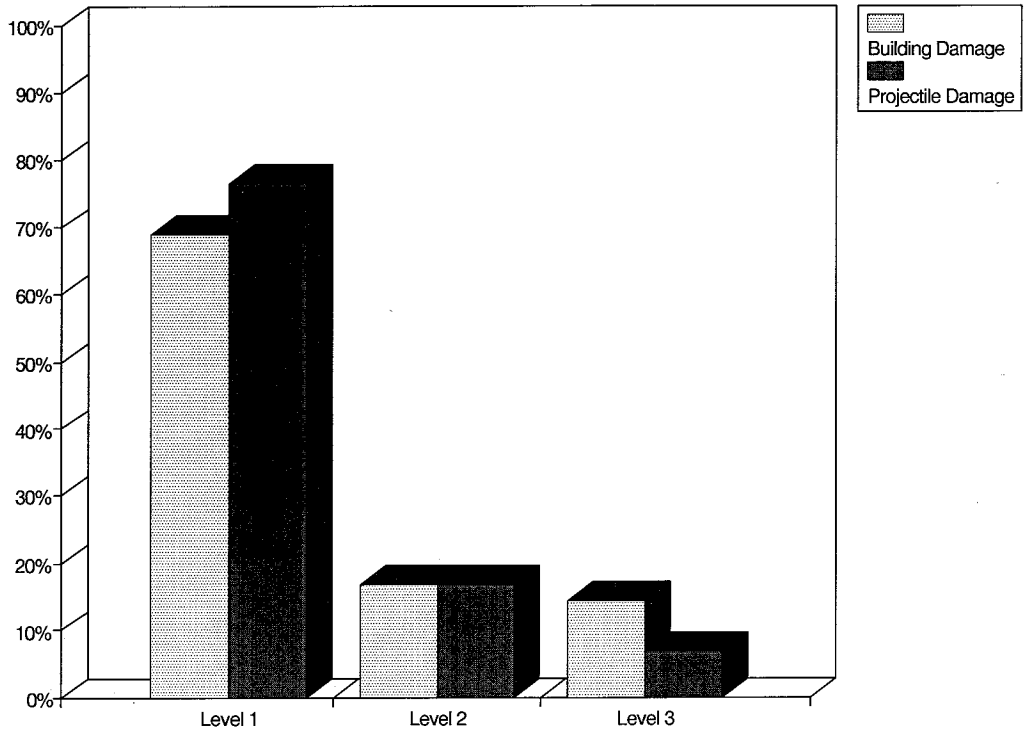
Figure 102. Distribution of projectile damage for all homes surveyed.

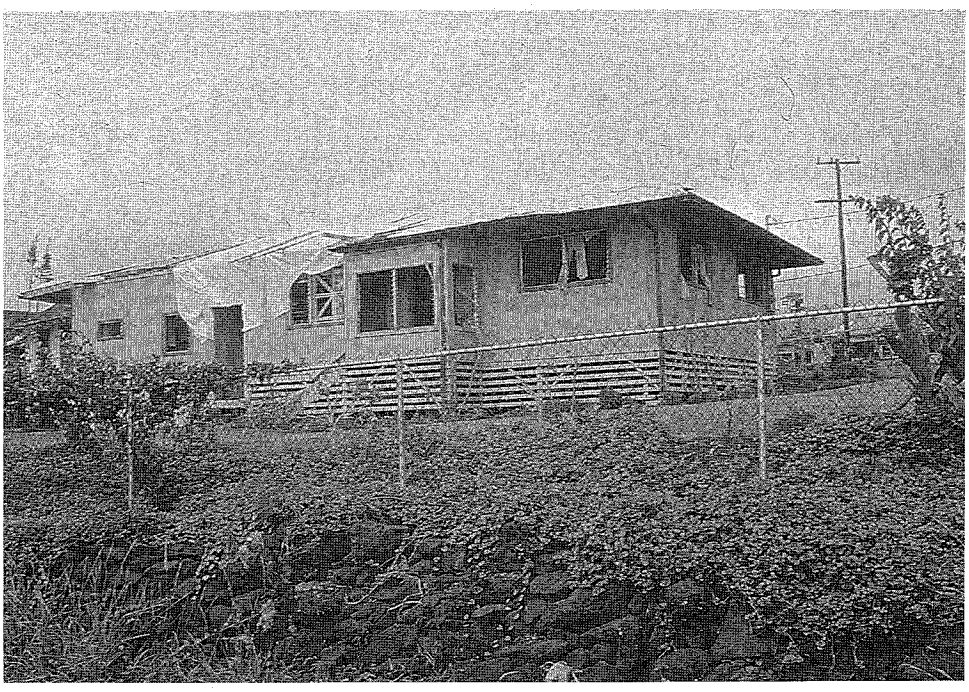
Figure 103. Shattered windows from gravel originating from a neighboring tar and gravel roof.

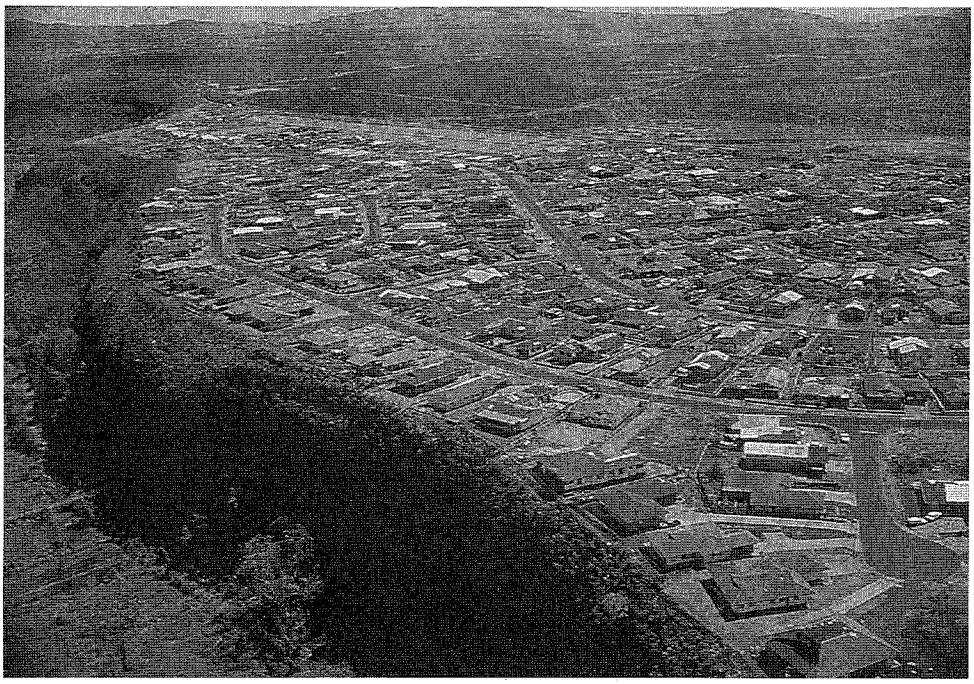
Topographic Wind Effects - One of the unique conditions on Kauai were failures apparently associated with topographical wind effects. Frequently homes were built on the edge of plateaus at the crest of a slope where localized high winds developed (Figure 106). The homes at the crest of the slope were commonly destroyed, whereas homes just behind them suffered less direct wind damage but some degree of projectile damage. This condition is shown in Figures 107 and 108. Neither the UBC-88 or ASCE 7-88 procedure for calculating wind loads accounts for the effects of topography on near-ground wind speeds.

Figure 106. Construction on a coastal plateau.

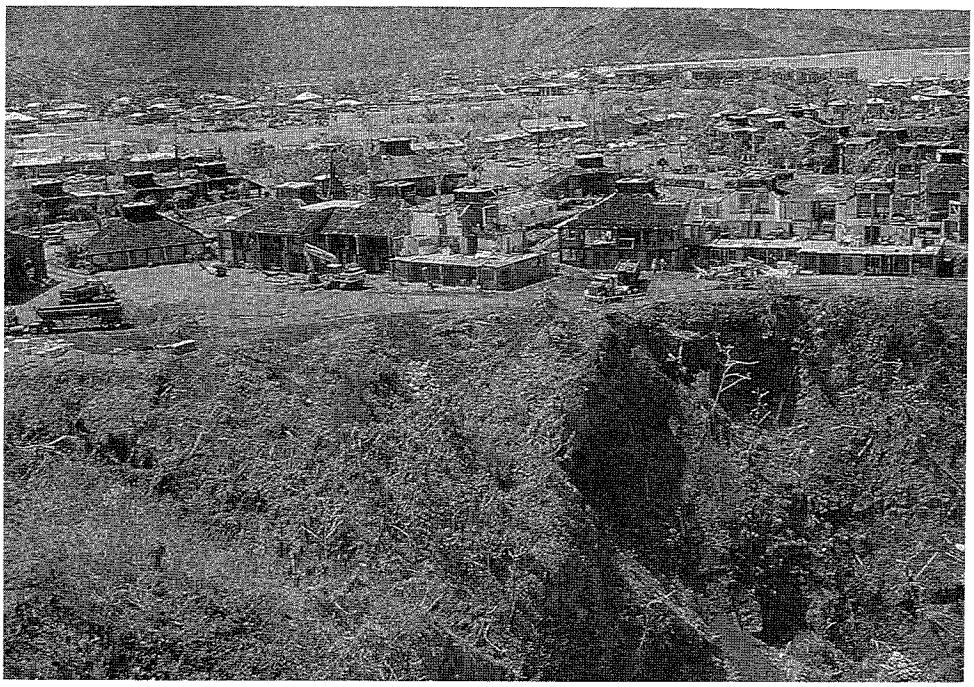
Figure 107. Residences located at the top of a slope on the shoreline of Kauai.

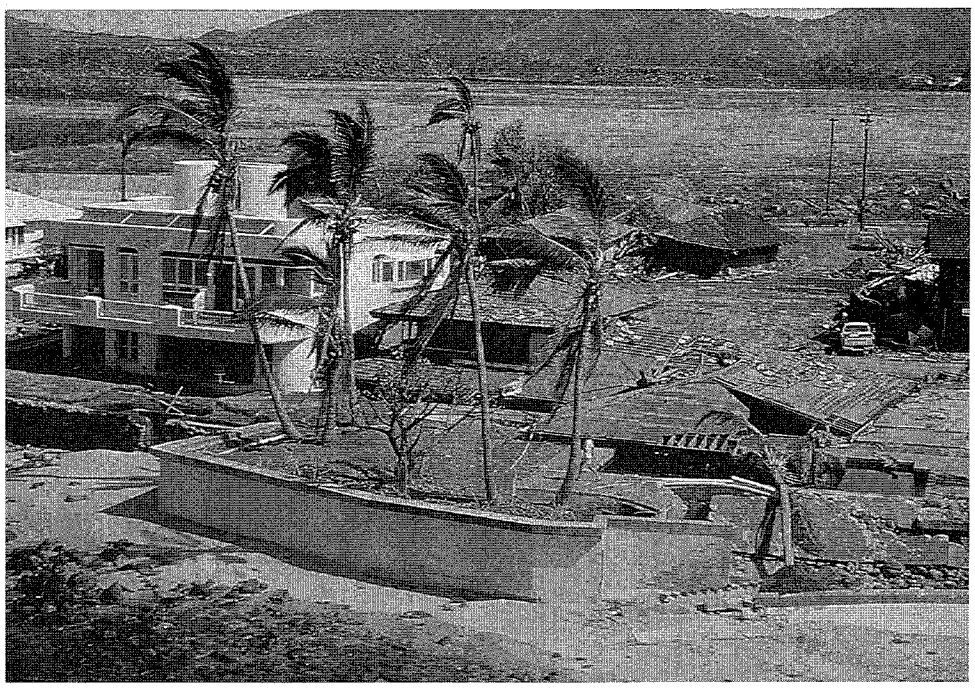
Figure 109. Storm surge damage to adjacent unelevated homes. The home on the left allowed the storm surge to pass through the lower level, which reduced the surge pressure on the structure.
