Assessment of Damage to Single-Family Homes Caused by Hurricanes Andrew and Iniki

This report, *Assessment of Damage to Single-Family Homes Caused by Hurricanes Andrew and Iniki*, evaluates the performance of houses damaged by these hurricanes. Extensive data collection, statistical analysis, and observations provide a realistic perspective on the damages that can guide decisions related to housing in hurricane-prone areas. While comprehensive in detail, this report also identifies the major problems in home construction that can lead to productive improvements in hurricane resistant housing.

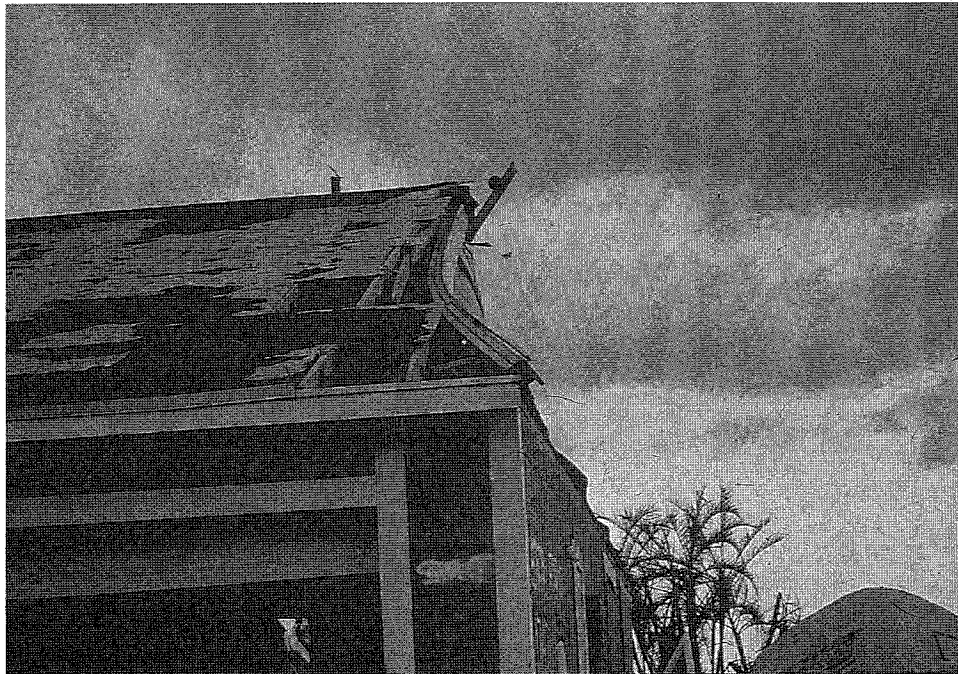
Figure 19. Wind damaged gable end wall. This home was not part of the random sample.

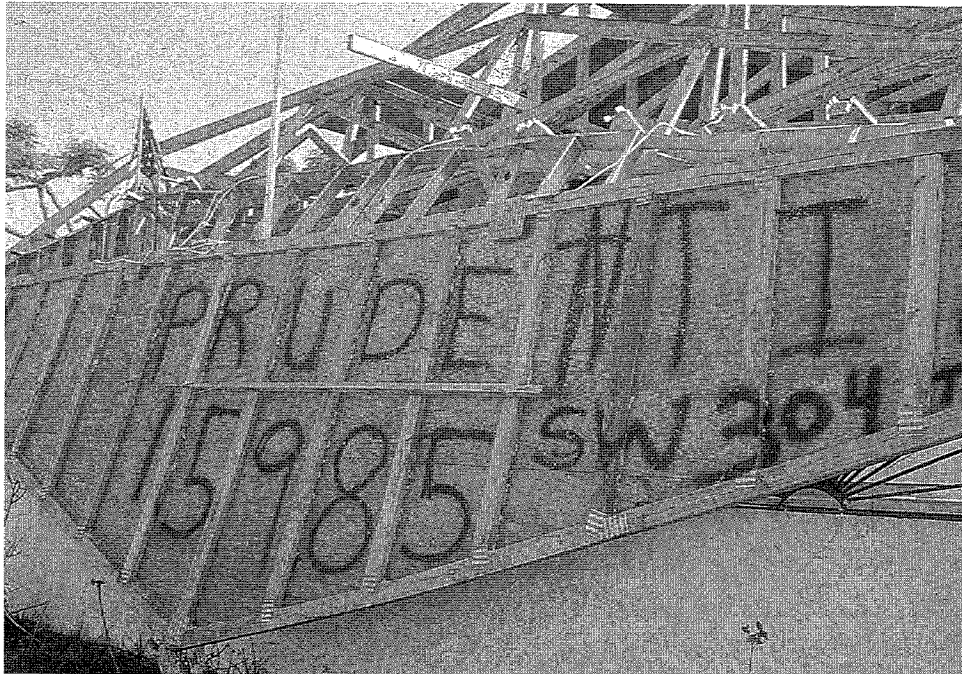
Wood trusses, as individual components, performed satisfactorily. However, the loss of a few panels of roof sheathing often led to structural failure and collapse of the roof system. Gable-end trusses were left hanging by their hurricane straps (see Figure 22) or were severely stressed in nearly one out of four single-family homes with gable roofs. Again, this represents the most significant element of structural damages experienced by the single-family homes surveyed. Some manufacturing defects of roof trusses were observed as shown in Figure 23, but these were uncommon and probably had little influence on the overall performance.

Figure 22. A gable-end truss dangling by hurricane straps.

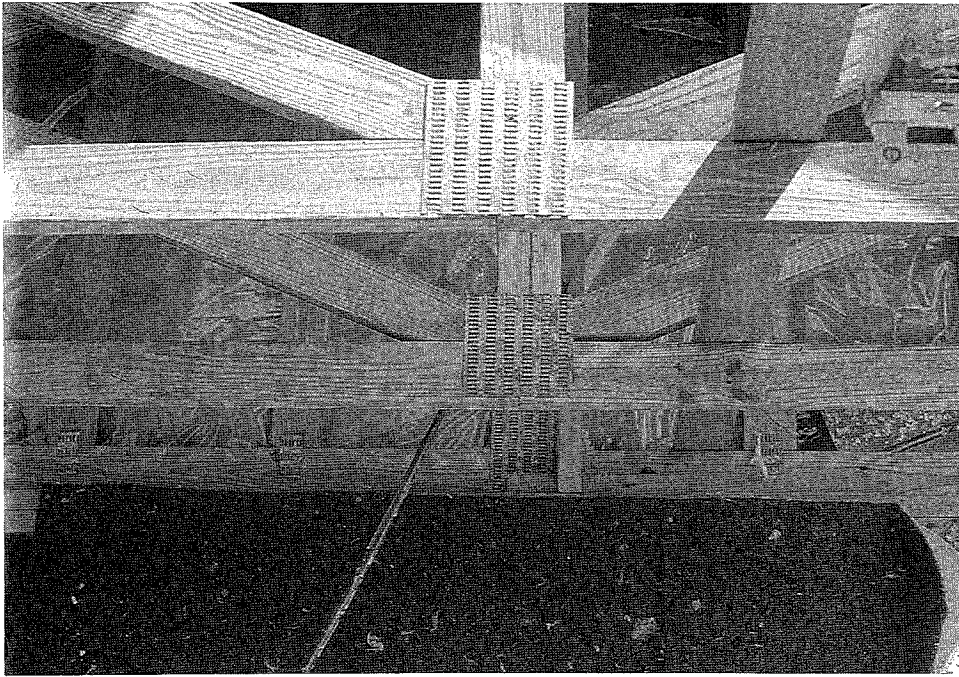
Figure 23. Misplaced (or undersized) steel connection plates on wood trusses.

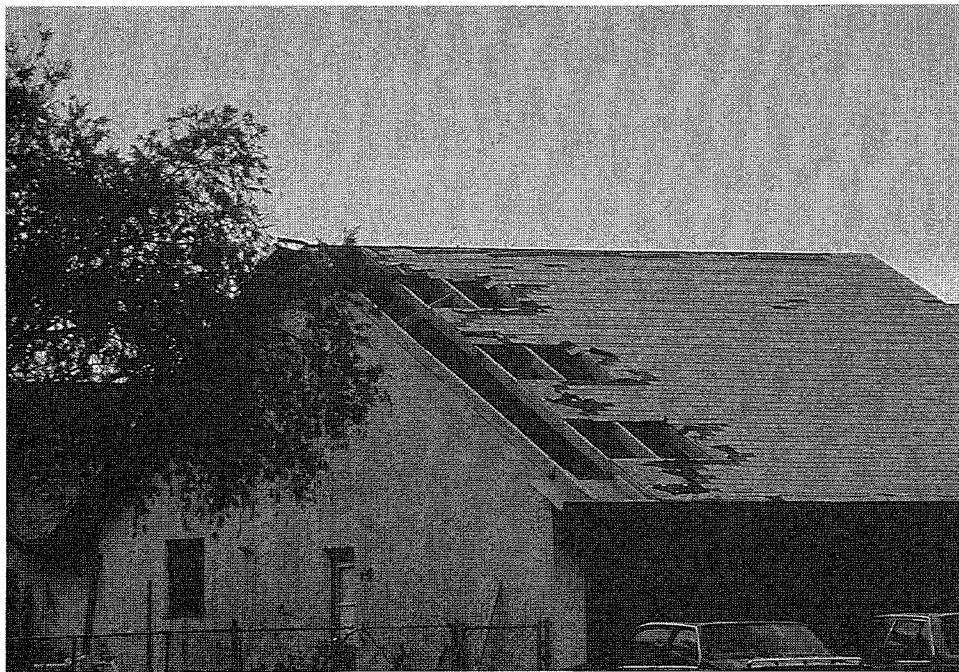
An important problem in roof framing was also observed for features such as soffits or overhangs. Any extension of the roof beyond the wall surface elevates wind pressures on both the sheathing and the framing system at these locations. In some cases where rake overhangs were used, nailing of the roof sheathing to the top of gable end trusses was inadequate. The photograph in Figure 24 demonstrates the result of a common framing problem at rake overhangs, which resulted in the loss of sheathing and the rake as shown.

Figure 24. Illustration of wind damage to rake overhangs when overhang framing was not anchored back into the roof system.

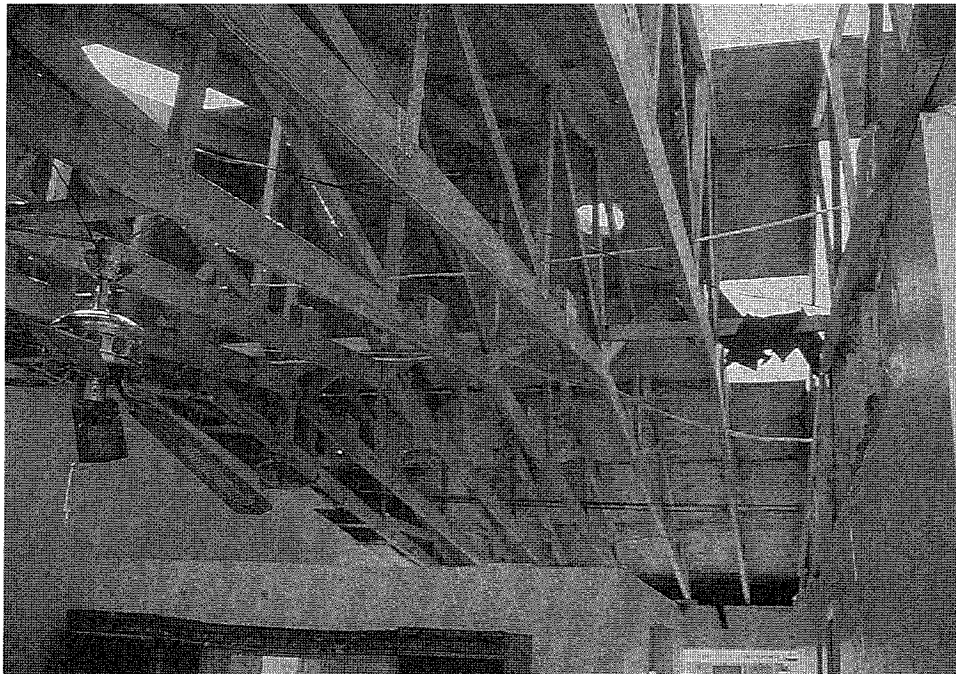
In most cases, there was no way for the survey team to distinguish between water damage from Hurricane Andrew and the ensuing rains. However, findings in the preliminary survey and discussions with home owners indicate that drywall ceilings did fail during the hurricane, as shown in Figure 31. Failure of a drywall ceiling of this type will weaken the roof system and reduce lateral support to exterior walls.

Figure 31. Illustration of a collapsed drywall ceiling from water damage.

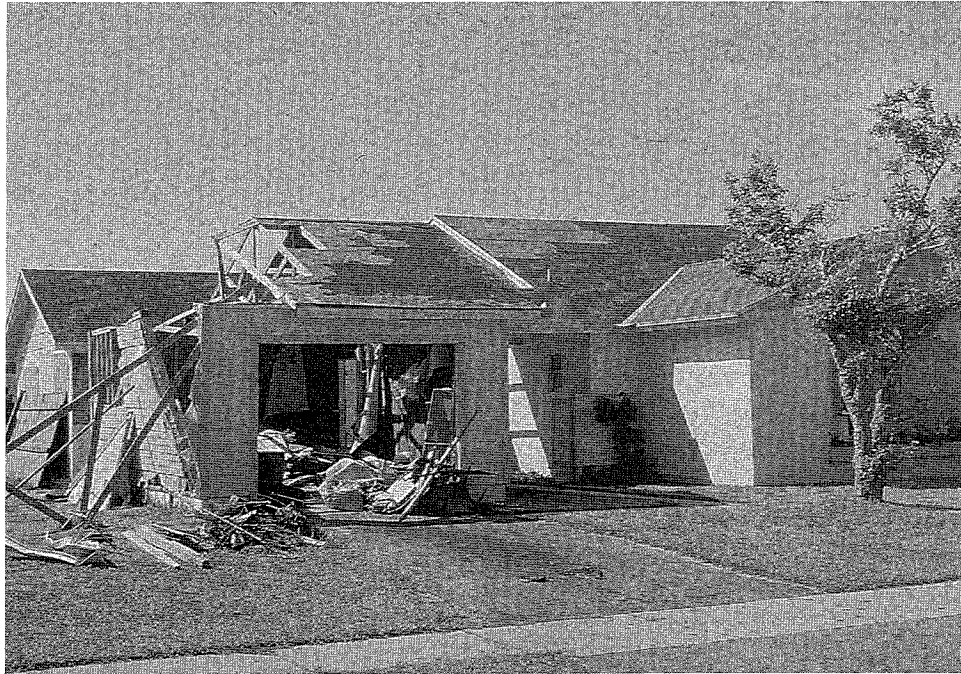
Garage doors provided another weak link in the building systems surveyed. Though not broken out on the survey form, team members examined many garage doors and found them to be reinforced with two-by lumber fastened edgewise to the back of the door as required by code. However, garage doors often failed because the fastening of the door track to the wall opening failed, or the track and wheel system failed. All of the garage doors surveyed were installed so that the track fasteners were loaded in the more severe direction of withdrawal from the inside edge of the opening. This is common practice and is not very forgiving of fastening deficiencies or overloading. An example of a garage door failure is shown in Figure 41.

Figure 41. This garage door failure lead to internal pressures that contributed to blowing out the roof and the improperly connected wall corner joint of the garage.

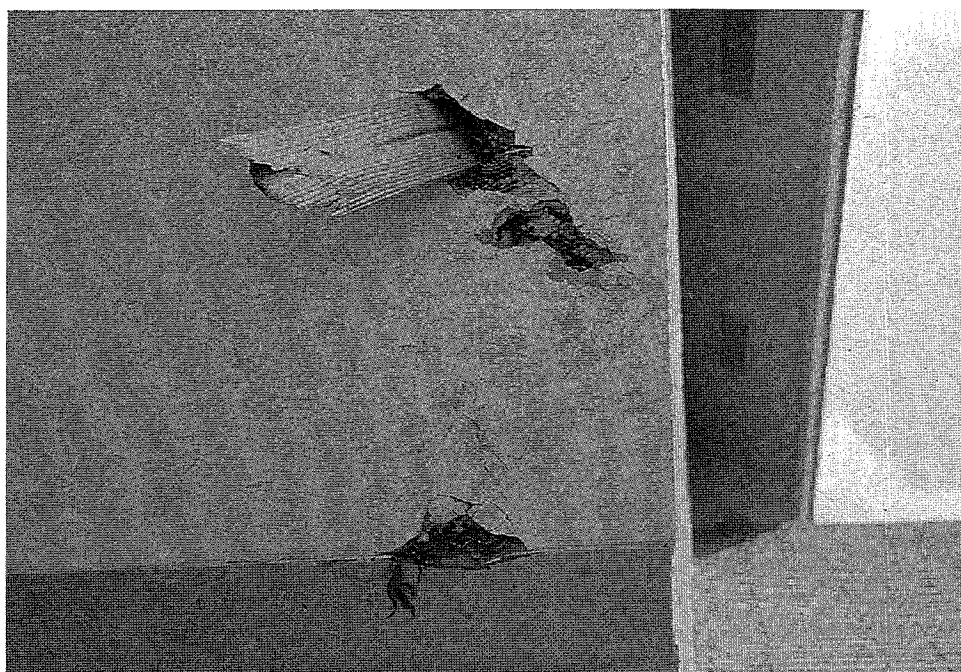
Although much of the projectile damage was rated in the lower category, even small projectiles can have a major impact (see Figure 43). On the other hand, the projectile damage to elements such as CBS walls was relatively low or superficial. Improvements in areas such as roofing systems (materials and installation) and window protection (preparedness) will not only improve the performance of individual homes but will also reduce the proliferation of projectiles and their associated damages.

Figure 43. An example of projectile damage—a 1x fence board pierces the stucco finish and sheathing on a wood-framed wall.

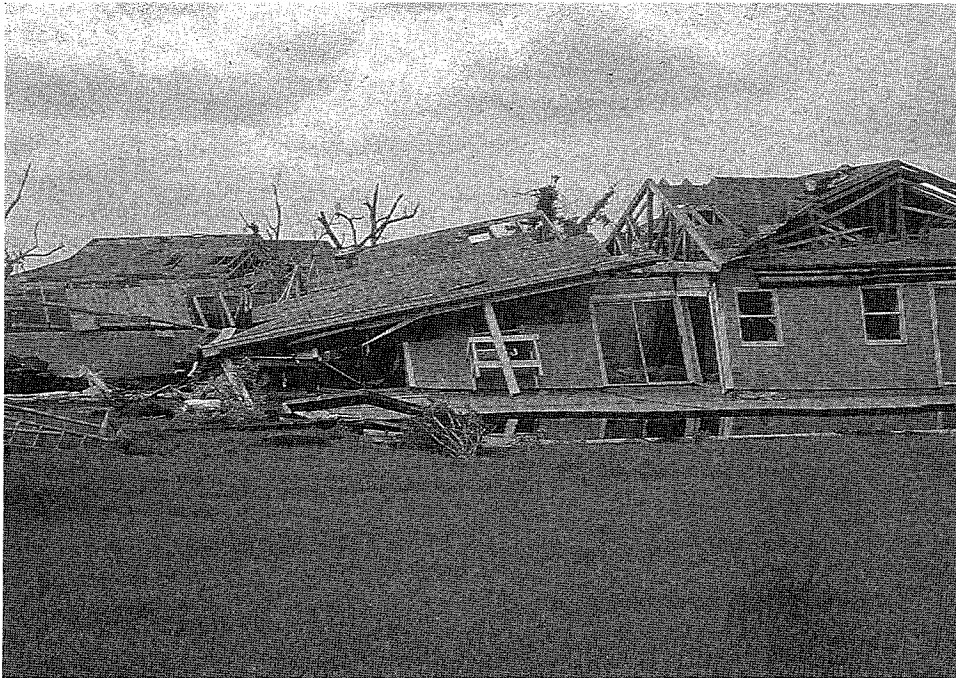
Figure 44. Complete failure of a wood framing system: shattered windows, failed porch overhang, detached roof sheathing, collapsed gable end, and fallen drywall ceiling. Exterior walls are severely racked from reduced lateral support from the tattered roof structure and inadequate shear wall construction.

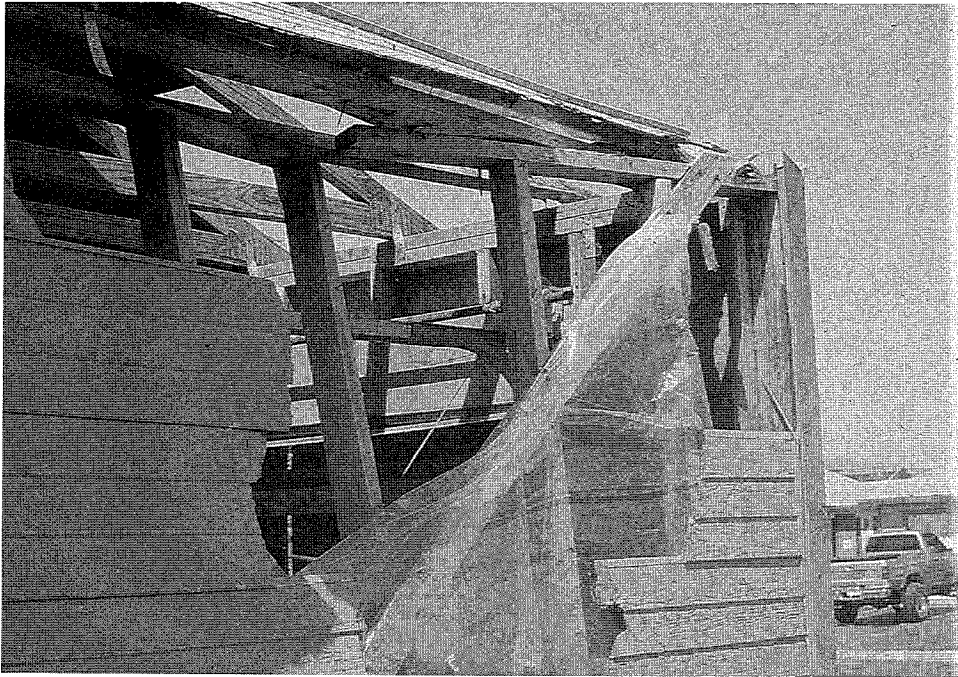
Figure 47. Failure of hardboard exterior wall siding with a let-in brace.

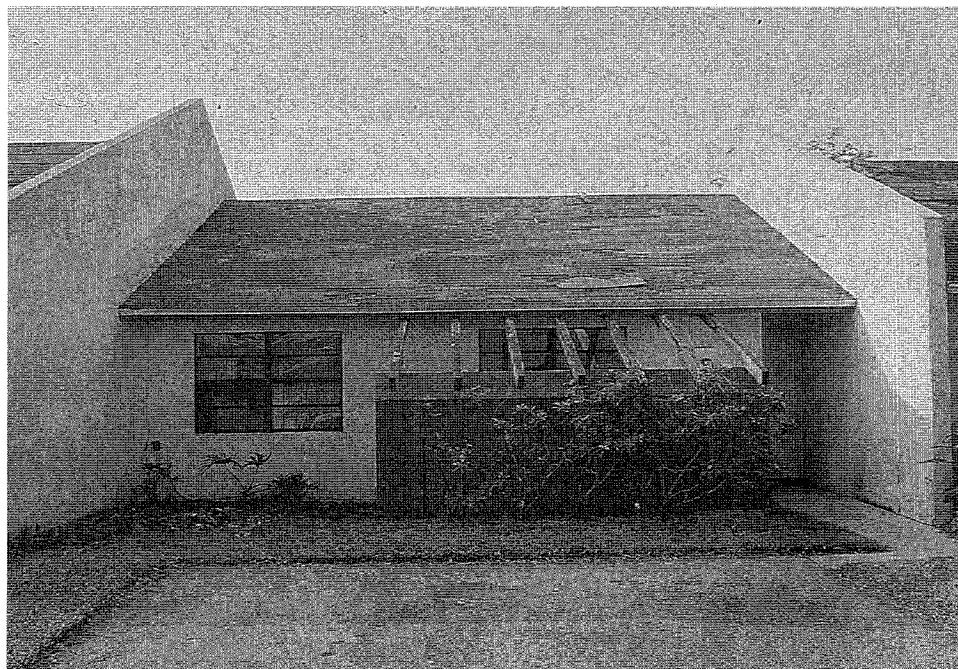
Typically, the roofs of the middle units in these two developments sustained minor to moderate shingle loss and suffered minor window and door damage from projectiles (Figure 49). Party walls that extend above the roof gave additional protection to the roofing of the interior units. The end units generally exhibited greater roof damage because of the increased exposure (Figure 50), and several gable ends were destroyed. The interiors of all units observed suffered minor to moderate water damage.

Figure 49. Typical damage to the middle unit of one-story town houses.

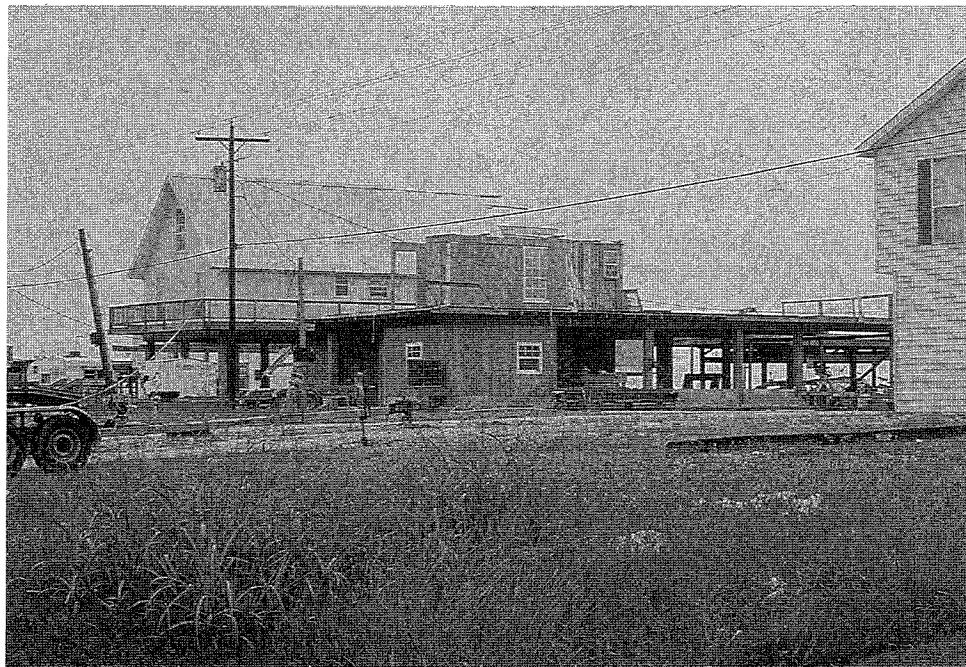
Figure 52. Destroyed coastal home on a concrete pier and heavy timber foundation.

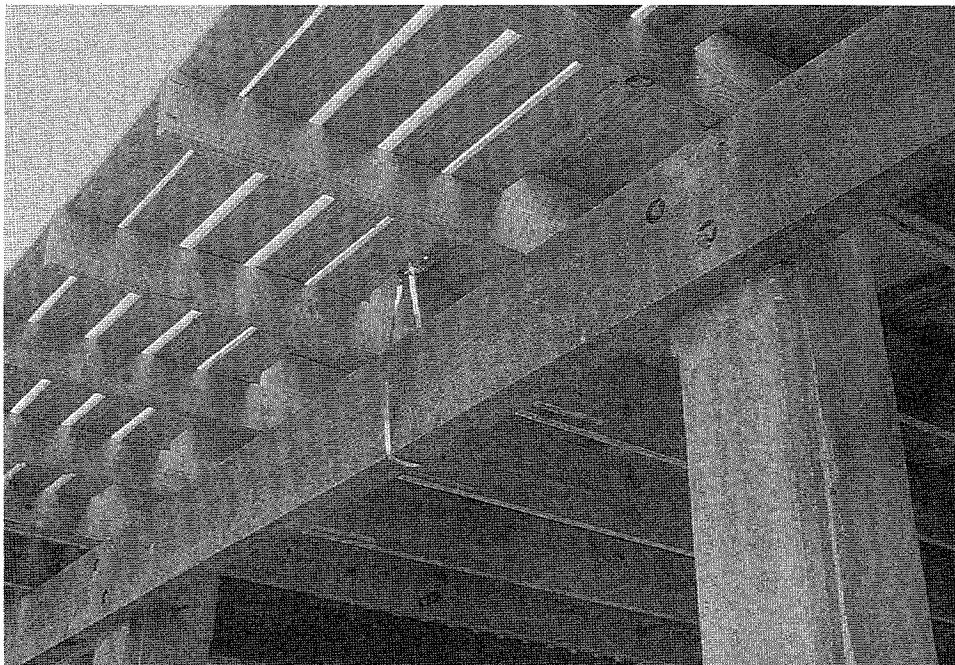
Commonly, provisions for a continuous load path were not considered or were inadequately devised (Figure 54). Even so, there were relatively few serious structural failures observed in single-family housing along the coast of Louisiana.

Figure 54. Steel bands were used to tie the now missing upper story walls to the foundation beams of the home shown in Figures 52 and 53.

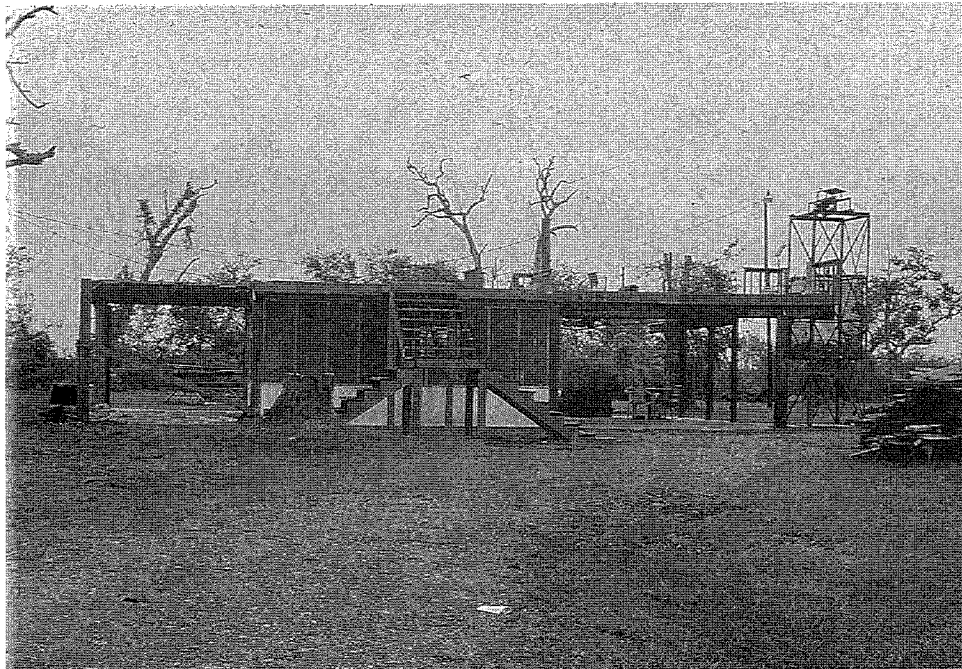
Figure 56. The manufactured (mobile) home, once positioned on this elevated foundation with an open exposure on the coast, was found some distance downwind.

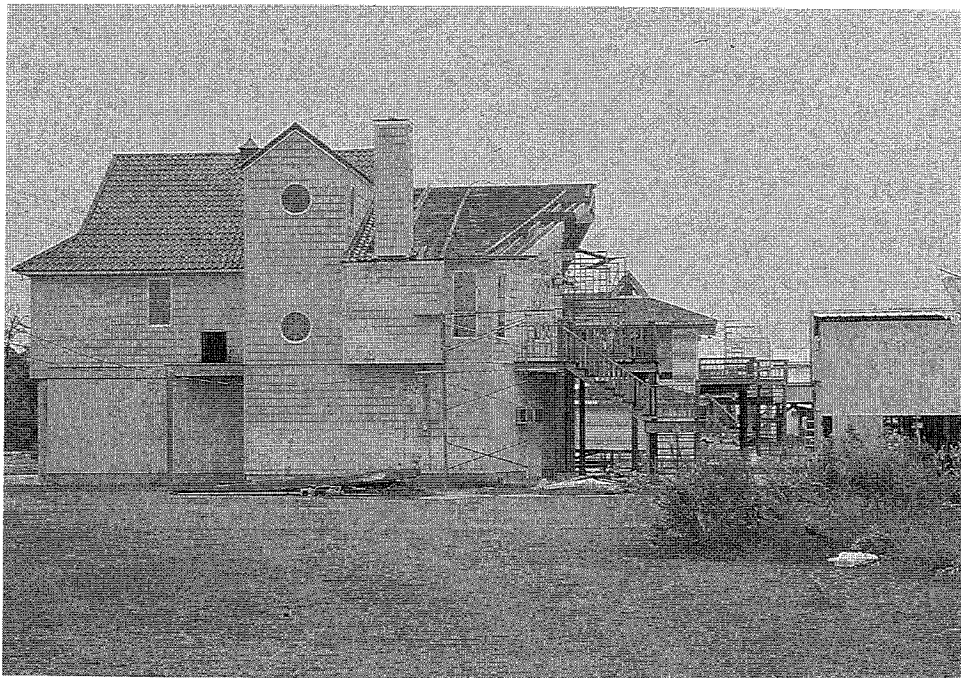
Figure 58. Gable ends and overhangs presented some problems in Louisiana, similar to Florida.

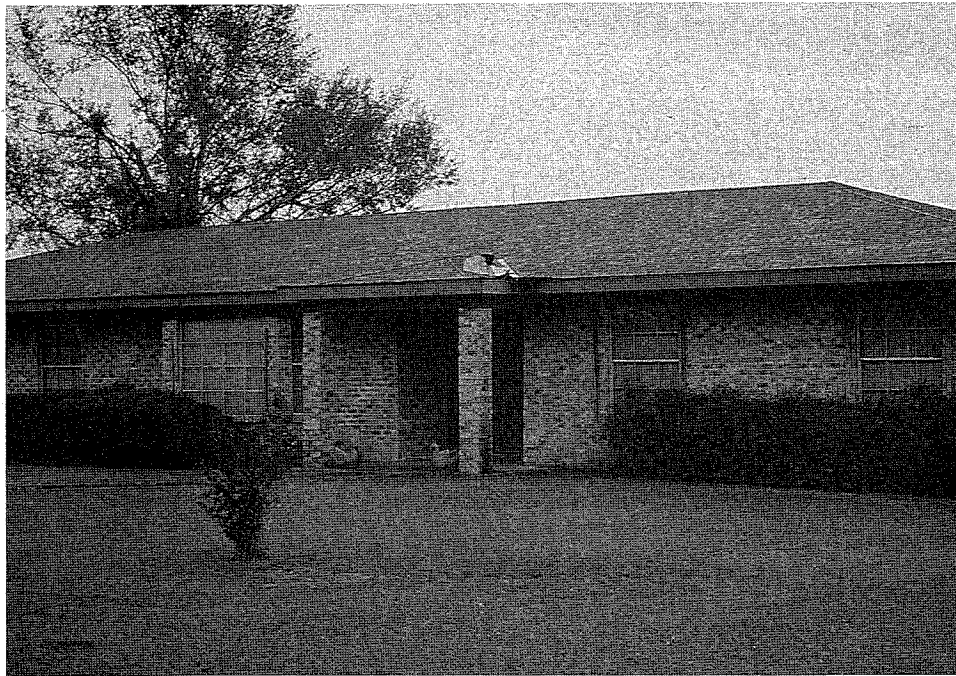
Figure 59. Inland home with minimal damage to roof shingles.

Inland homes ranged from single-story construction with hip roofs, as shown in Figure 59, to older tenant homes and manufactured homes. Damage to these homes was mainly due to water damage from loss of roofing. In a very few cases, over-stressed or collapsed gable-end walls were observed. In some cases the damages were thought to be related to localized high winds or tornados.

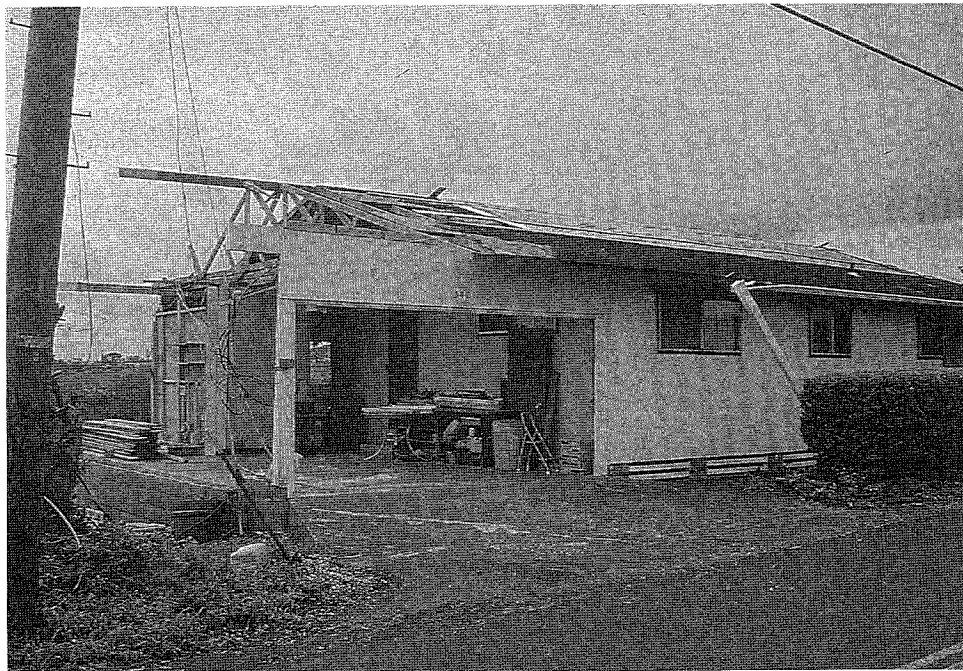
Figure 69. Site-built trusses on a single-wall home with lapped and nailed joints in lieu of metal or plywood gusset plates.

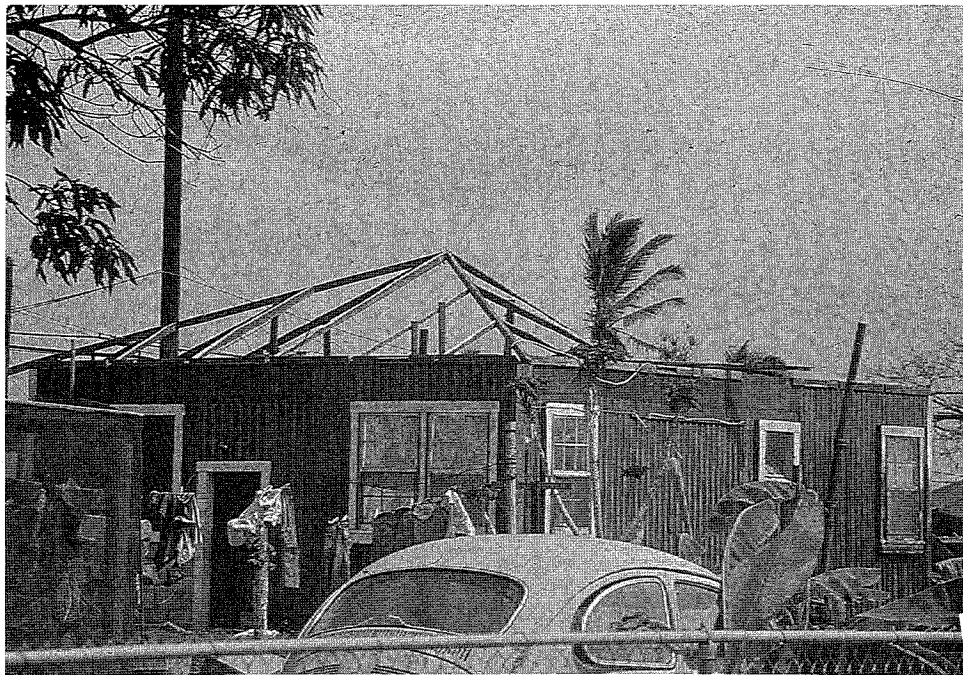
Many homes in Kauai had roofs covered with corrugated sheet metal on wood purlins. Frequently, the sheet metal roofing was completely stripped and often the purlins as well. Purlin-to-truss connections and metal roofing-to-purlin connections both appeared to be weak points. When metal roofing was stripped, the homes lost their structural sheathing as well as their water resistance.

Figure 72. Light-frame wood roofs with corrugated metal roofing on single-wall homes did not fare well.

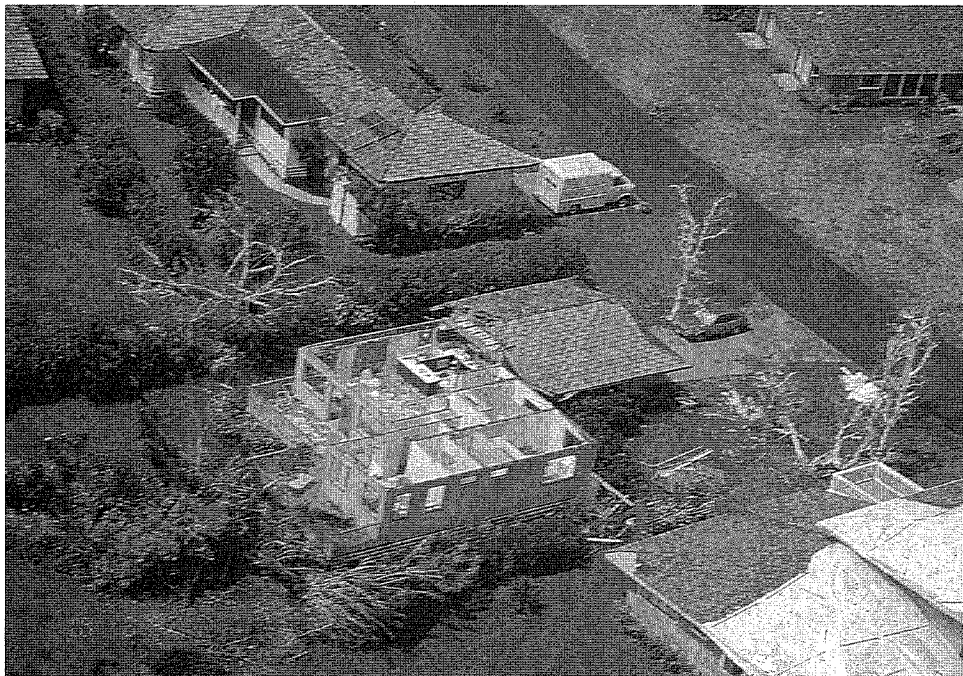
Figure 73. This home lacked a continuous load path from the roof to the walls and lost its entire roof.

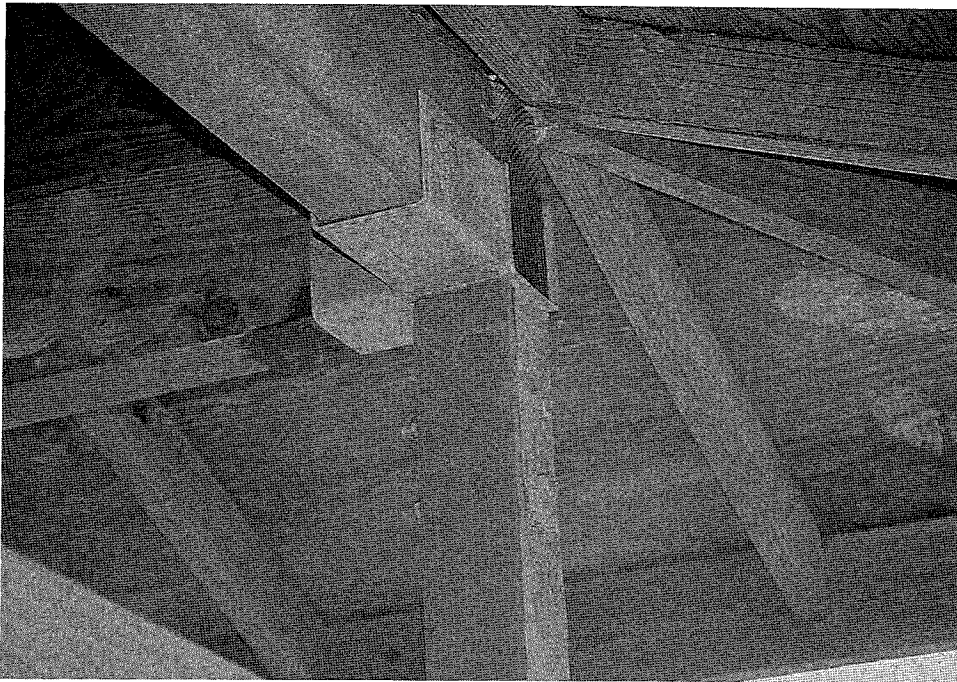
Figure 74. This roof beam connection to a column provided resistance against uplift and also created a stiff joint for lateral forces.

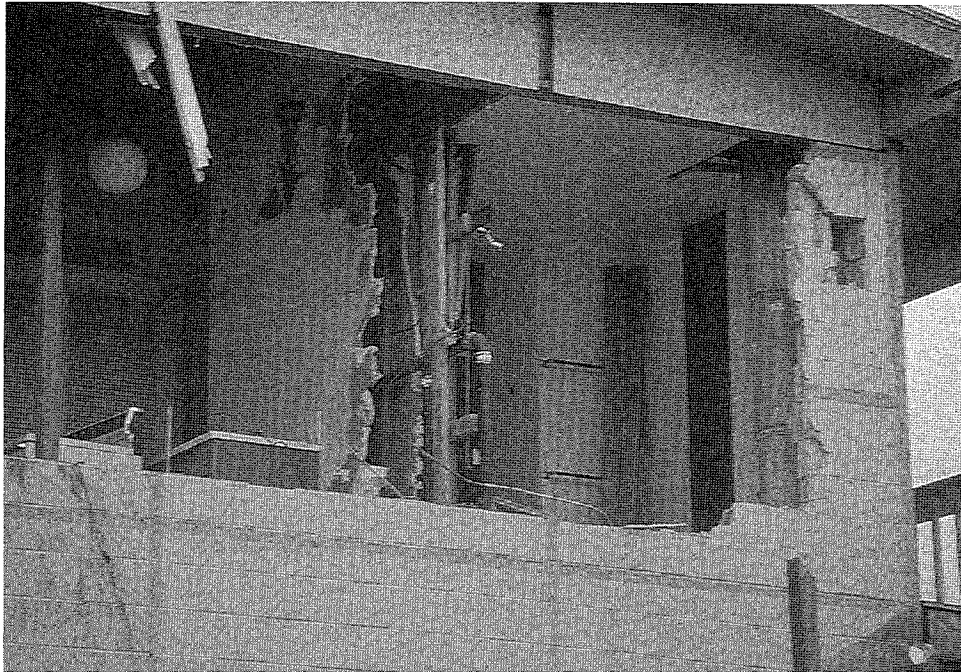
Figure 82. Blown out concrete block end wall that lacked a concrete tie beam and proper reinforcing.

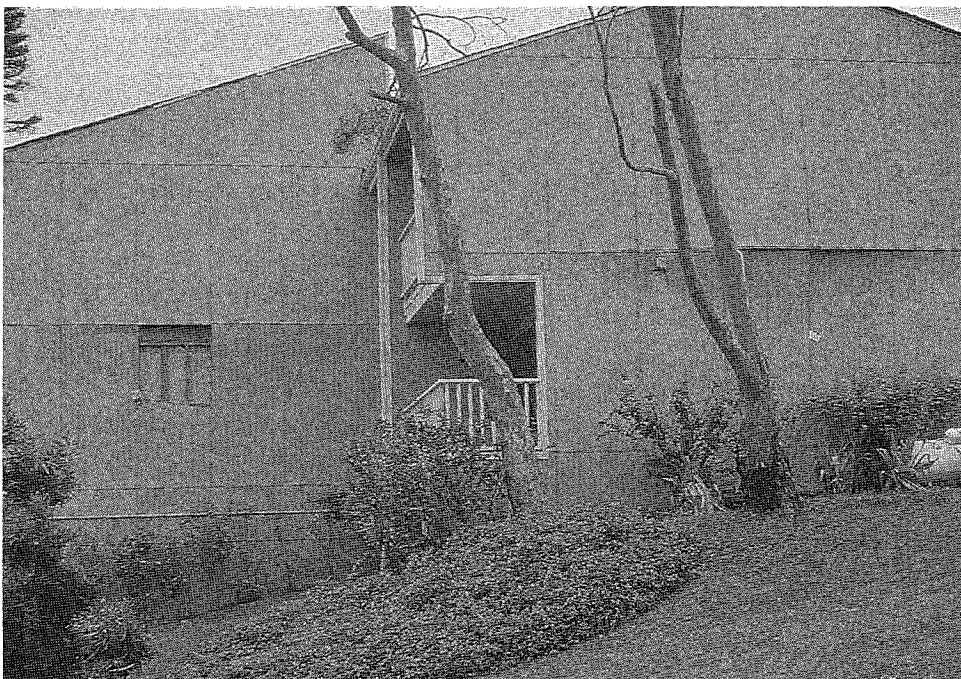
Figure 83. Wood-frame end wall with buckling and tearing of hardboard siding panels.

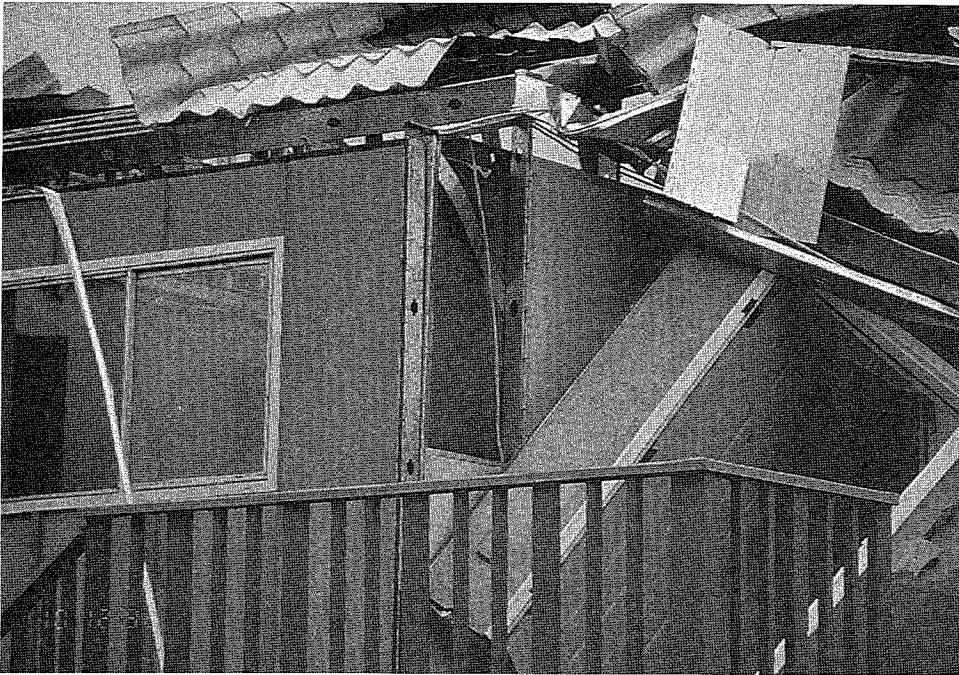
Figure 84. Light-gauge steel framing was also subject to severe damage.

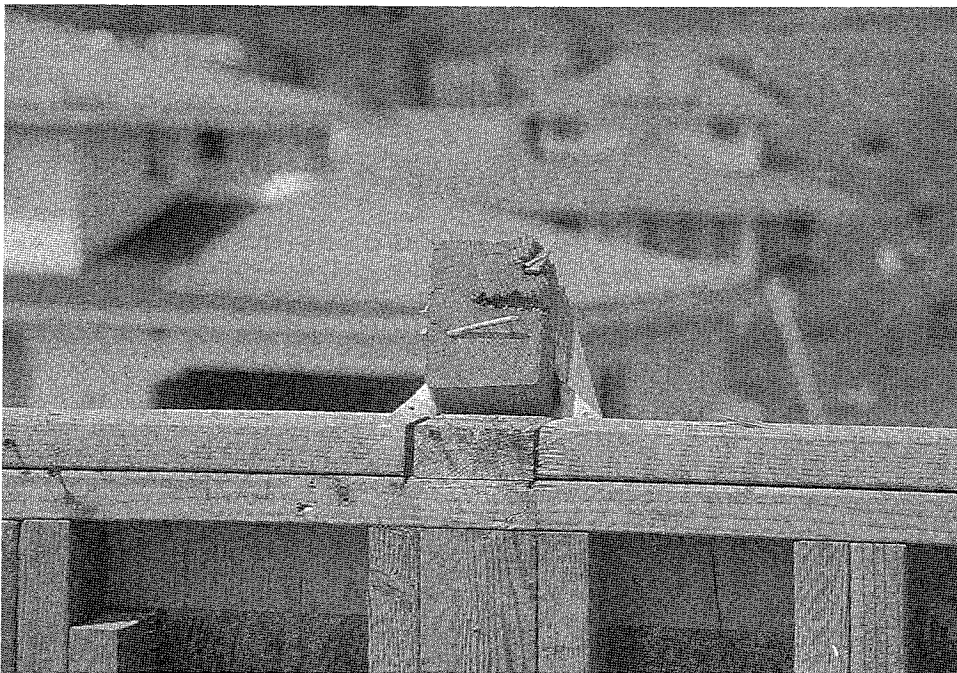
Figure 85. The metal strapping between the first and second story on this home did not provide adequate structural continuity between stories.

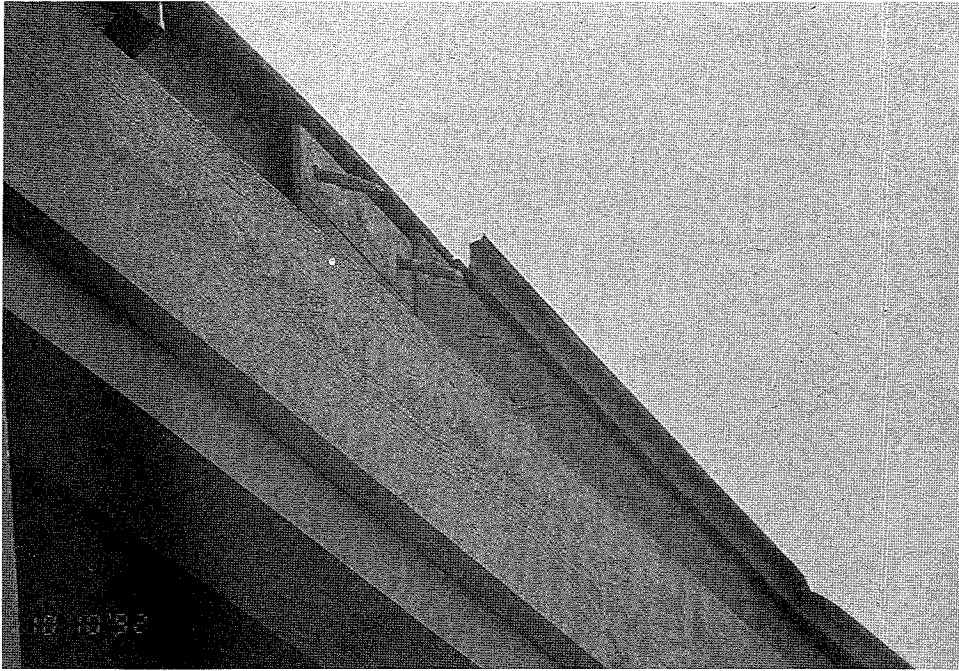
The distribution of wall damage is shown in Figure 80. About 88 percent of the surveyed homes were rated in the lowest category (Level 1) for wall damage. Some examples of the wall construction variations and damages are shown in Figures 81 through 86. Examples of deficient design and construction were found in all wall types surveyed, including wood, steel, and masonry. Some coastal homes on elevated foundations did experience problems with continuous load paths or structural connections from the wall to the foundation members (see Figure 86).

Figure 86. The bracket and lag bolts that anchored the wall post to the elevated foundation on this coastal home provided insufficient lateral resistance against the wind loads experienced by the inadequately braced wall.

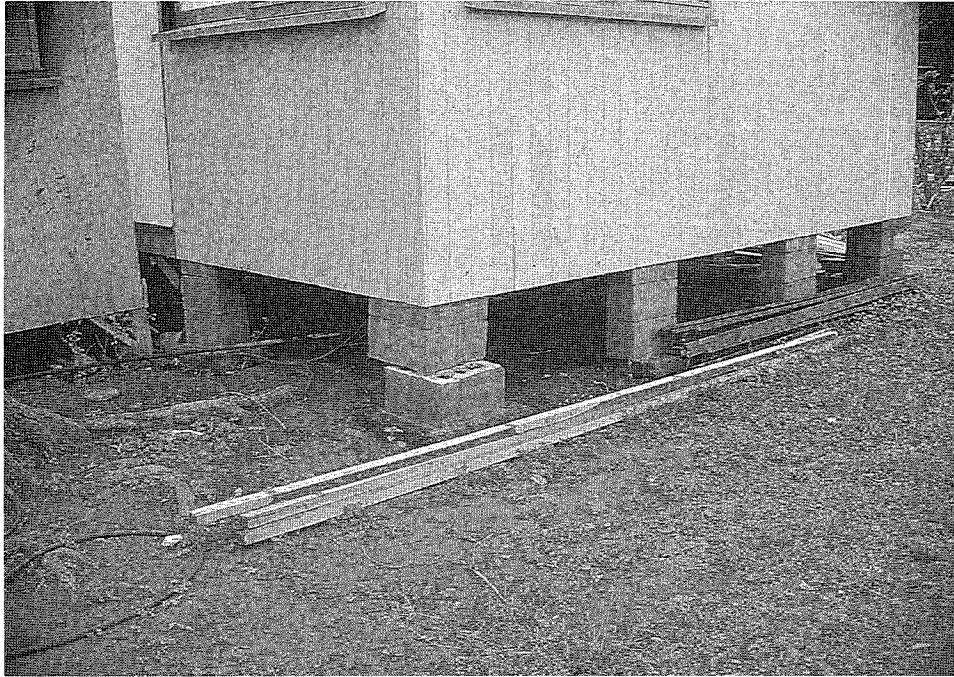
Figure 89. Shear slippage of an unreinforced CMU pier foundation.

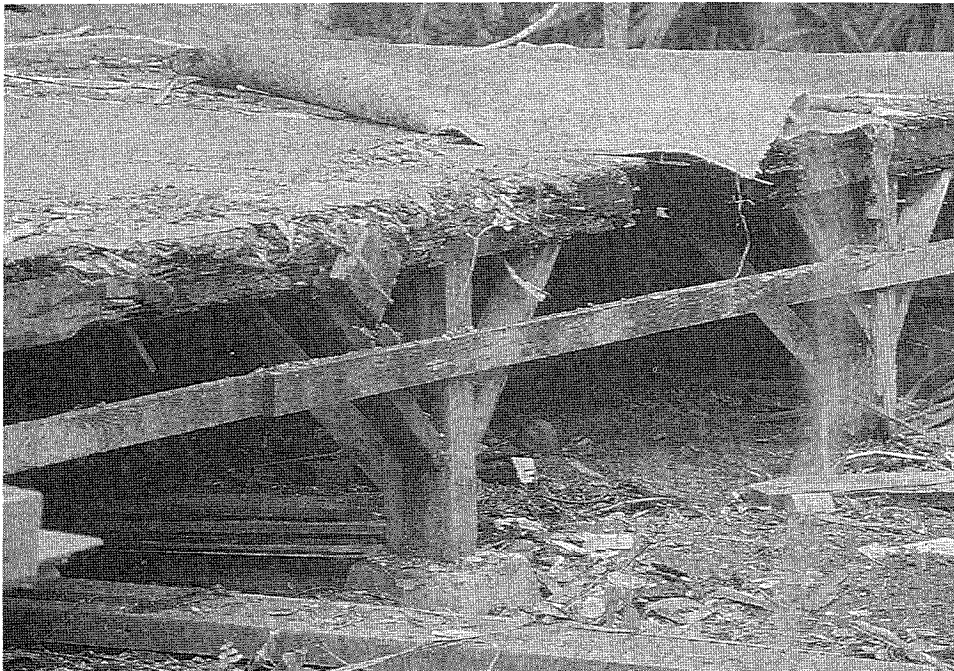
Figure 90. Wood post foundation with severe rot and termite damage.

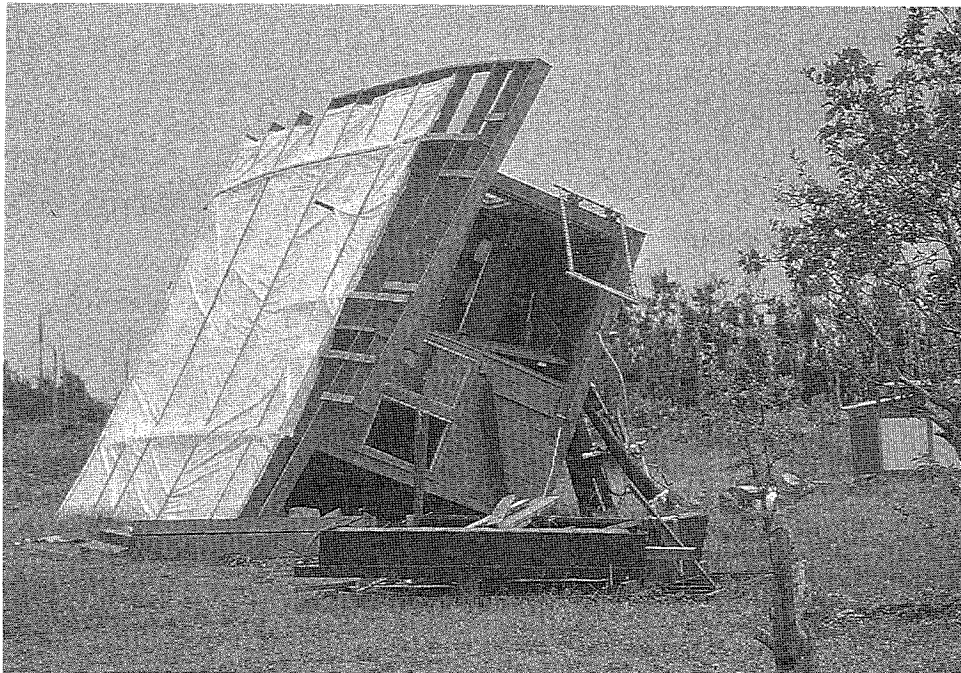
Figure 92. With its large overhangs and lacking connection to a foundation, this small home was lifted and moved several feet from its original location.

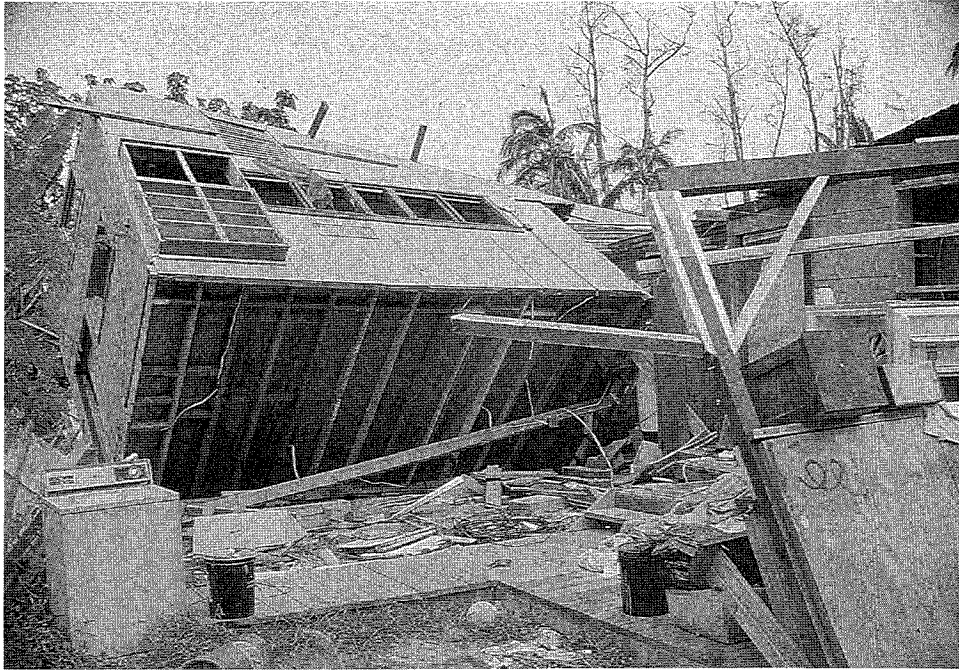
Figure 93. This single-wall home lacked continuous load paths to the foundation and failed by overturning.

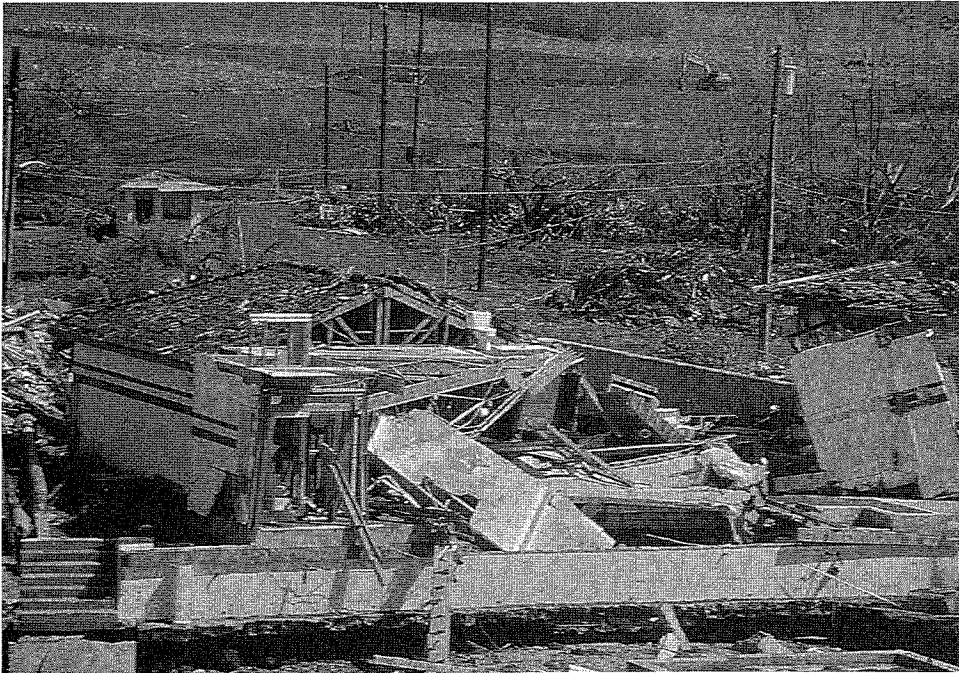
Figure 94. Slab-on-grade foundation survives the storm surge but the remainder of the home was demolished by storm surge. Away from the coastal flood plain, slab-on-grade foundations performed well.

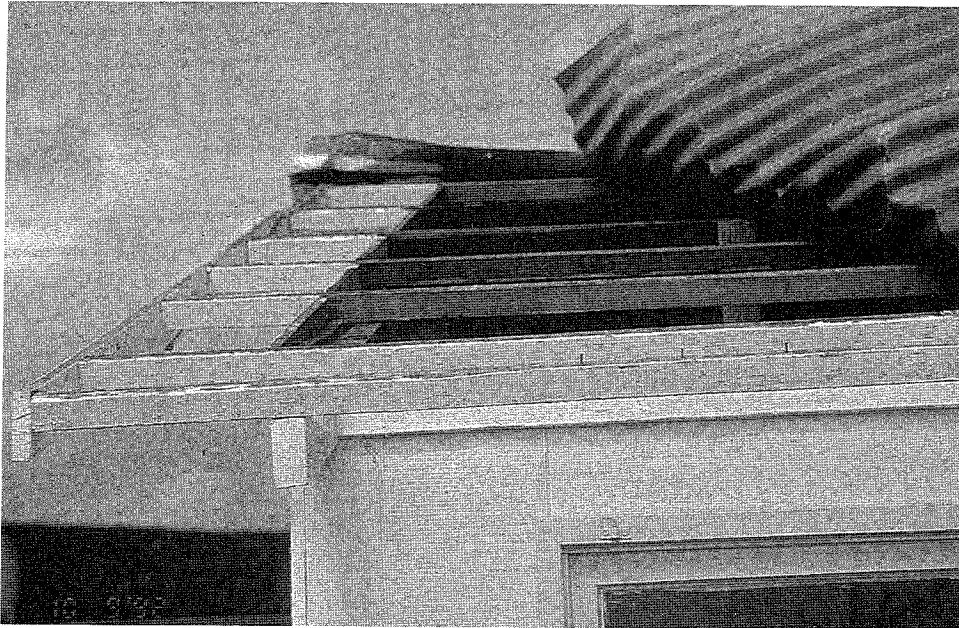
Figure 98. Steel roofing torn from the roof of a single-wall home. The wood purlins often went with the roofing.

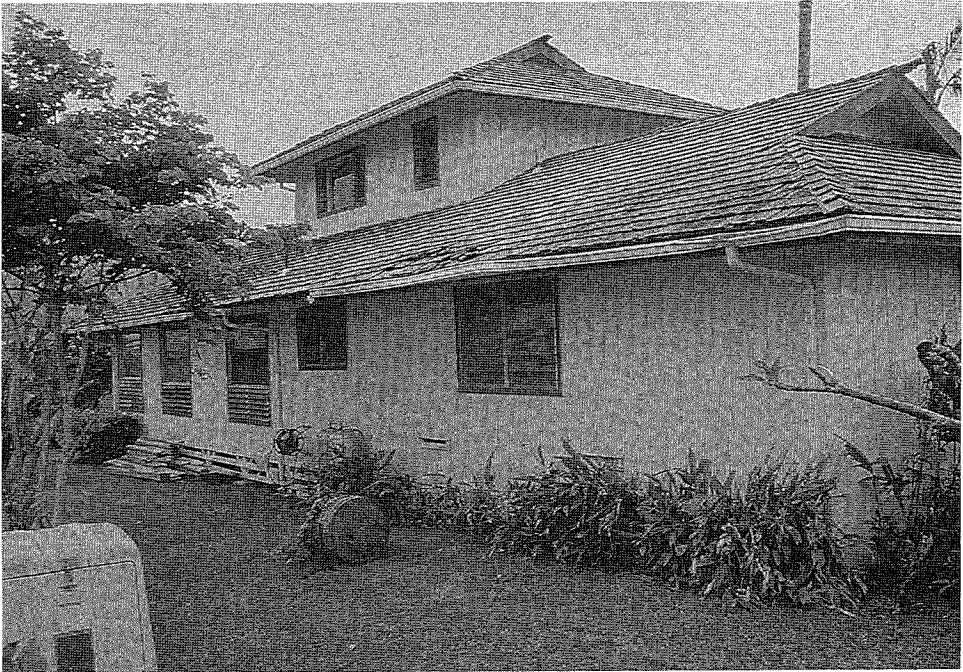
Figure 100. Wood shake roofs performed relatively well.
