Assessment of Damage to Single-Family Homes Caused by Hurricanes Andrew and Iniki

This report, *Assessment of Damage to Single-Family Homes Caused by Hurricanes Andrew and Iniki*, evaluates the performance of houses damaged by these hurricanes. Extensive data collection, statistical analysis, and observations provide a realistic perspective on the damages that can guide decisions related to housing in hurricane-prone areas. While comprehensive in detail, this report also identifies the major problems in home construction that can lead to productive improvements in hurricane resistant housing.

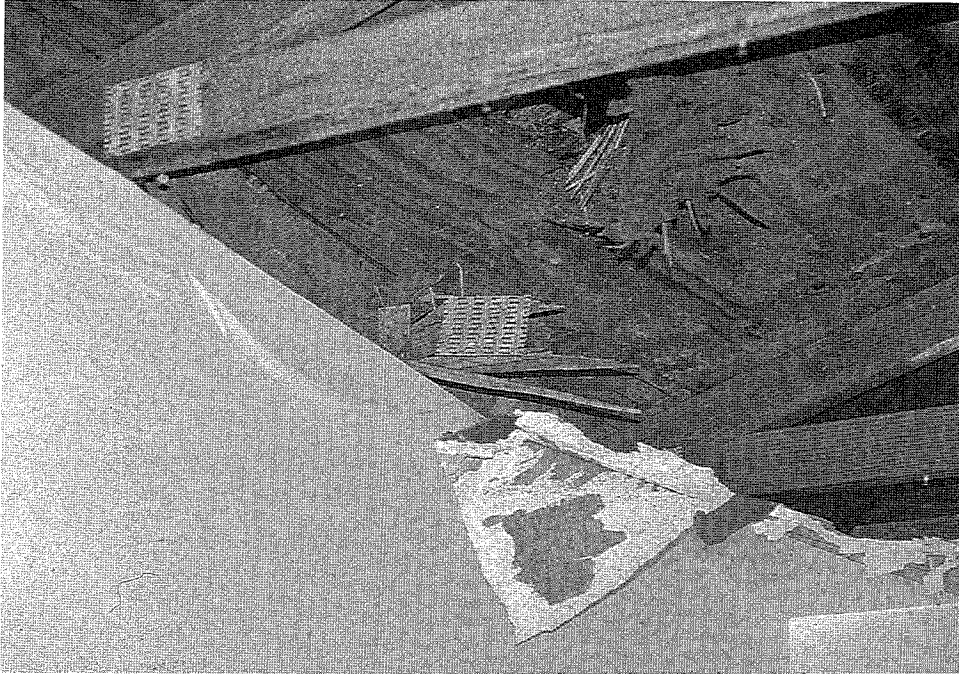
Unprotected windows are vulnerable to projectile damage as shown in Figure 103. In this case, a built-up tar and gravel roof on an upwind building became a launching pad for the gravel that broke every window in this home. In Figure 104, a piece of wood pierced the roof of this home, completely severing the hip joint of a truss. The house in Figure 105 was struck by a roof dislodged from a neighboring home. A particularly serious source of projectiles was corrugated metal roofing, which frequently appeared on the landscape. Unsecured propane fuel tanks also became projectiles in the high winds.

Figure 104. A wood projectile penetrates roof framing materials.

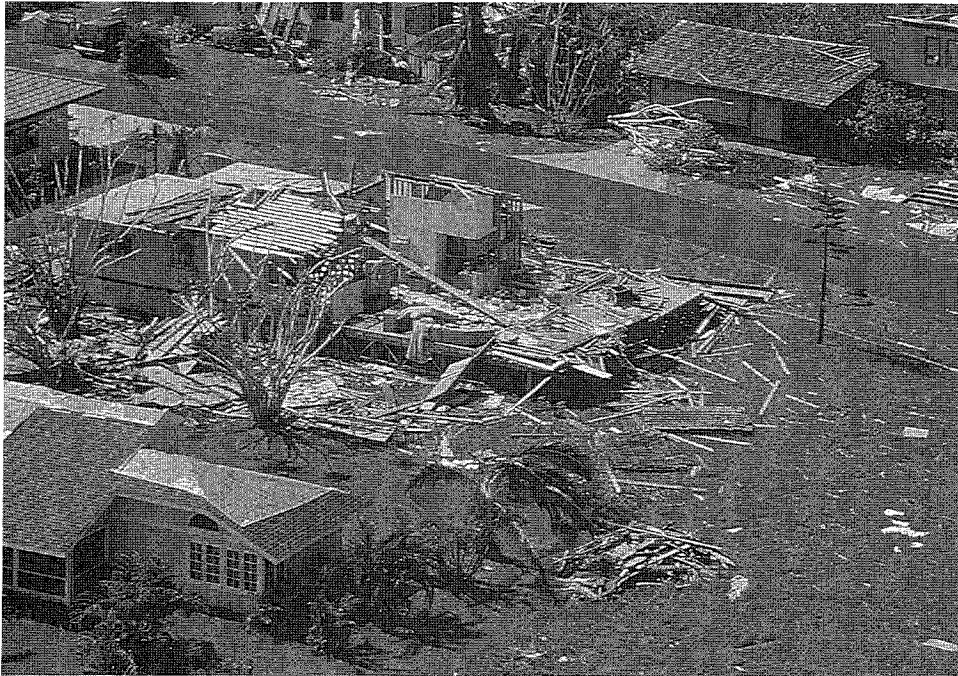
Figure 105. This home was struck by the roof blown off a neighboring home.

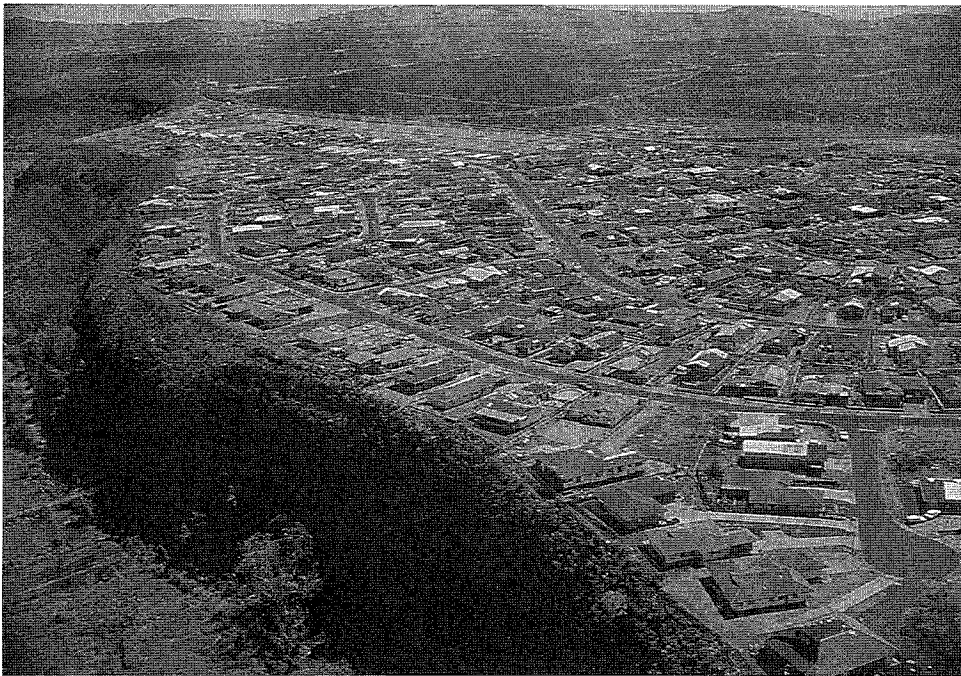
Topographic Wind Effects - One of the unique conditions on Kauai were failures apparently associated with topographical wind effects. Frequently homes were built on the edge of plateaus at the crest of a slope where localized high winds developed (Figure 106). The homes at the crest of the slope were commonly destroyed, whereas homes just behind them suffered less direct wind damage but some degree of projectile damage. This condition is shown in Figures 107 and 108. Neither the UBC-88 or ASCE 7-88 procedure for calculating wind loads accounts for the effects of topography on near-ground wind speeds.

Figure 106. Construction on a coastal plateau.

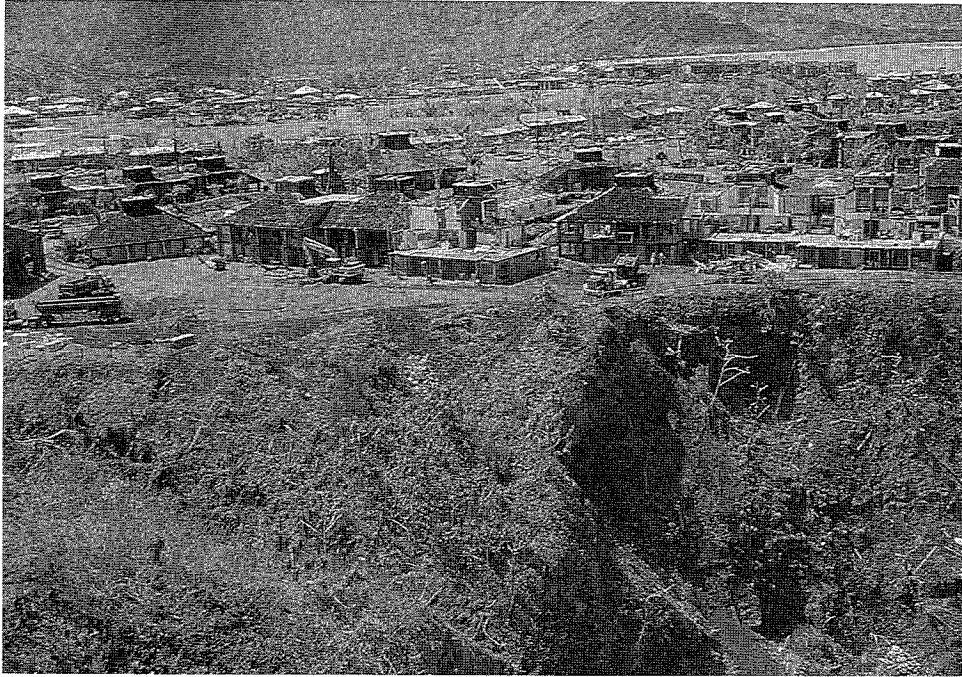
Figure 107. Residences located at the top of a slope on the shoreline of Kauai.

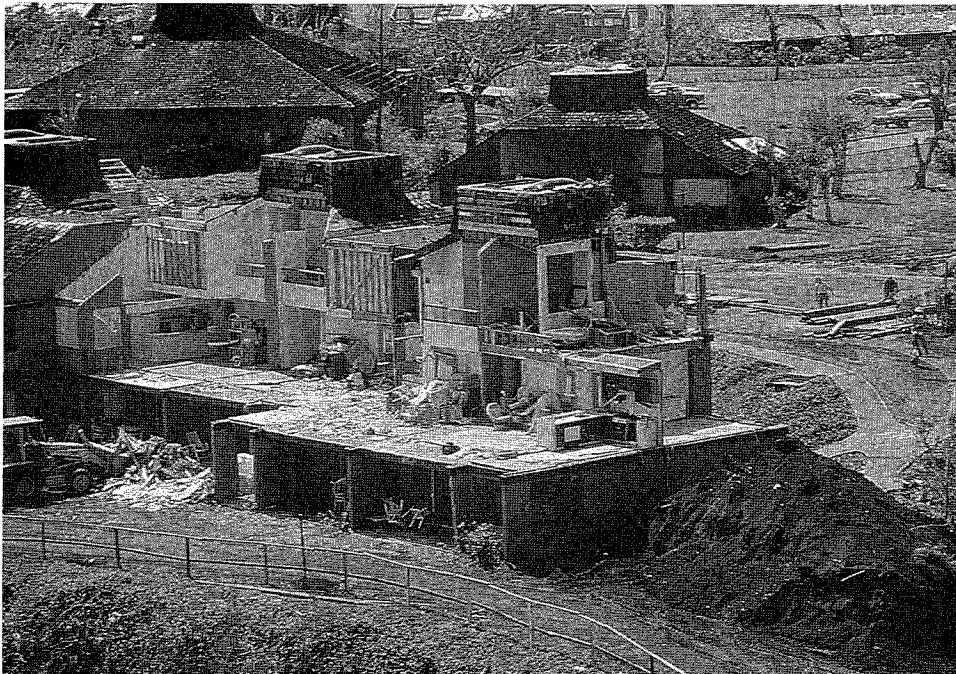
Figure 108. The residences at the top edge of the slope suffered severe damage while those further back were still intact.
