THE NEW YORK CITY 510 DEMONSTRATION:
THE NEIGHBORHOOD CO-OP EXPERIMENT

Contract 202-0008
Task Order No. 2

Resident and Building Report

February 1981

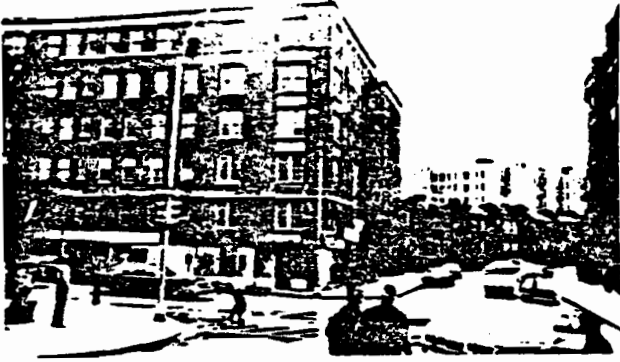
1890 Andrews Avenue,
Morris Heights

View from across Burnside Avenue,
showing commercial units.

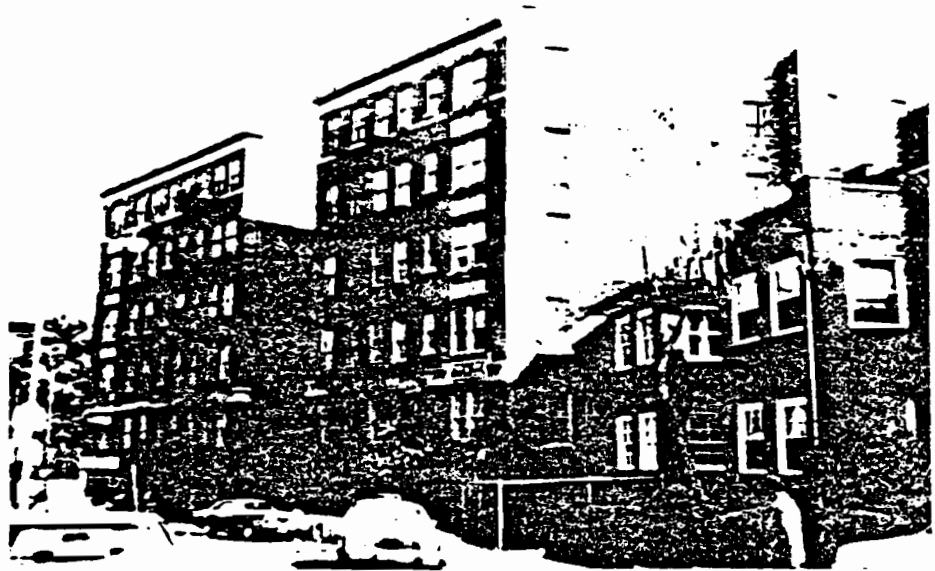
The building appears basically sound, with some signs of settlement and neglect. The courtyard stairs are cracked and uneven, and there is some indication of heaving in the courtyard surface. The fountain is not functioning. The brick wall requires some pointing and limited replacement, and there is evidence of several sill failures. Substantial floor deflection was observed in several areas of the interior, but HPD accepts the builder's contention that no structural work will be needed

View from Andrews Avenue,
showing main courtyard
entry to residential
units.

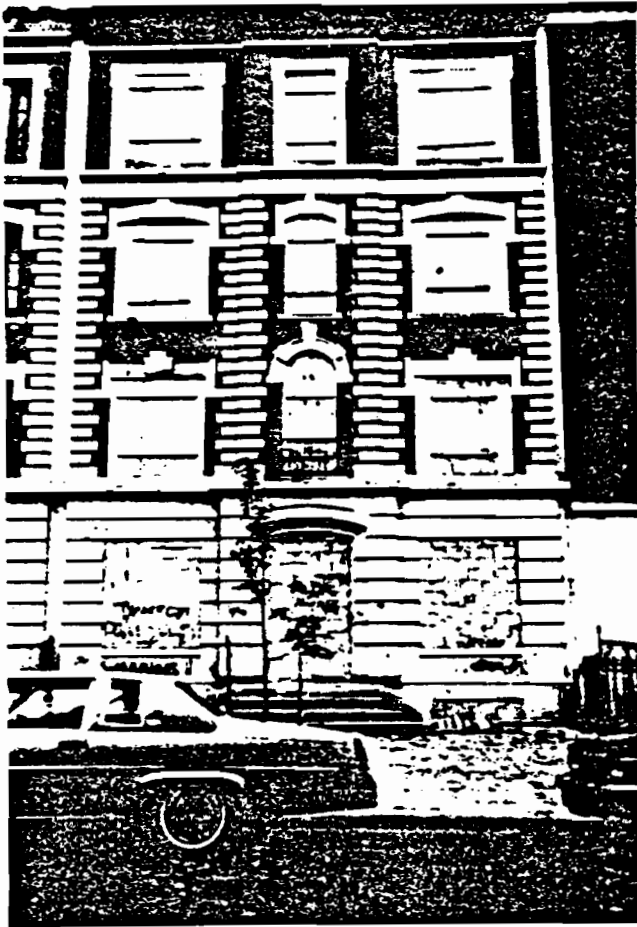
388 St. Johns Place,
Prospect Heights

View along the south side of St. Johns Place, showing the four identical row structures. 388 is the darker building on the left, 376 is on the right, in the foreground.

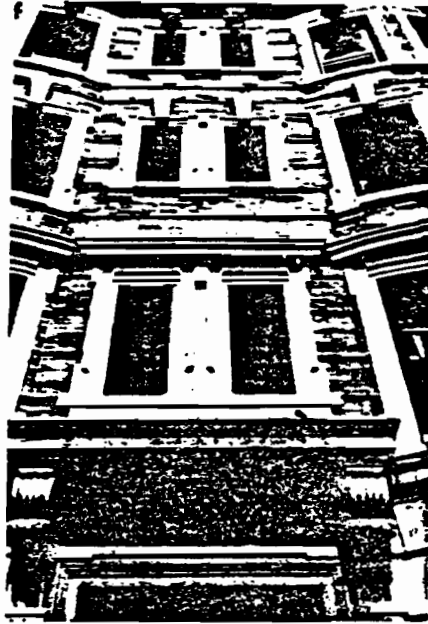
Windows are showing signs of deterioration, with paint peeling and flaking, revealing the beginnings of rot. The building has broken windows on the first and fourth floors.

431 Sterling Place, showing the stone facing along the first story, window ornamentation and brick binding at the upper floors. Note the open, shattered windows exposing the interior to weather.

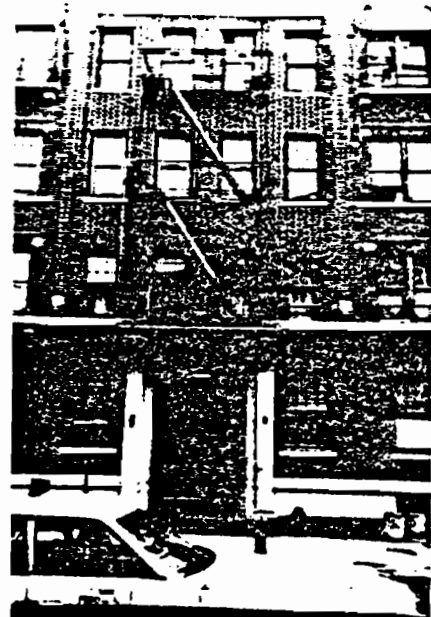
345 Lincoln Place, showing Tudor Style window treatment and ornamentation of the project.

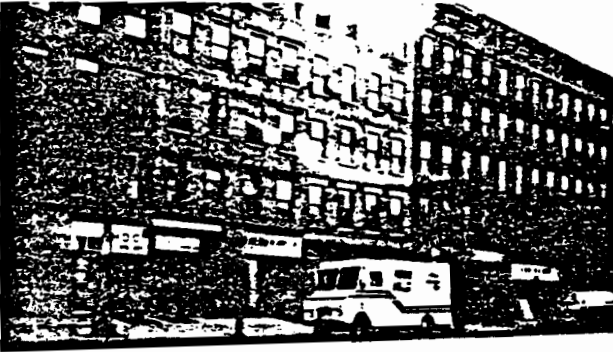
465 W. 46th St.,
Clinton

View from across 10th Avenue,
showing first floor commercial
units and the new windows in the
residential units.

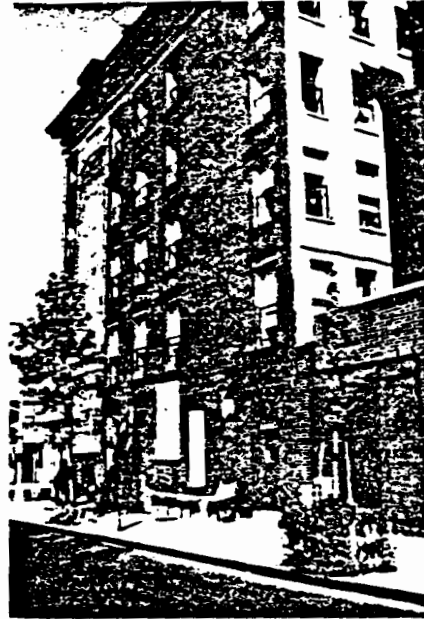
View from across W. 46th St.

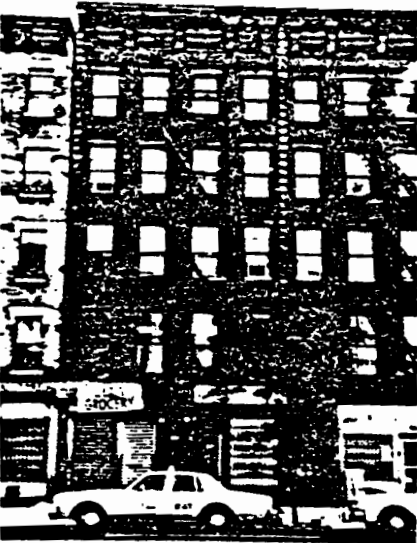
One old-law tenement
structure (4 windows wide)
comprising two housing units,
side by side, on each floor.
